RE: Annual Inspection for Bristol Landfill
GME Project No. 25-015

**Explanation of Findings
Bristol Landfill Inspection Report - 2019**

Bristol Landfill Inspection Report – April 2019
Inspection Photographs

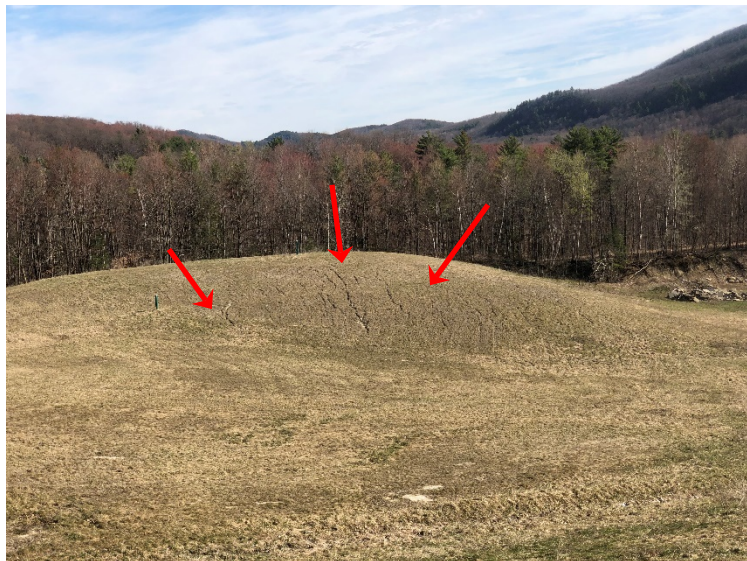
Photo #1: Erosion along southern facing slope

1. Several areas of the cap showed erosion as can be seen in attached photos and marked up site plan. The areas shown on the marked plans are approximate, and GME recommends that all areas of erosion be scarified, filled and reseeded to prevent erosion through the cap.
2. The area shown in photo #7 the plan appears to have been damaged by mowing and should be addressed the same way as erosion.
3. The drainage swale along the north limits of the landfill cap is showing some erosion as shown in photo #6 - #9. Any areas where the outer drainage swale is eroded should be restored.

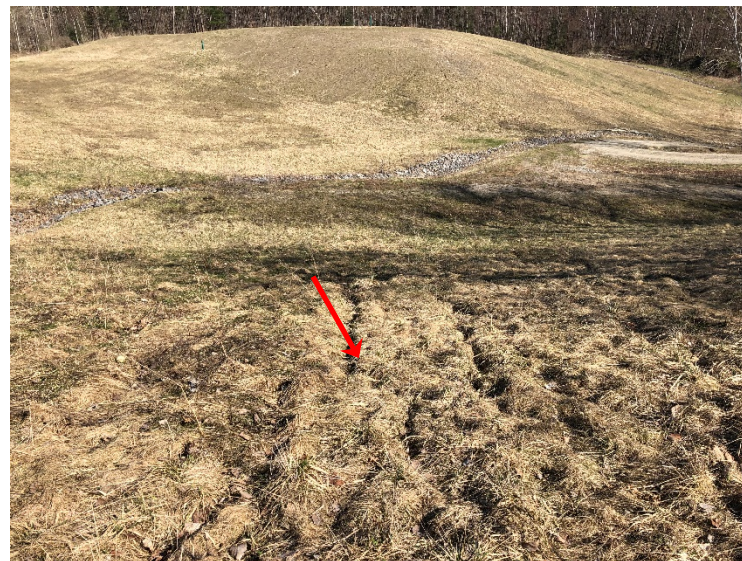
Photo #2: Closeup of eroded areas on north facing southern limit

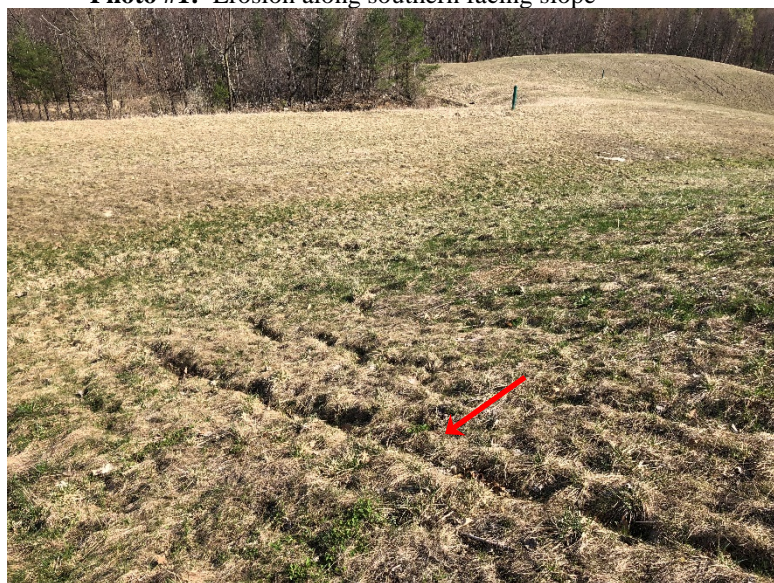
Photo #3: Closeup of eroded area on south facing slope

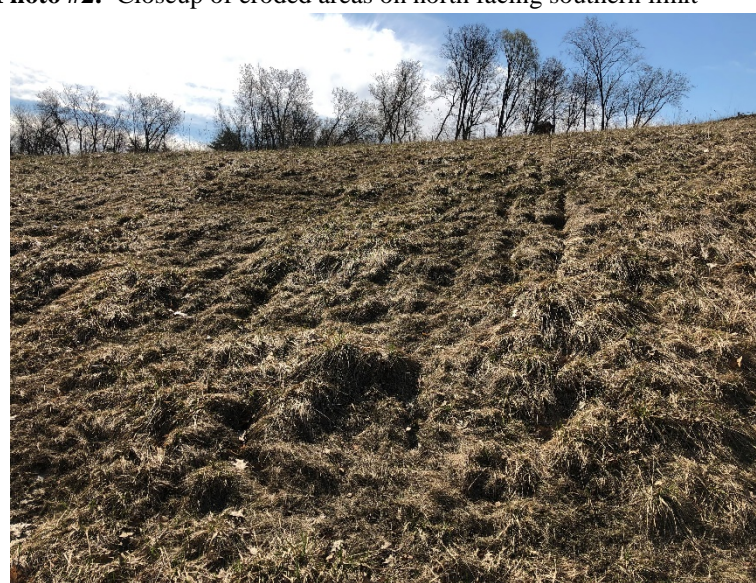
Photo #4: Closeup of eroded area on north facing slope

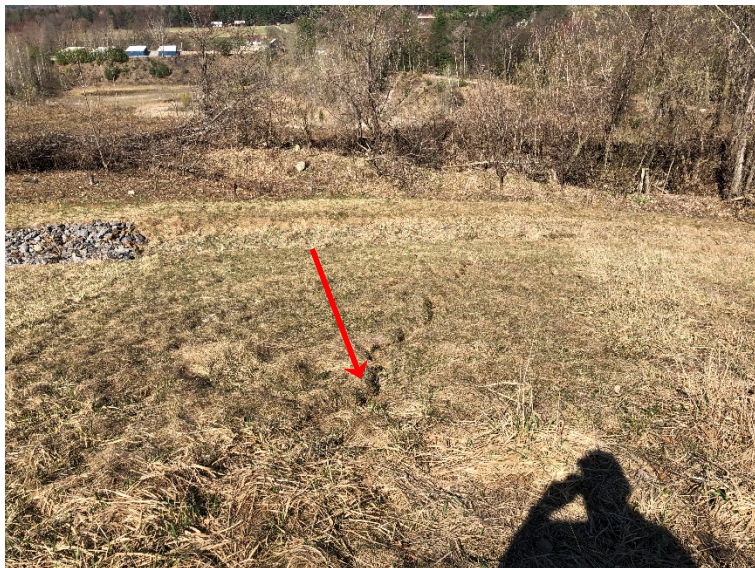
Photo #5: Eroded area on West facing slope

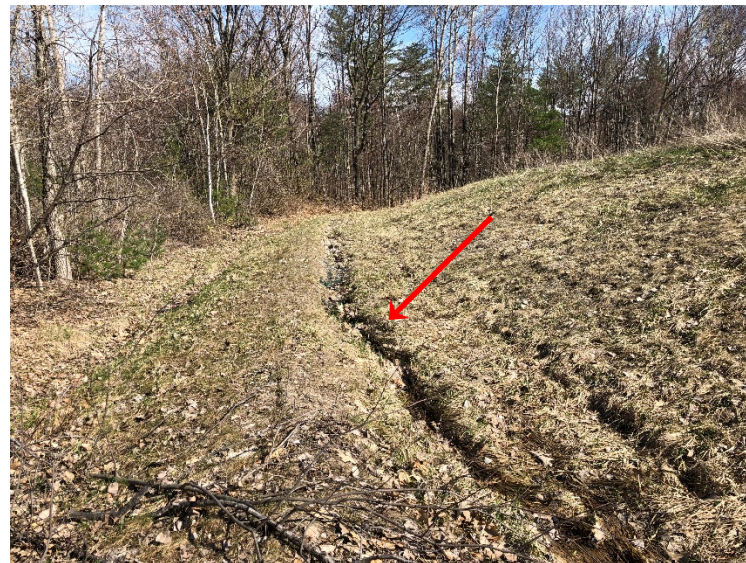
Photo #6: Eroded area on north facing drainage swale

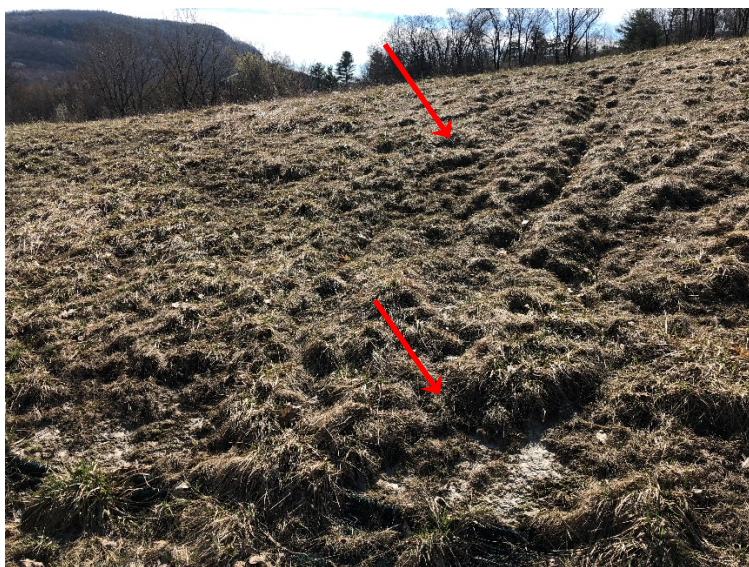
Photo #7: Damage showing some erosion
Green Mountain Engineering, Inc.

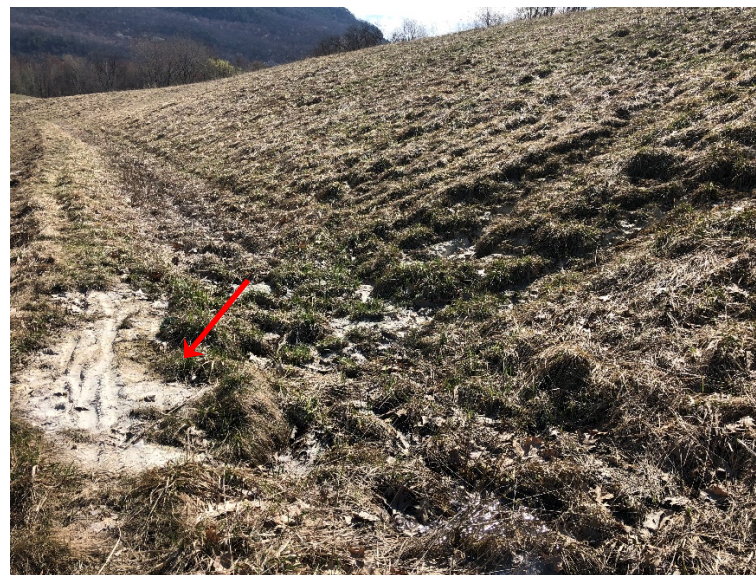
Photo #8: Closeup of erosion on north facing swale

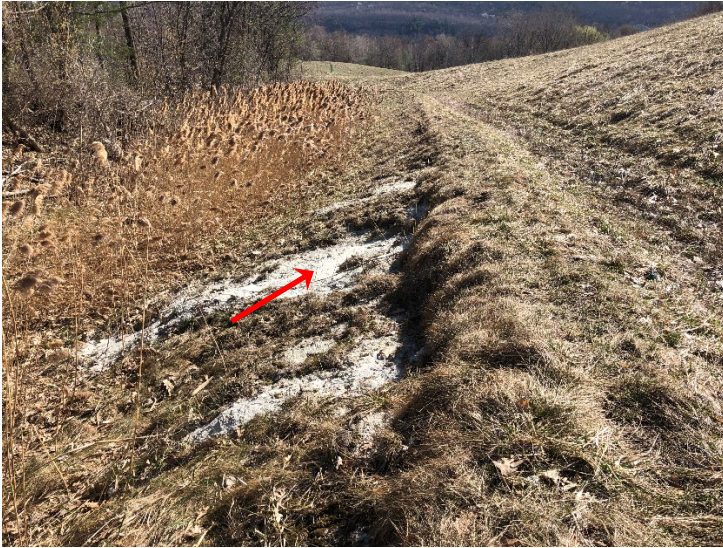
Photo #9: Erosion along drainage swale on northern limits

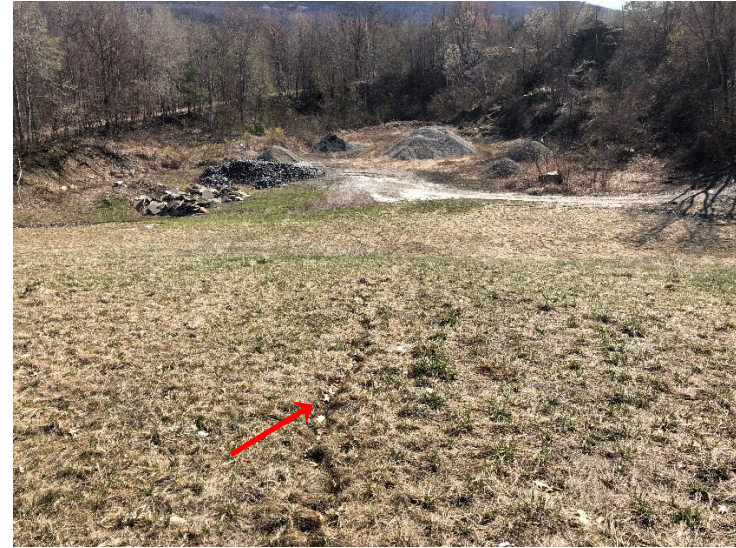
Photo #10: Erosion on northeast slope
