Annual Inspection for Bristol Landfill

GME Project No. 25-014

Explanation of Findings Bristol Landfill Inspection Report - 2021

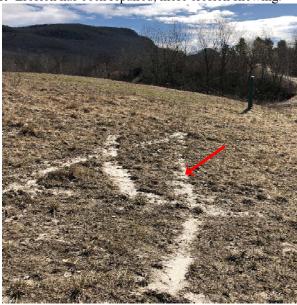
Photo #1: Erosion has been repaired, more erosion showing.

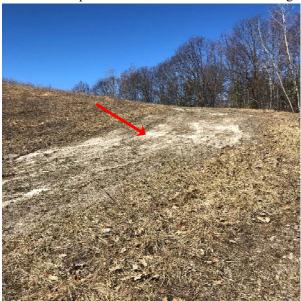
Photo #2: Erosion has been repaired in these areas on the south facing slope

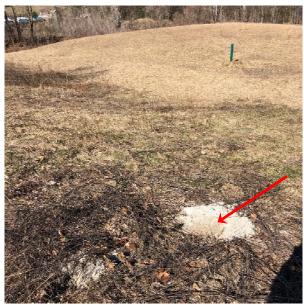
Photo #5: Animal holes along southern limit.

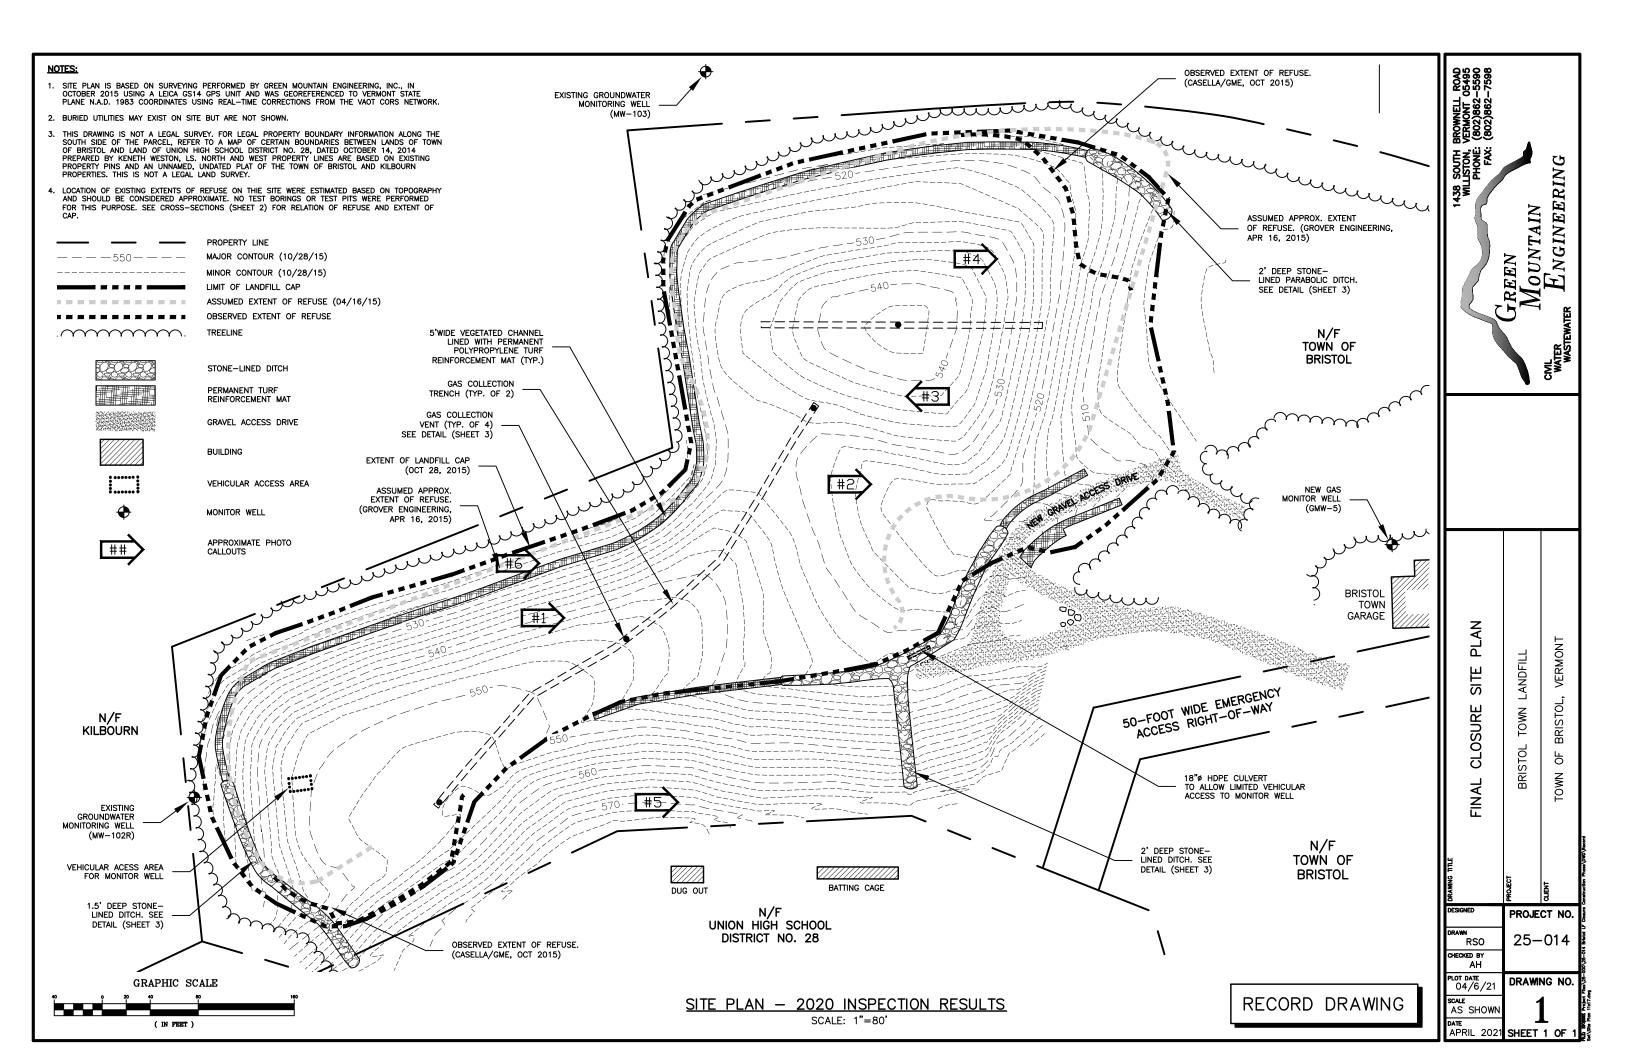
Photo #6: Eroded area on north facing drainage swale

- 1. Several areas of the cap showed erosion in 2020. Most of these areas have been repaired. Photo#1-2
- 2. Some areas still show erosion that appears to be mostly from vehicular traffic. These areas can be seen in attached **Photos #1 & #2- #4** and marked up site plan. The areas shown on the marked plans are approximate, and GME recommends that all areas of erosion be scarified, filled, and reseeded to prevent erosion through the cap.
- 3. **Photo #5** shows an area where animals have burrowed into the cap. This area should be restored to prevent erosion.
- 4. The drainage swale along the north limits of the landfill cap is showing some erosion as shown in **Photo #6**. Any areas where the outer drainage swale is eroded should be restored.
