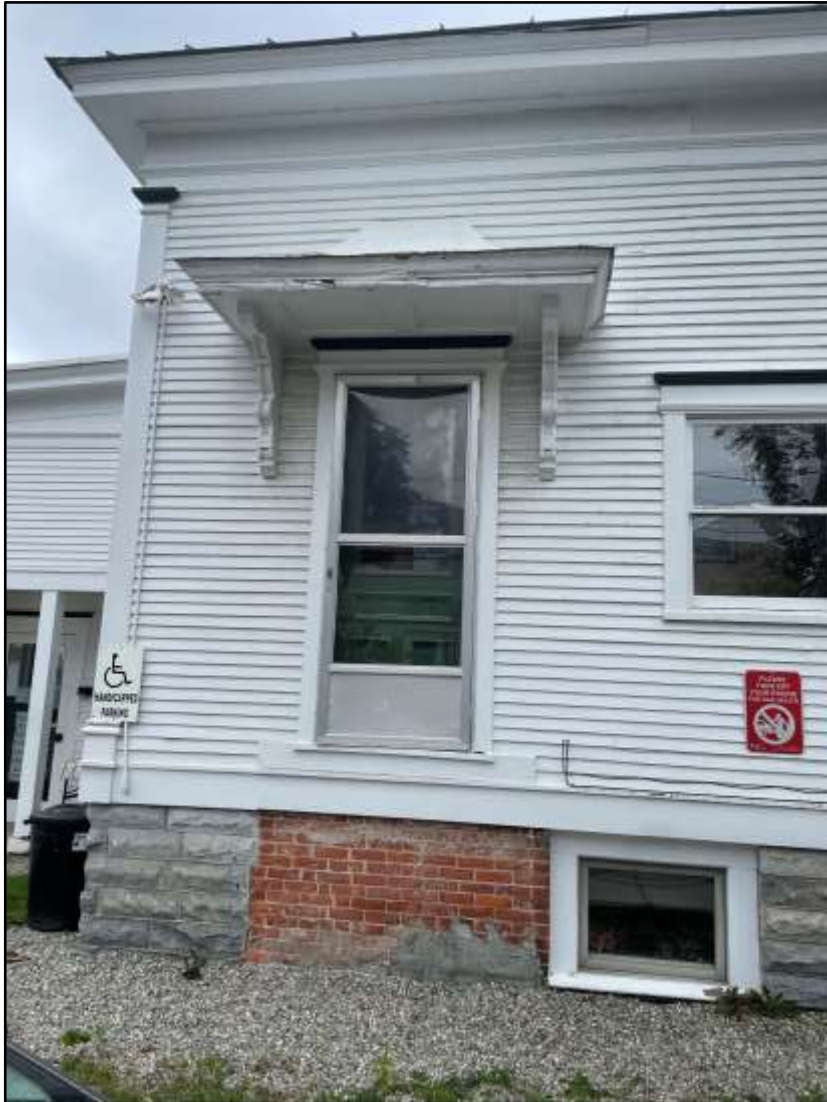
Figure 1. Side door overhang, north side. (09/10/2021)

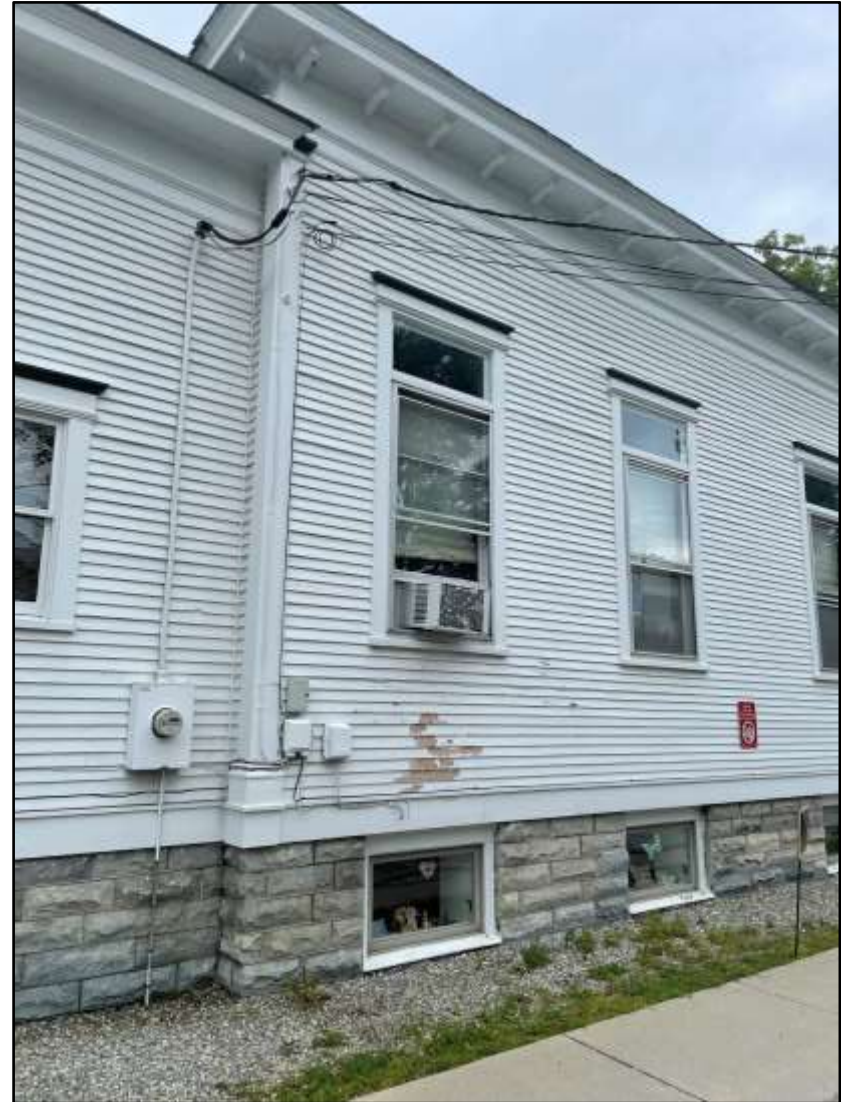
Figure 2. North side peeling paint. (09/10/2021)

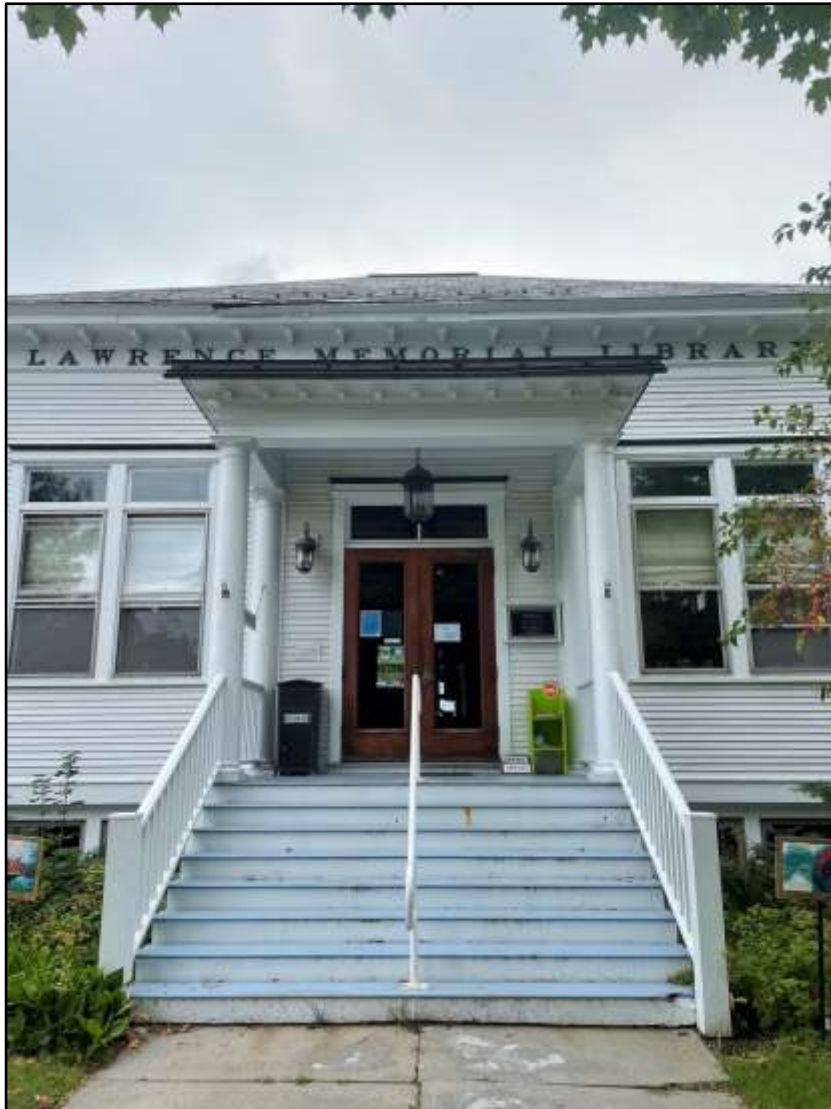
**Figure 3.** Front steps and porch. (09/10/2021)

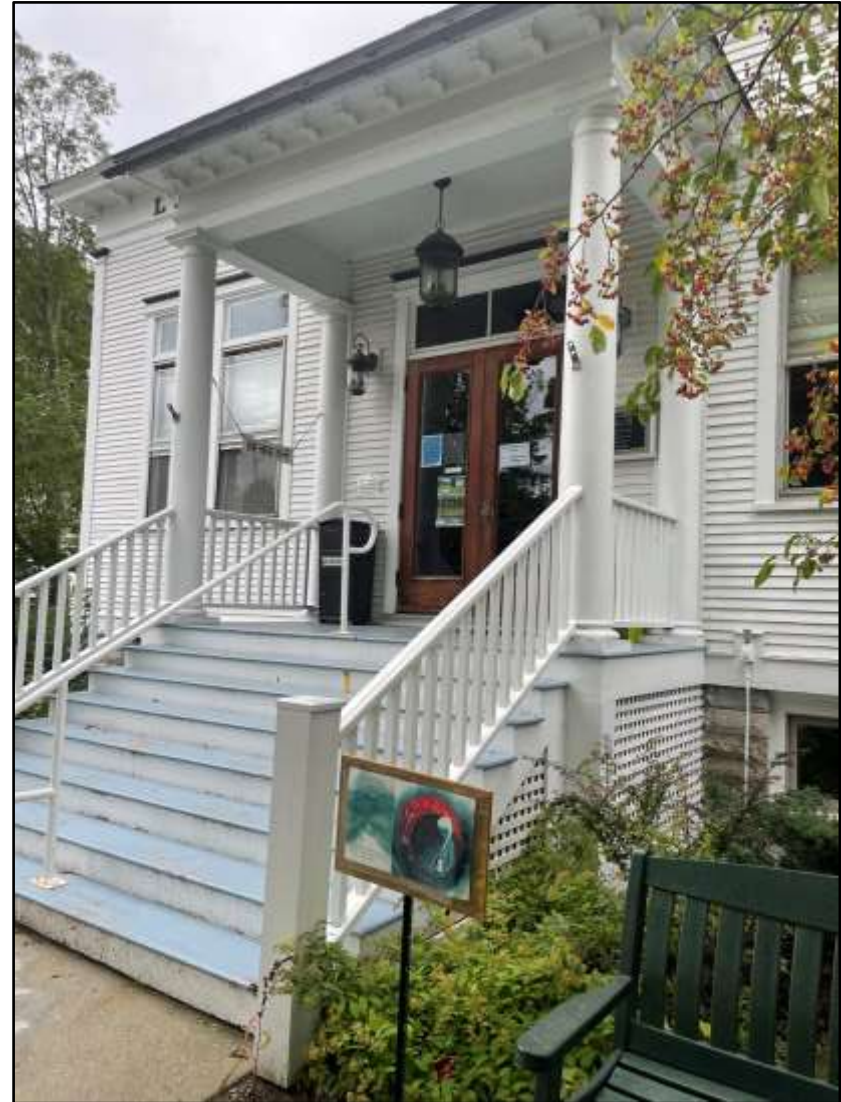
**Figure 4.** Front steps and porch, south side. (09/10/2021)

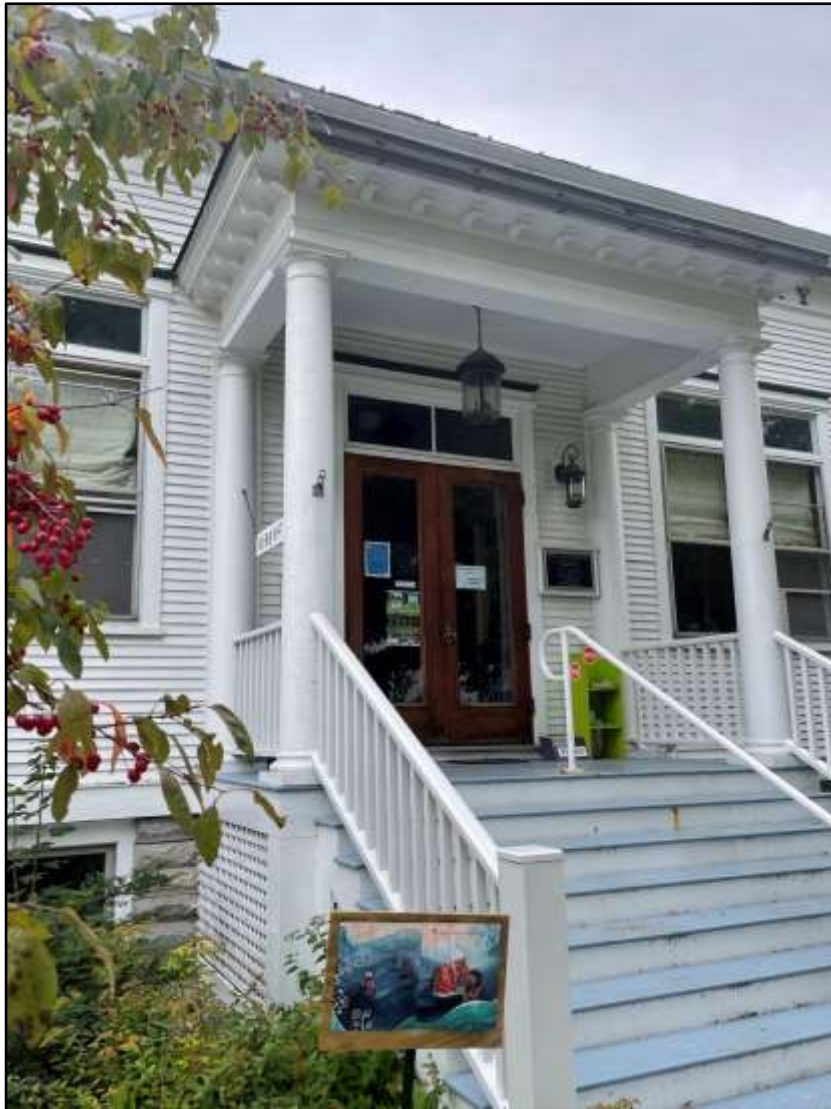
**Figure 5.** Front steps and porch, north side. (09/10/2021)

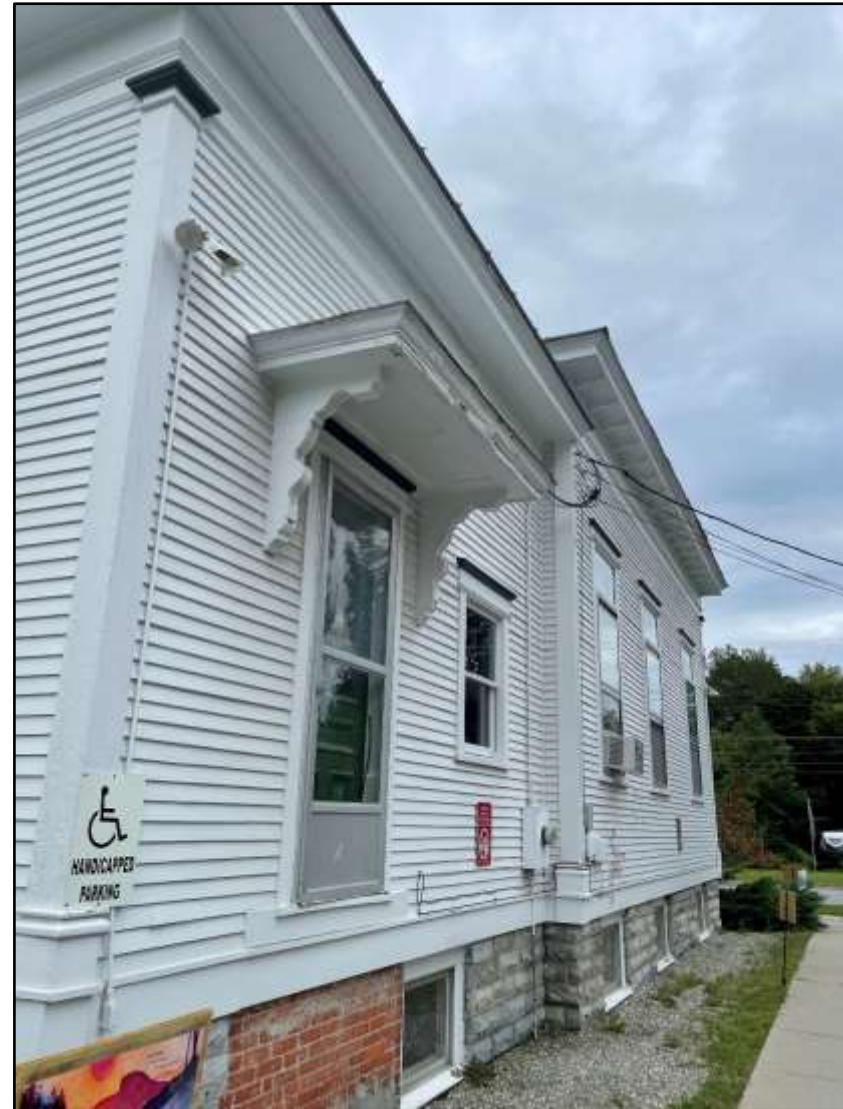
**Figure 6.** North side of the building. (09/10/2021)

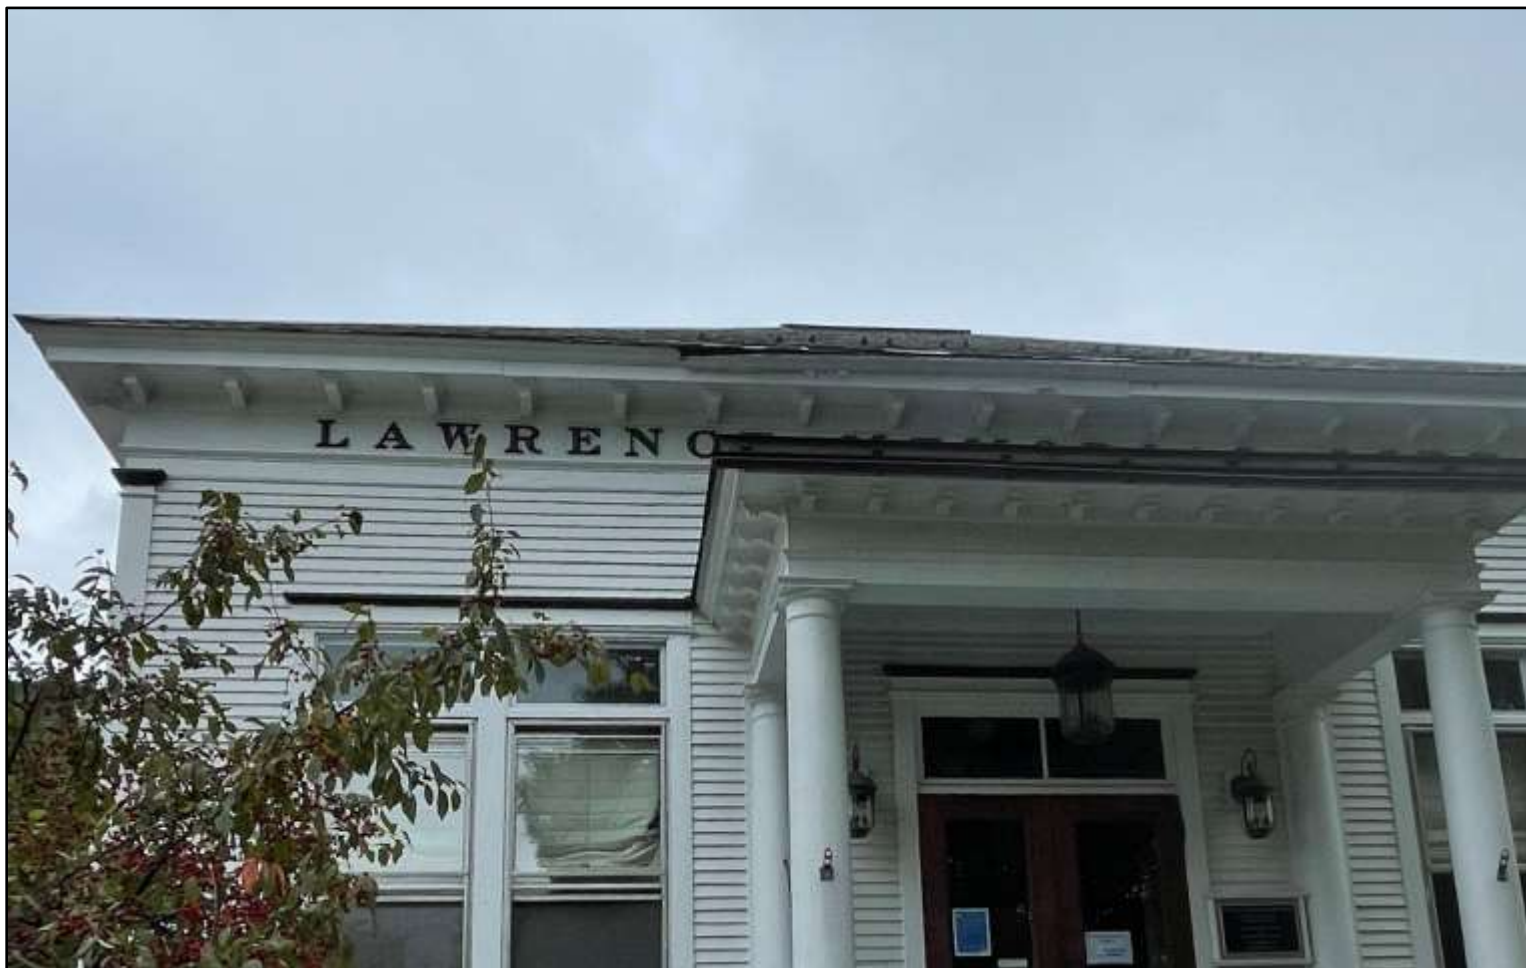
**Figure 7.** Closer view of upper roof eave deterioration. (09/10/2021)
