RE: Bristol Landfill – 2022 Annual Inspection
Solid Waste Identification Number AD080
ANR Project Identification Number RU95-0205

**BRISTOL LANDFILL
2022 ANNUAL INSPECTION REPORT**

**Prepared for:
Town of Bristol, Vermont**

**Prepared By:
VTM Engineering**

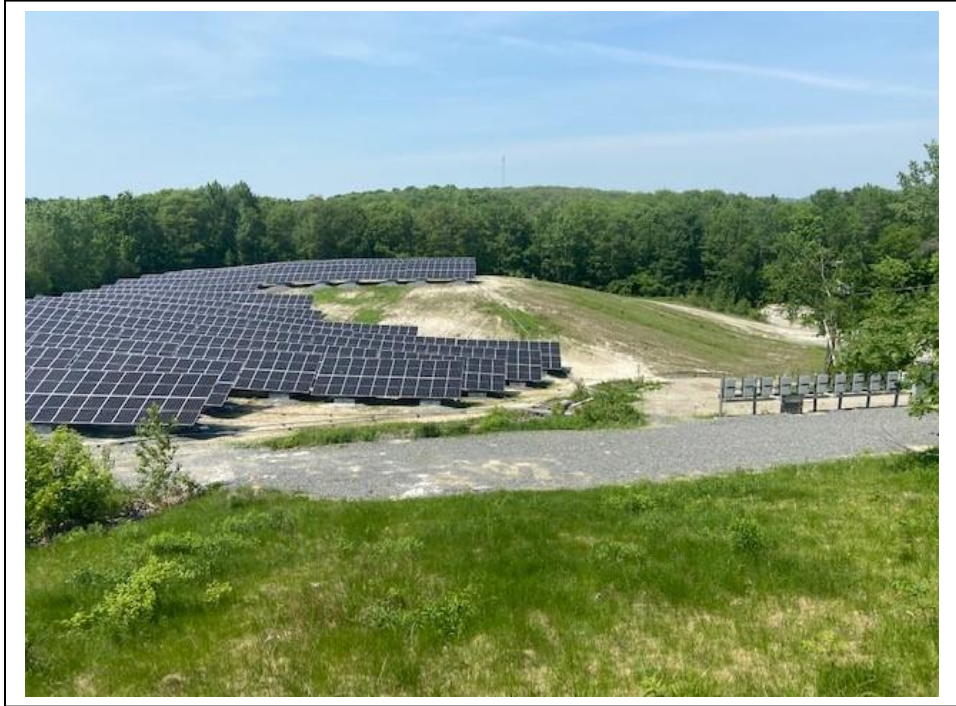
Photo #1 – Landfill Overview

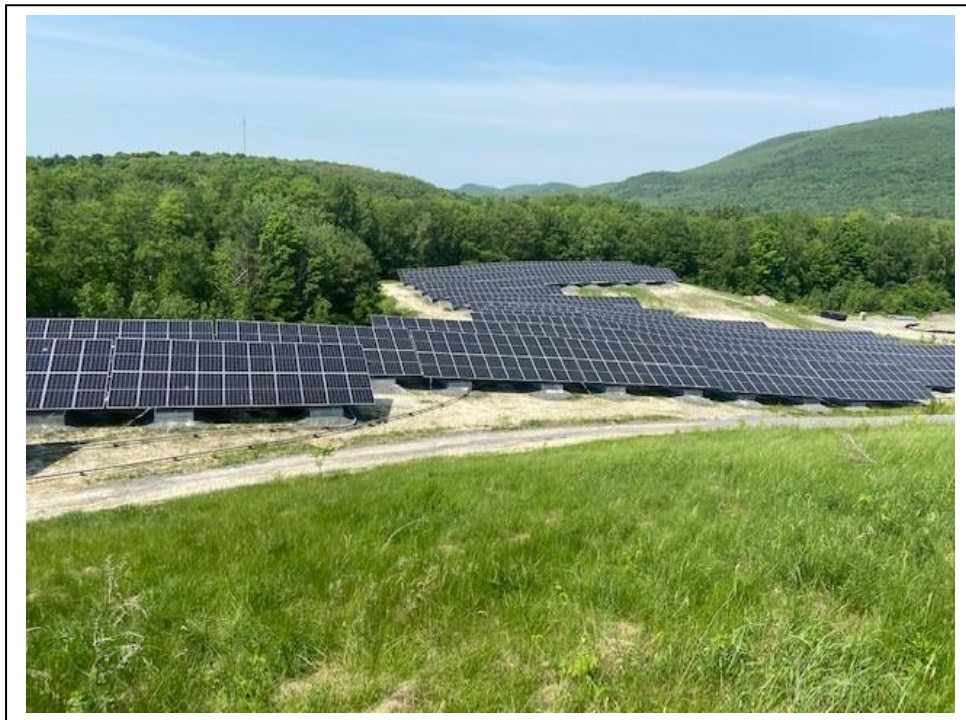
Photo #2 – Landfill Overview

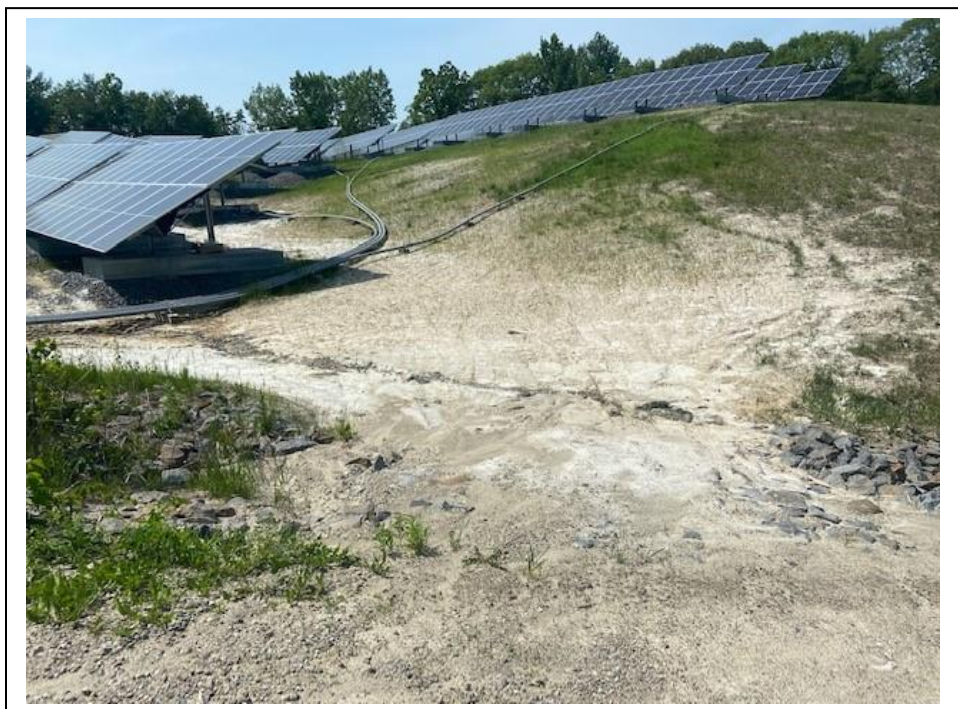
No areas containing significant differential settlement were noted during the inspection. Small bushes/trees were noted to be growing within the former landfill limits in a number of areas indicating that annual mowing of the vegetated cover does not appear to have been conducted recently. The vegetative cover (grass) itself appears to be receding and in decline over much of the landfill cover area. This decline is likely due in part to a lack of recent mowing. A number of areas particularly near the solar arrays were noted to have little to no vegetative cover whatsoever. The vegetative cover in these areas had been disturbed during construction of the solar arrays (as would be expected). Minor erosion was noted to have occurred in a number of areas, predominately on the north and west sides of the former landfill. It was also noted that several larger areas on the north side of the landfill had recently been smoothed and repaired. It did not appear at the time of the inspection that seed, mulch or other efforts to re-establish growth of the vegetative cover where needed had been conducted. On June 15, 2022 the Bristol Town Administrator, Valerie Capels and Steven Palmer participated in a follow up meeting with the solar array project manager for Acorn, Nick Morehouse. Mr. Morehouse confirmed that the solar array construction was not fully complete as of the date of the annual inspection and that additional work to address re-establishment of the vegetative cover concerns was planned.

Photo #3 – Area in Need of Vegetative Cover

- A. All areas should be mowed at a minimum of once per year. Following the initial mowing, further evaluation of the vegetative cover and underlying vegetative cover layer should be performed. Mowing and re-establishment of vegetative cover (where needed) should be a priority. Where erosion is noted or vegetative cover is limited, areas should be filled (as necessary), smoothed, re-seeded and mulched. Maintenance of all newly seeded areas should be performed as needed.

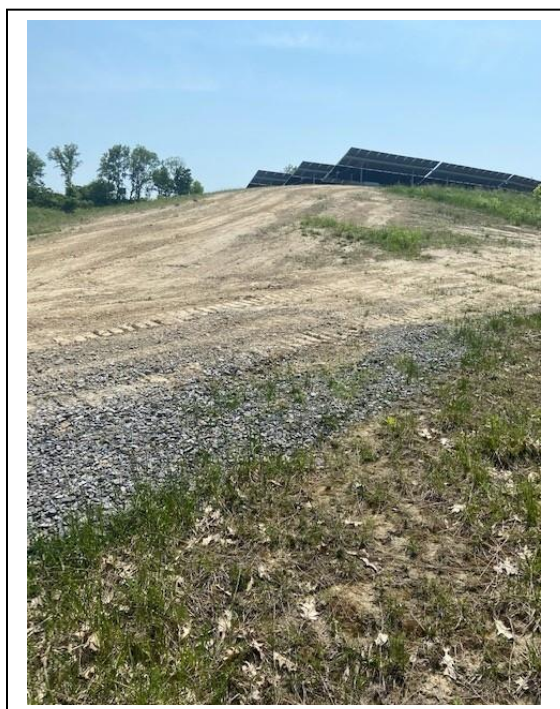
Photo #4 – Areas in Need of Vegetative Cover

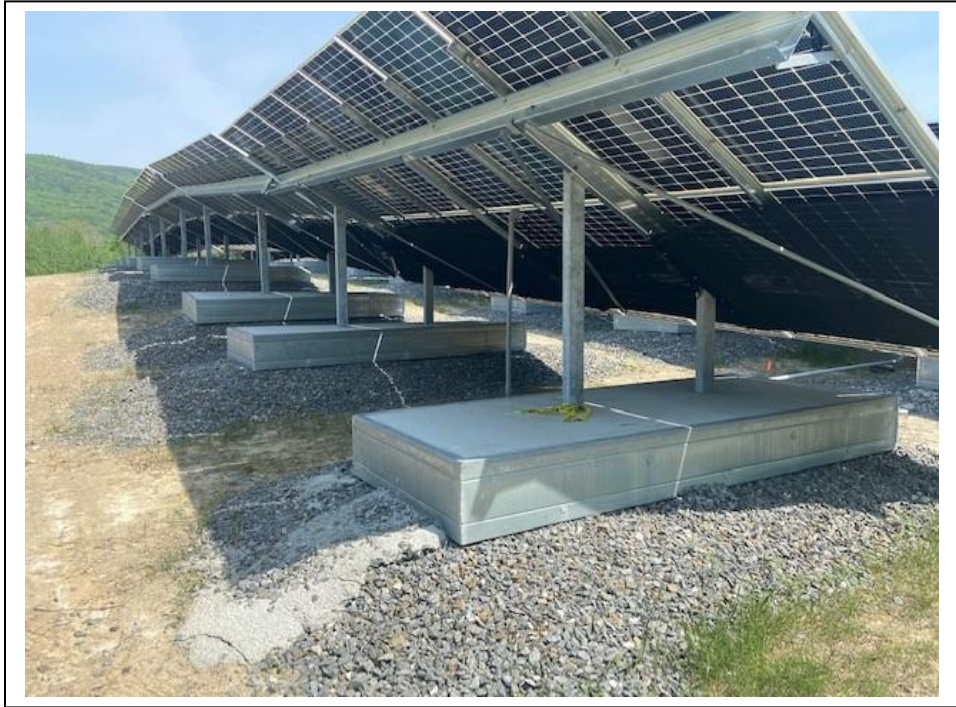
In 2021, a new solar array was constructed on top of the former Bristol Landfill. The solar array appears to be a completely free-standing design with no buried foundations, wiring or other components that may have directly impacted the final cover integrity during construction. No notable differential settlement, lateral foundation movement, or ballast issues were noted, and the solar arrays appear to all be in excellent condition.

Photo #5 – Solar Array

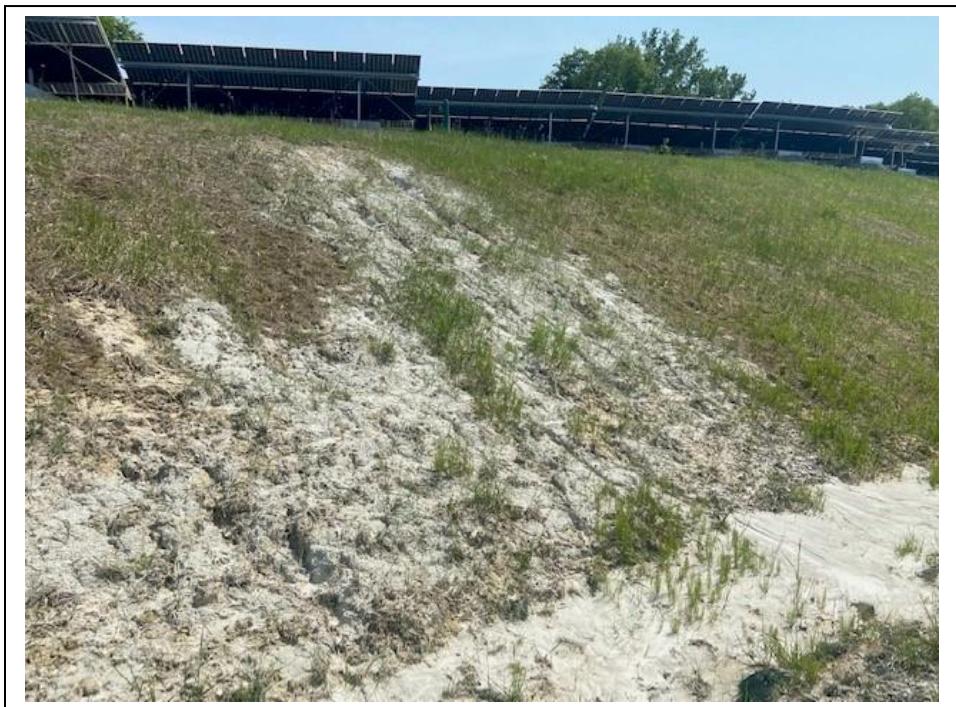
Photo #6 – Erosion

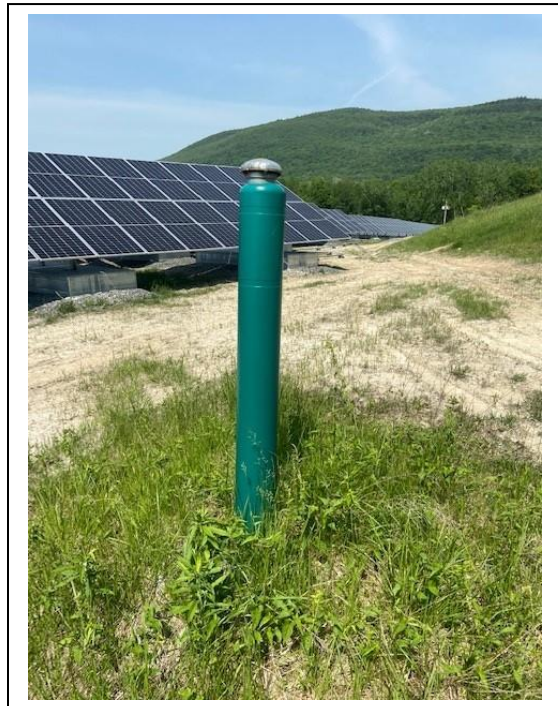
Each of the existing passive gas vents were observed during the inspection. No settlement or other visible issues were noted, and the gas vents appeared to be functioning.

Photo #7 – Gas Well

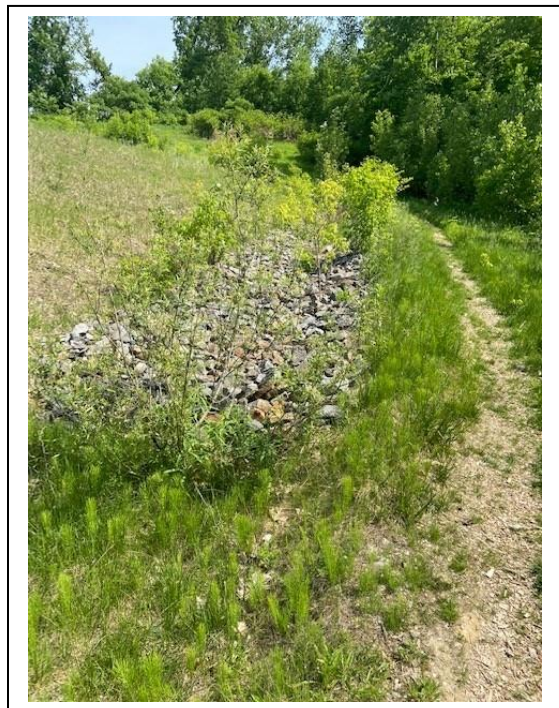
Lastly, the stone lined drainage ditch along the northwest side of the facility was noted to contain a moderate amount of brush and small trees. This ditch however appears to still be fully functional. Valerie Capels indicated that the Town would develop a plan to address this issue.

Photo #8 – Stone Drainage Ditch Growth

- C. All brush and small tree growth within the existing stone perimeter drainage ditches should be removed. This appears to be an issue specific to the west side of the site.

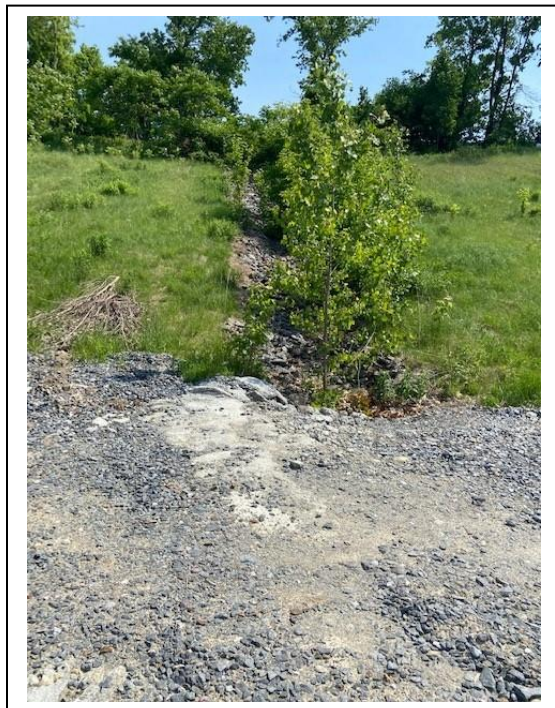
In general, the stone drainage ditches surrounding the site appear to be in good physical condition. No settlement or other similar damage was noted which would impact their operation. One section of the stone lined ditch on the south end of the former landfill appears to have recently been filled to facilitate vehicular access to the west side of the site. It is assumed that this was done to allow access during construction of the solar array (see attached photographs). Small amounts of sediment from erosion were noted directly below this area. Valerie Capels indicated that the Town would develop a plan to address this issue.

Photo #9 – Filled Stone Drainage Ditch & Growth

- D. The portion of the stone lined ditch that was filled to provide access around the north side of the site should be addressed. The ditch should be re-established. If vehicular access is required in this area, a culvert could be installed and the access road re-established. In this instance, care should be taken to ensure that there are no adverse impacts to the existing final cover system.
