Lawrence Memorial Library – Bristol, Vermont

Historic Architectural Assessment

Site Visit: October 24th, 2022 11am
60 Deg. Calm to light wind, overcast.
Report Date: November 11th, 2022

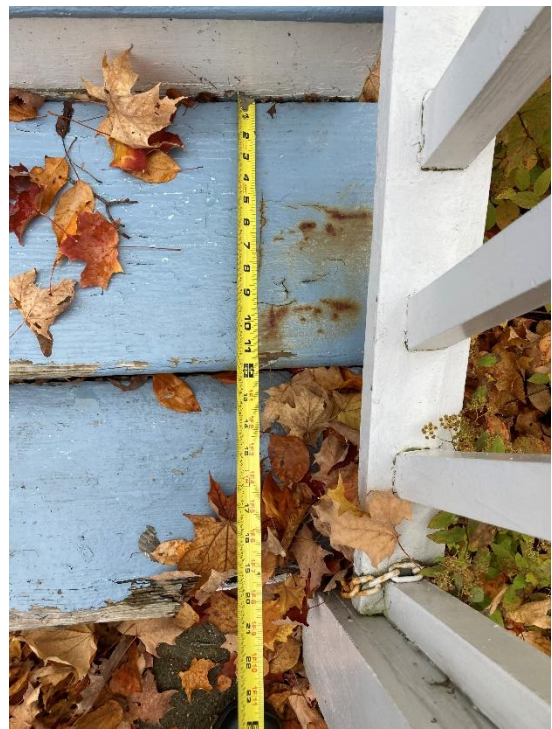
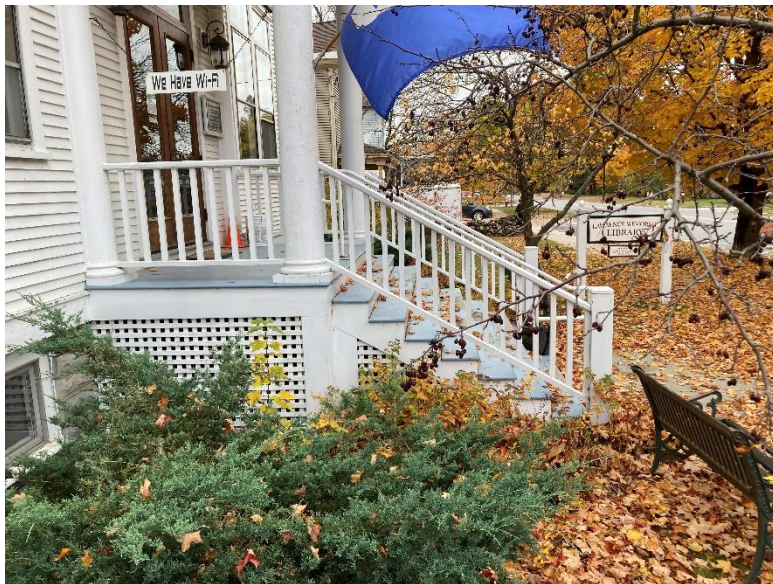
The stairs are exhibiting excessive paint chipping and rust discoloration coming through the finish. This was described as an ongoing issue that has had several attempts to resolve unsuccessfully. On consideration, this is likely caused in-whole or in-part by the salt put down to avoid slip and falls in in climate weather. This physical abrasion and chemical reaction may have caused the salts to leach into the wood and causes the fasteners to rust and the paint finish to not get a good attachment to the wood fibers when it is applied. My recommendation is to use a chemically resistant epoxy

primer and paint (such as Rust-Oleum Marine Topside Paint) or a two-part epoxy made for exterior wood decks, with a no slip additive as recommended by the manufacturer. This will need to be applied by a professional. Because of the use, and circumstances, this will need to be renewed at intervals more frequent than other surfaces of the building.

Front step refinish - **Allow ~\$3,000 – \$7000**, this includes removal of current paint finish, rust remediation of handrails, (possibly replacement), chemical neutralization, primer and two or more coats of epoxy with slip resistant additive.

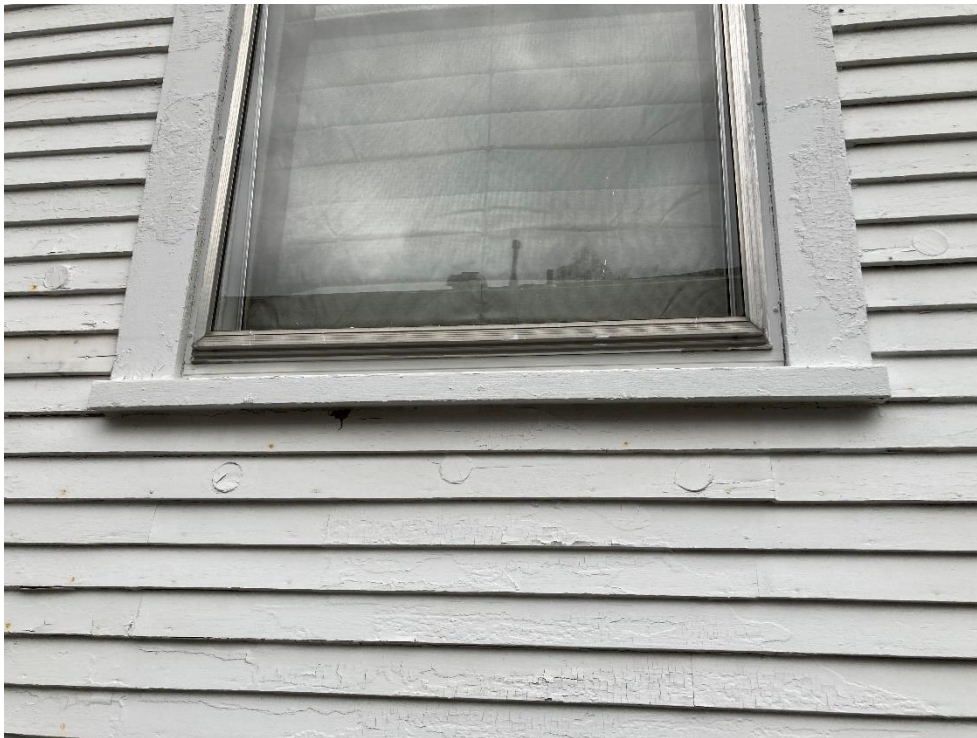
panels appropriate for this method. There are tell-tale patched holes in the siding of (on the South side) where cellulose insulation was added into the wall cavities.

Figure 10 - showing cylindrical holes indicating blown in insulation in the wall cavity from the exterior side.

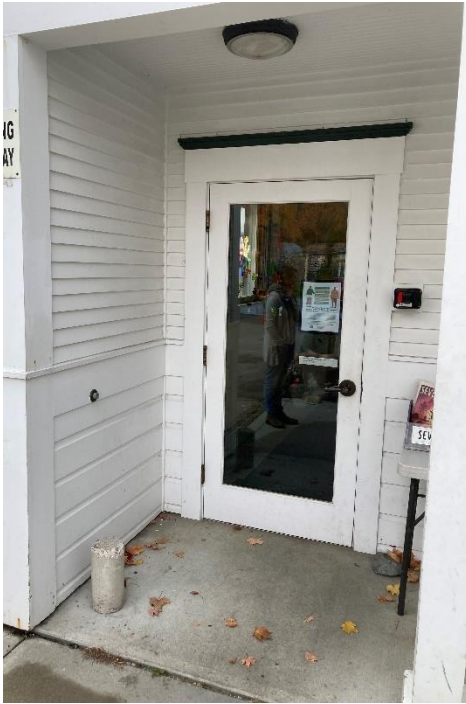
Figure 15- ADA entrance on the North side

The ADA entrance on the north side is in the newer addition, and seems to work for this purpose. It appears to have proper access, and door hardware, and accesses a stair landing that includes a lift to the upper and lower levels.

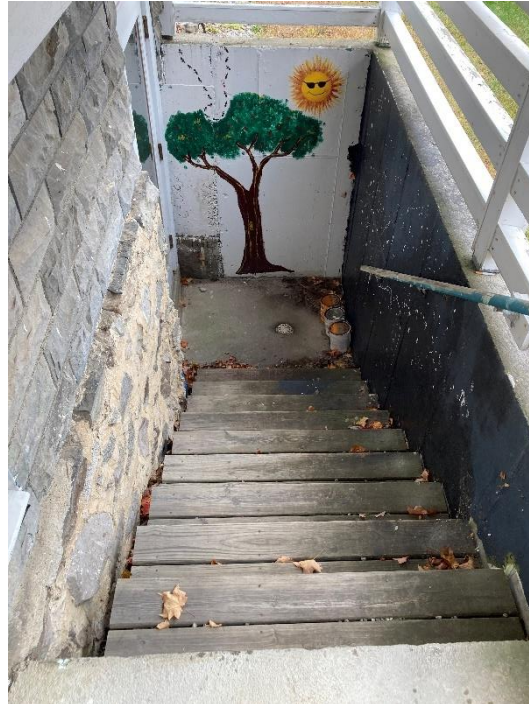
Figure 16a- Egress door and stairs from lower level (outside)

The lower-level egress door exits from the children’s space, and has a set of small gates on the interior side. And wooden exterior stairs on the outside. The handrail on these stairs appears to be non-code-compliant (extensions). In my opinion this is a low priority for modification.

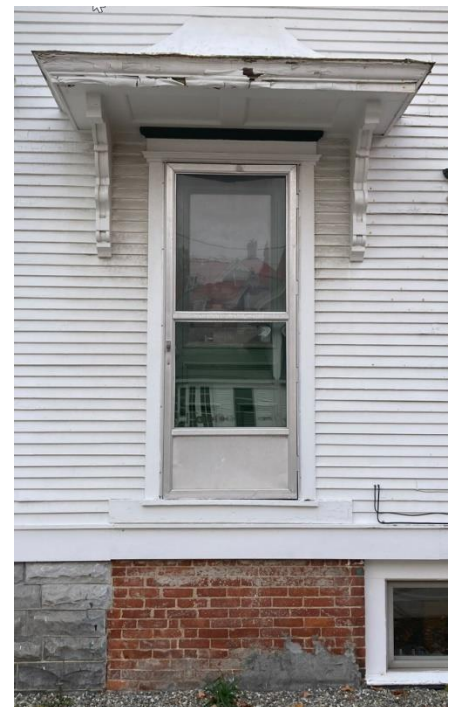
There is a curious exterior door on the north side that is vestigial, presumably abandoned when the stair / lift addition was added. Provided this door is not accessible from the inside, it is not necessary to remove this door. If it is desirable to remove the door, it should be replaced with a window of similar sized and character as the adjacent window. The overhang should be kept and maintained as an important part of the historic nature of the building.

The brick infill is not historically accurate and it may be desirable to infill with stone matching the rest of the building. It almost appears that there was a surface applied finish to mimic the stone color and texture? But this was unsuccessful, and may have since partially been removed or come off by other means. The glass and aluminum storm door does nothing but detract from the historic character of the building, but does appear to have done its job protecting the door itself. My suggestion is to either: remove the door and replace with a window, or leave it as is until a renovation is planned for this area that will resolve the incongruity / anachronistic character of this opening.

Remove exterior door and replace with window and exterior siding back to like new condition.

Allow \$17,000 (some of this repair may be covered in the siding replacement scope above).

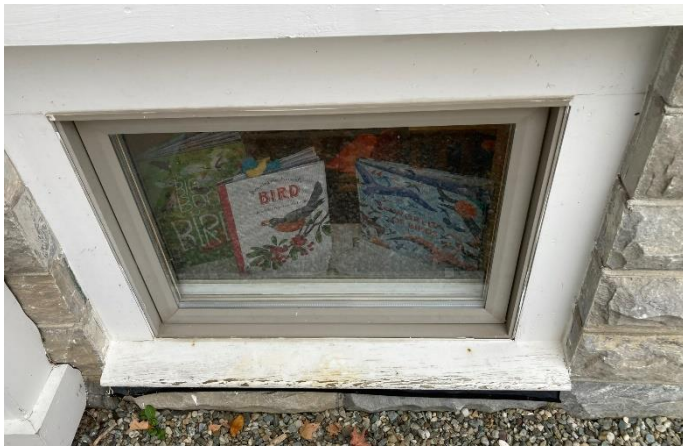
Figure 18a- Typical lower-level Al. clad wood window

These lower windows are 2'- 0 3/4" tall by ~ 3'-0" wide (varying from 2'- 8" to 3'- 4"). They are awning of mixed cocharacter, most aluminum clad wood windows, of contemporary construction. The lower-level bathroom window is green painted wood (appearing as original window) with obscured glass.

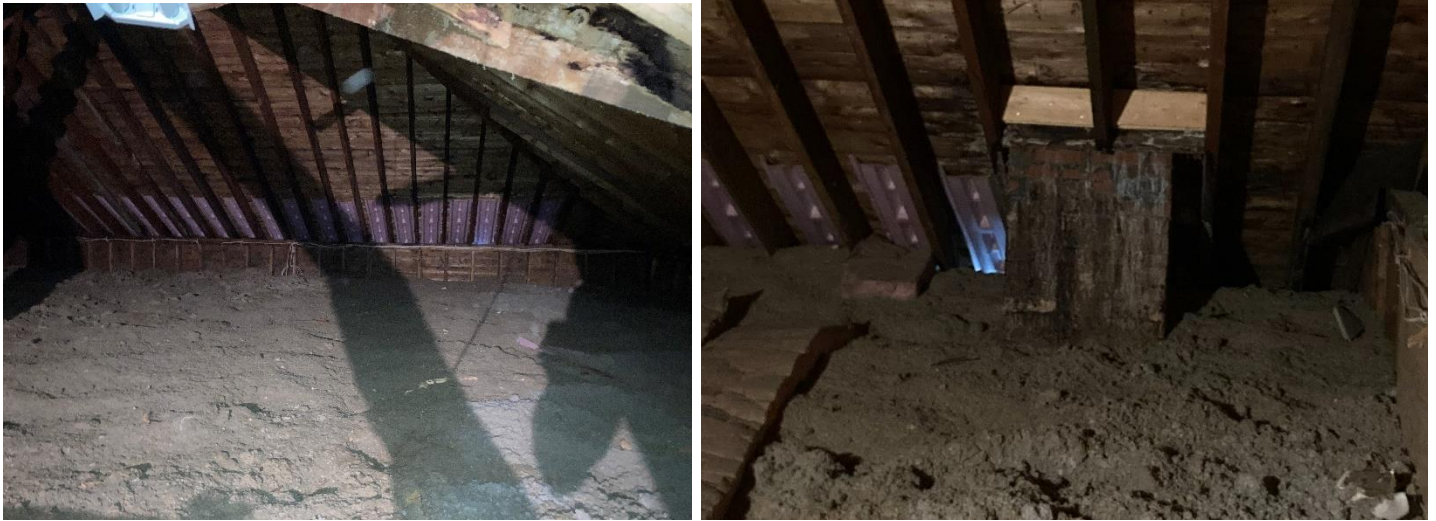
Attic space was observed. Of note in the attic, was the discoloration at the chimney indicating water leakage at some point in the building's history; and curiously what appeared to be daylight coming up from one of the soffit baffles, (not necessarily indicative of some issue or problem, but it certainly stuck out in its singularity).

Miscellaneous roof repairs including patching and repair at chimney, restoring original slate that may be broken, and replacing roof flashing, and waterproofing.

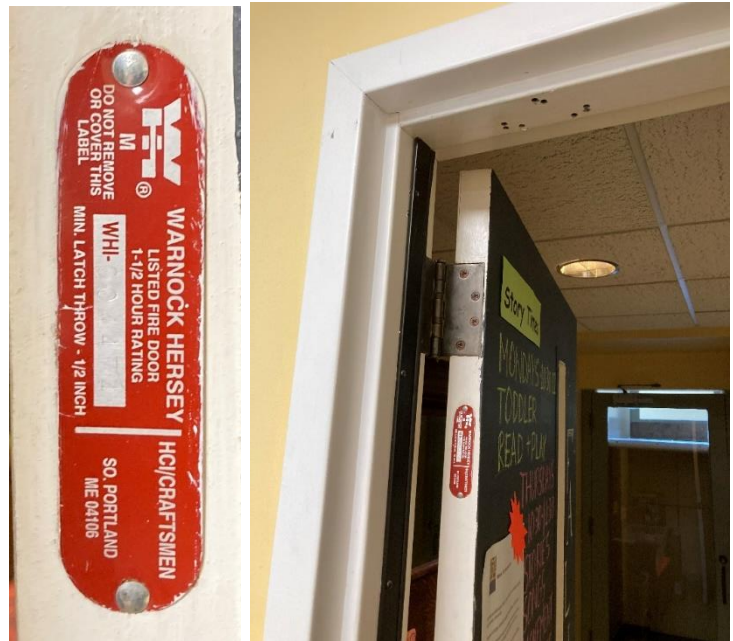
The door separating the stair area from the children's space on the lower level is appropriately a rated door and as such requires a closer. (See the red tag on the door in the photo indicating an hour and a half (90 min) fire resistance rating. A closer shall be reinstalled on this door as soon as possible. If it's desirable to keep this door open (which greatly adds to the welcome of the space), a magnetic hold open tied to the fire alarm system may be used.

Add a closer to the fire door located on the lower level.

Allow the range of \$250 to \$5,000+ or more (range is based on if there is the desire to tie into the fire alarm system. I did not see an addressable fire alarm panel, and this addition of a complete fire alarm system may be an expensive proposition). On the other hand, if the closer that was there is still available the cost may be minimal to reinstall.
