RE: Town of Bristol Fire Station
Authorization to Discharge Permit No. 7468-9015.T

This letter and supporting documentation represent the 2023 Bristol Fire Station Annual Stormwater Inspection Report as required by the above referenced Permit.

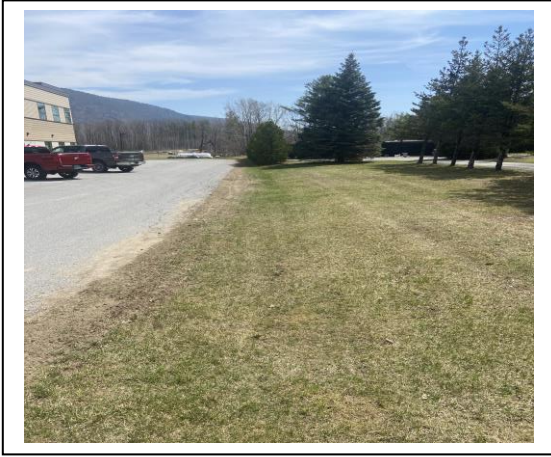
Grass lined swale along driveway

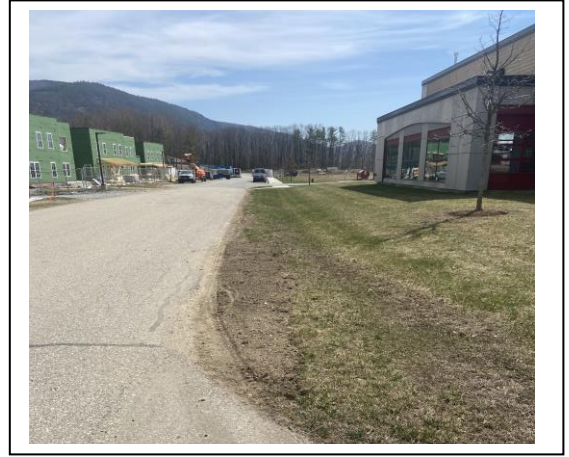
systems were noted that would necessitate maintenance. Several small areas of grass adjacent to the driveway were noted to have minor damage likely due to slow plowing over the winter months. All areas where damage was noted had been recently raked, seeded and mulched at the time of the inspection. The paved parking lot and driveway areas were also generally clean and free of dirt and debris that might eventually contribute to sediment buildup in the stormwater treatment system. Additionally, VTM personnel reached out to Assistant Bristol Fire Chief Kevin LaRose concerning any problems noted with the stormwater system over the past year. Mr. LaRose stated that there were no noted issues of concern with the stormwater system operation over the past year.

Recently repaired grass areas along driveway

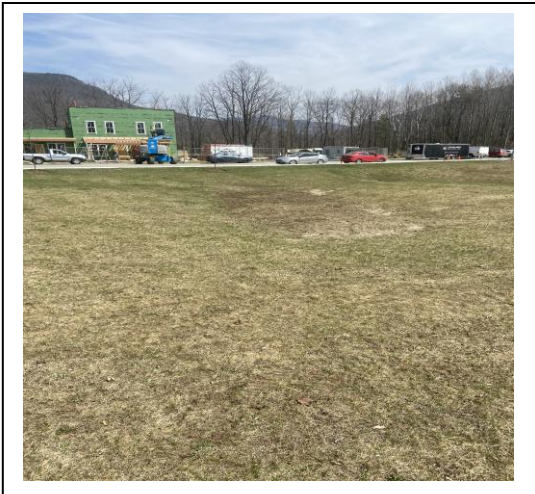
Forebay

During the field inspection, no areas of erosion or significant sediment buildup were noted in or around the forebay or infiltration basin. No other issues of concern related to the stormwater conveyance or treatment
