# LEAK DETECTION SURVEY REPORT

| Survey Area | Town of Bristol Water Distribution System | Survey Date | Apr 9th - Apr 12th 2023 | Leak # 1 |

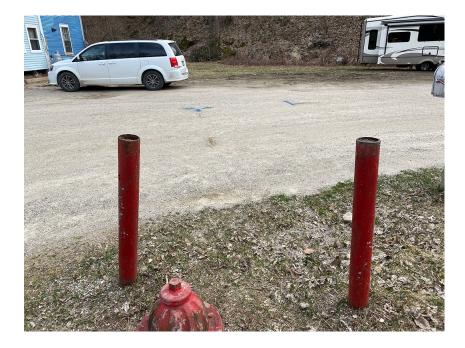
| Survey Area | Town of Bristol Water Distribution System | Survey Date | Apr 9th - Apr 12th 2023 | Leak # 1 |
|---|---|---|---|---|
| Leak Category | Hydrant Lateral | Pipe Material | Cast Iron | Diameter 6" |
| Cover | Soil | Loss Rate | > 50 gpm | Status Active |

### **Remarks** Correlates to a point beside the hydrant lateral Corporation. Best ground sound near corporation. However could be at hydrant base.

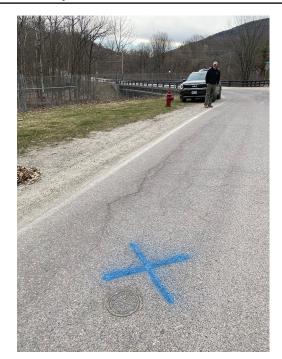
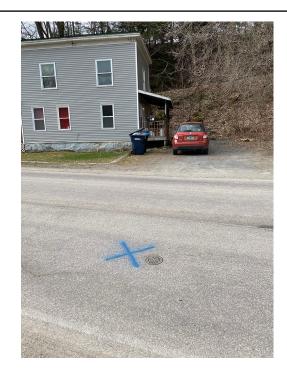
| Client Name | Town of Bristol, VT | <b>Client Address</b> | 1 South Street, Bristol, VT 05443 | |
|---|---|---|---|---|
| Leak Category | Distribution Main | Pipe Material | Cast Iron Diameter | 6" |
| Cover | Asphalt | Loss Rate | ≤ 40 gpm Status | Active |

Leak confirmed at, or adjacent to, main valve.

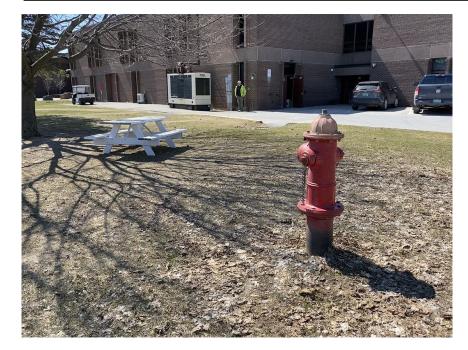
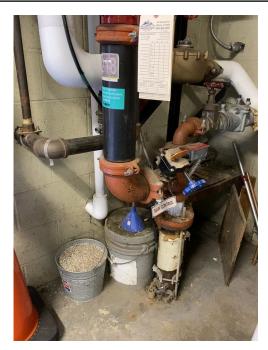
| Client Name | Town of Bristol, VT | <b>Client Address</b> | 1 South Street, Bristol, VT 05443 |
|---|---|---|---|
| Leak Category | Service Line | Pipe Material | Cast Iron Diameter 4" |
| Cover | Asphalt | Loss Rate | ≤ 40 gpm Status Active |

Correlates to the point at which the service line enters the building. Leak is probably at the vertical bend, at the base of the riser pipe.

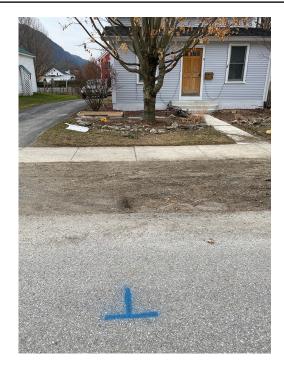
| Client Name | Town of Bristol, VT | <b>Client Address</b> | 1 South Street, Bristol, VT 05443 |
|---|---|---|---|
| Leak Category | Corporation | Pipe Material | Cast Iron Diameter 6" |
| Cover | Asphalt | Loss Rate | ≤ 15 gpm Status Active |

**Remarks** Confirmed at or adjacent to corporation of service line for #9 Church St.

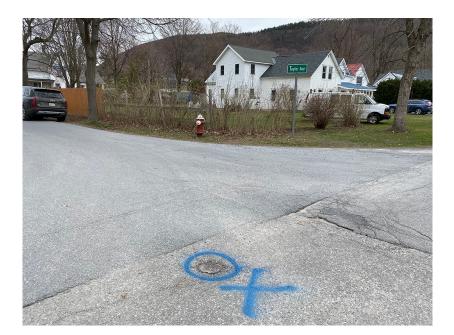
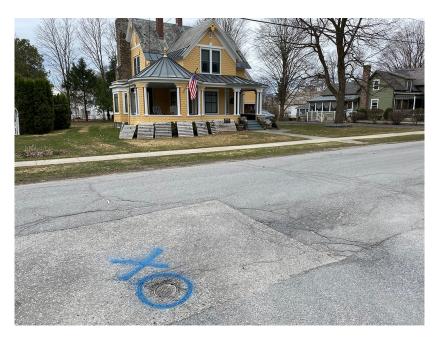
| Client Name | Town of Bristol, VT | <b>Client Address</b> | 1 South Street, Bristol, VT 05443 |
|---|---|---|---|
| Leak Category | Valve | Pipe Material | Cast Iron Diameter 8" |
| Cover | Asphalt | Loss Rate | ≤ 10 gpm Status Active |
| Remarks | Leak is at, or adjacent to, main valve. | | |
