RE: Bristol Landfill – 2023 Annual Inspection (Draft)
Solid Waste Identification Number AD080
ANR Project Identification Number RU95-0205

**BRISTOL LANDFILL
2023 ANNUAL INSPECTION REPORT**

**Prepared for:
Town of Bristol, Vermont**

**Prepared By:
VTM Engineering**

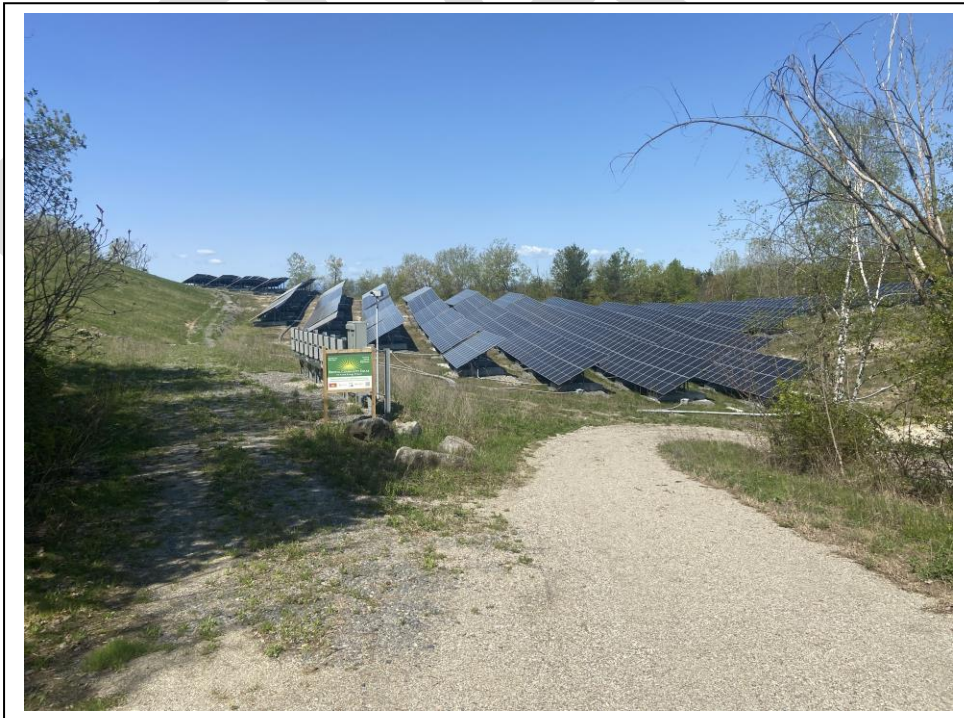
Photo #2 – Solar Array

impacted the final cover integrity during construction. The foundations for each array are designed to spread out the weight of each array and limit the potential for differential settlement. During the 2023 annual inspection, no areas with notable differential settlement, lateral foundation movement, or ballast concerns were noted. The solar arrays appear to all be in excellent condition and functioning as designed.

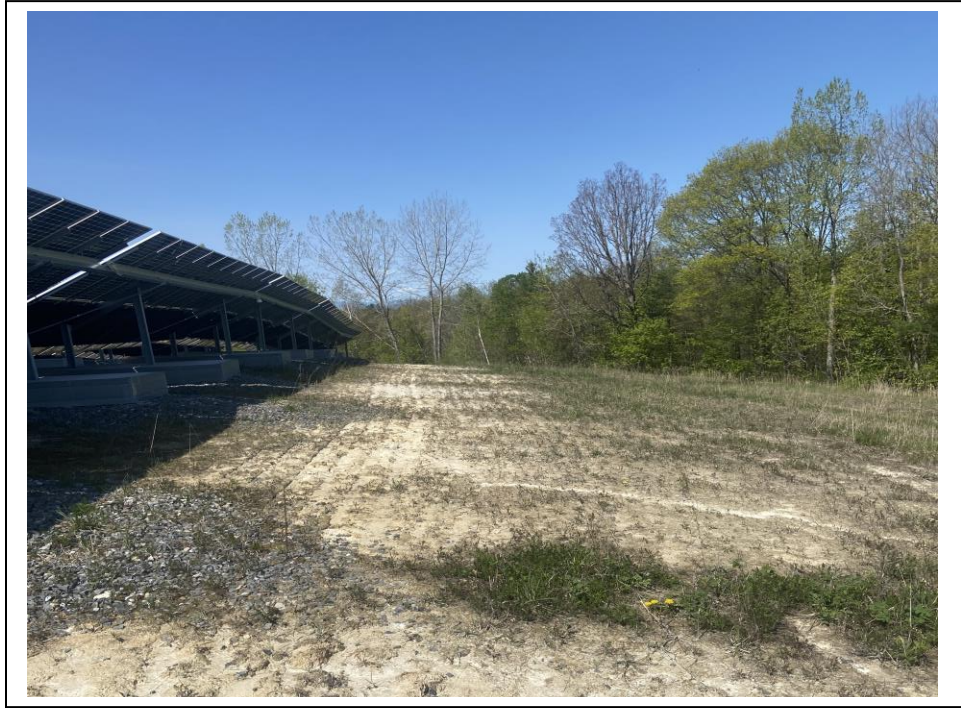
There were still areas lacking vegetive cover in and around the new solar arrays. Photographs of these areas are attached.

Photo #3 – Area in Need of Vegetative Cover

- B. Re-seeding and re-establishment of vegetative cover (where necessary). If any areas of erosion are noted during re-seeding activities, areas should be filled and smoothed prior to re-seeding. Monitoring of all newly seeded areas should be performed as needed. In and around the solar arrays, grass seed that is designed for shady areas should be utilized.

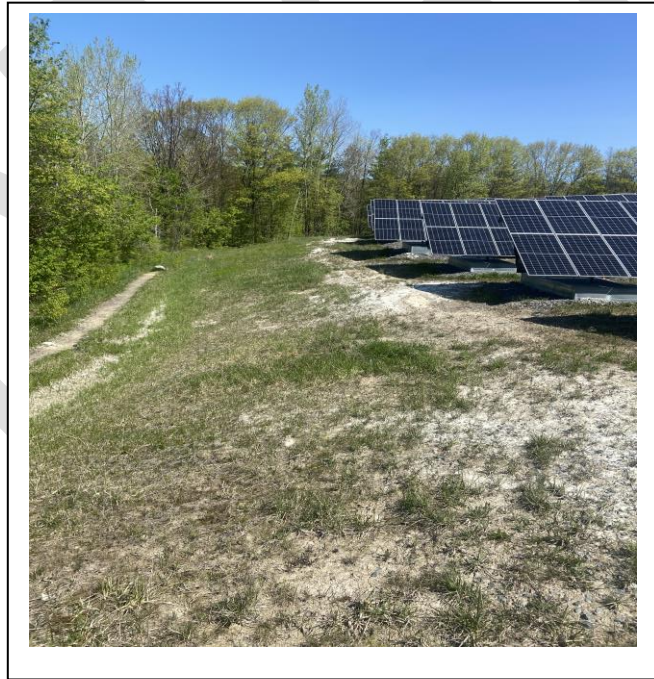
Photo #4 – Areas in Need of Vegetative Cover

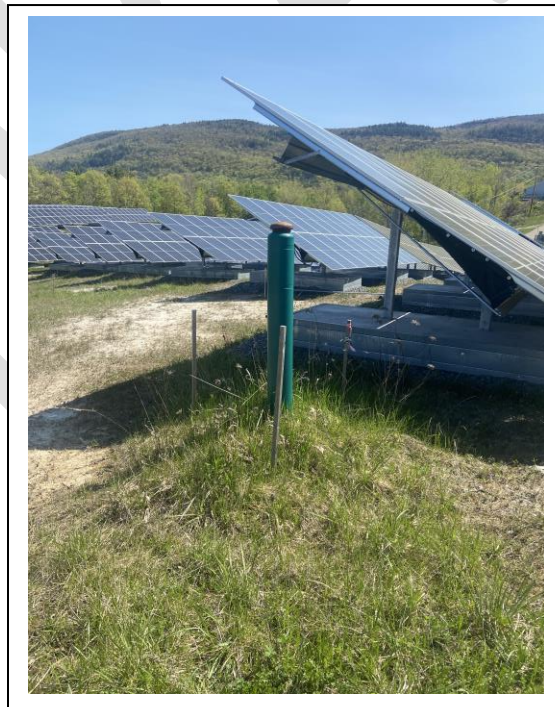
Photo #6 – Gas Well

Each of the four (4) existing passive gas vents were observed during the inspection. No settlement or other visible issues were noted and the gas vents appear to be functional.

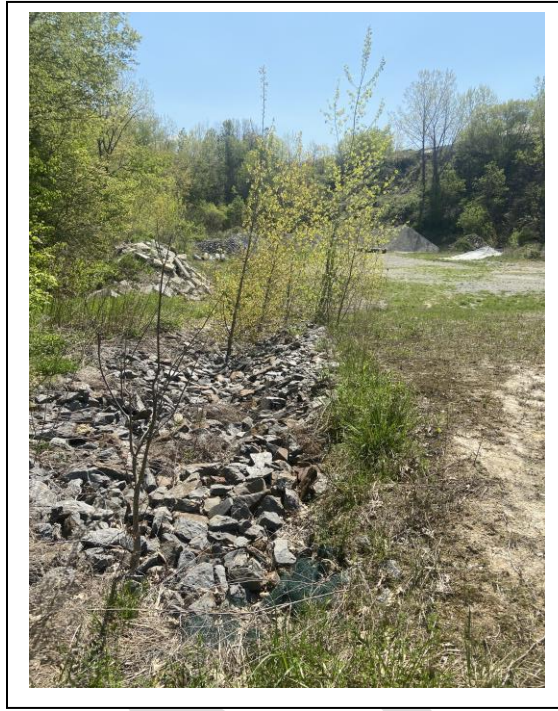
One small drainage ditch along the northeast side of the facility was noted to still contain brush and small trees. The ditch still appears to be fully functional however from a stormwater transmittance perspective.

Photo #7 – Stone Drainage Ditch Growth Northeast Corner

- C. All brush and small tree growth within the existing stone perimeter drainage ditch on the northeast side of the site should be removed.
- D. The portion of the stone lined ditch that was filled to provide access around the southeast end of the site should be addressed. A culvert should be installed across the access road to facilitate drainage across the roadway and limit the potential for future erosion. Care should be taken to ensure that there are no adverse impacts to the existing final cover system during the work.

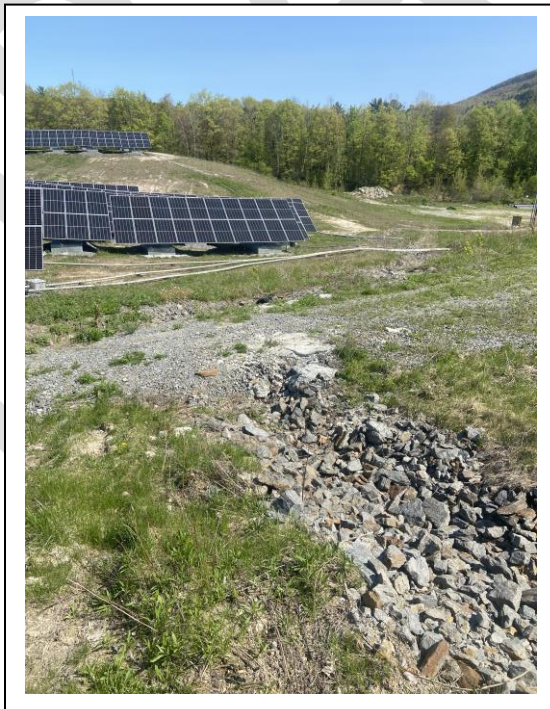
In general, the stone drainage ditches surrounding the site appear to be in good physical condition. No settlement or other similar damage was noted which would impact their operation. One section of the stone lined ditch on the southeast side of the former landfill appears to have been filled. During the 2022 annual inspection, small trees were noted to be growing in a number of the stone lined ditches, primarily along the west side of the former landfill. It was noted during the 2023 inspection however that the trees in this area had been removed and the drainage ditches appeared to be in good functional condition.

Photo #8 – Filled Stone Drainage Ditch
