VTM Engineering, PLC

May 9, 2023

RE: Bristol Landfill Solar Annual Stormwater Inspection Report
Authorization to Discharge Permit No. 9252-9050

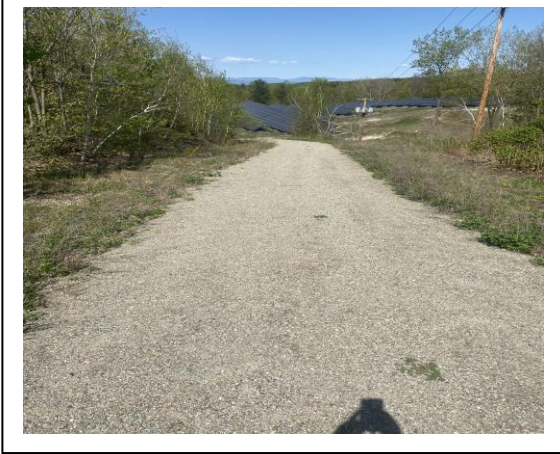
Upper Driveway
Entrance & Ditching

- Annual mowing of the grass around the infiltration gallery
- Reconstruction of approximately 20-feet of existing stormwater transmittance ditching immediately prior to the infiltration basin (see photo's).
- Remove trees and shrubs from the stormwater transmittance ditching at the upper end of the entrance driveway. VTM recommends mowing this area annually to the extent possible.
- Adjust the surface grading at the entrance to the stormwater forebay to ensure that stormwater does not short circuit the forebay and flow directly into the infiltration gallery.

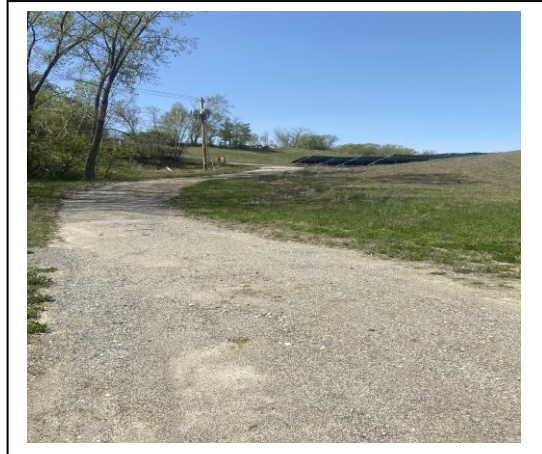
Lower Driveway
Entrance

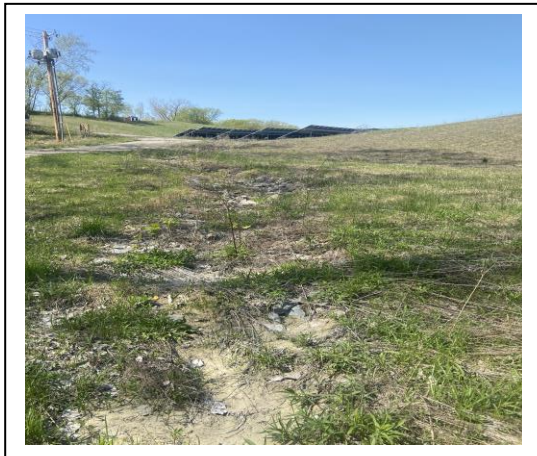
The 2023 annual inspection was performed by Steven Palmer, P.E. of VTM Engineering, PLC (VTM) on May 8, 2023. During the field inspection, one small area of transmittance ditch was noted to contain a significant amount of sediment buildup. This ditch is located just prior to the forebay. No other areas of erosion or sediment buildup were noted in the driveway, associated ditching or forebay/infiltration basin. Brush and small trees were noted to be growing in the ditches along the upper part of the drive. Surface grading at the entrance to the forebay appeared visually to be higher than the entrance to the forebay. This could allow stormwater to potentially short-circuit the forebay and flow directly into the infiltration basin. No other issues of concern related to the stormwater conveyance or treatment systems were noted that would necessitate maintenance.

Stormwater Ditch in Need of
Reconstruction

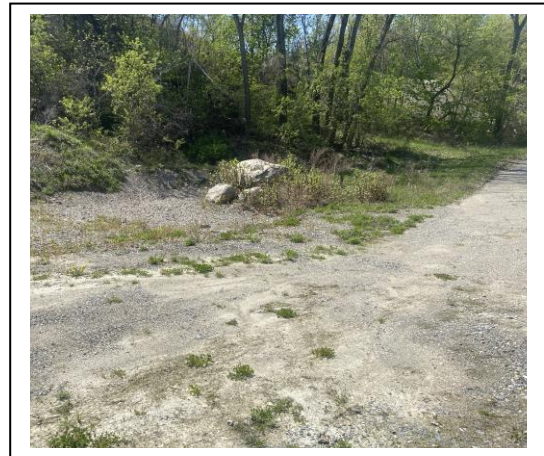
Grading at Stormwater Infiltration
Basin

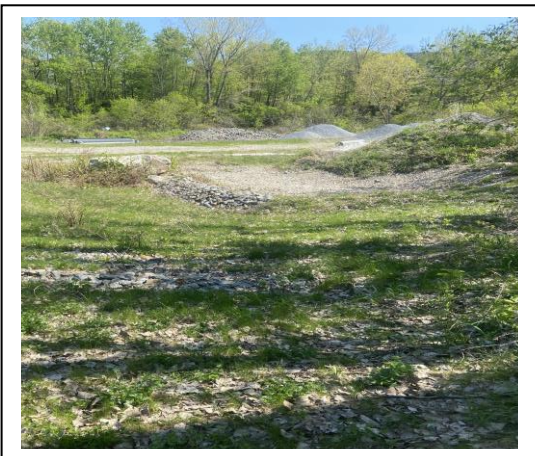
Infiltration Basin Forebay

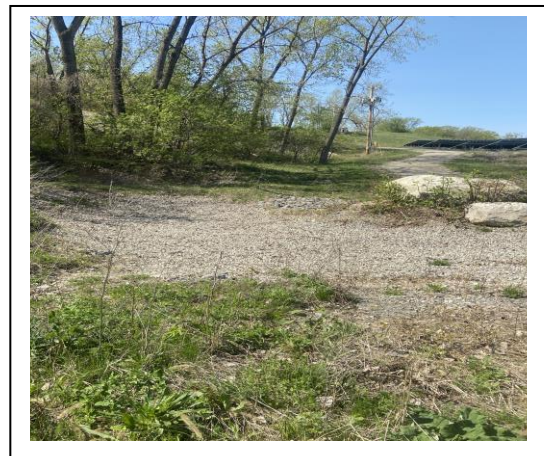
Infiltration Basin
