**BRISTOL LANDFILL  
2024 ANNUAL INSPECTION REPORT**

**Prepared for:  
Town of Bristol, Vermont**

**Prepared By:  
VTM Engineering**

**May 2, 2024**

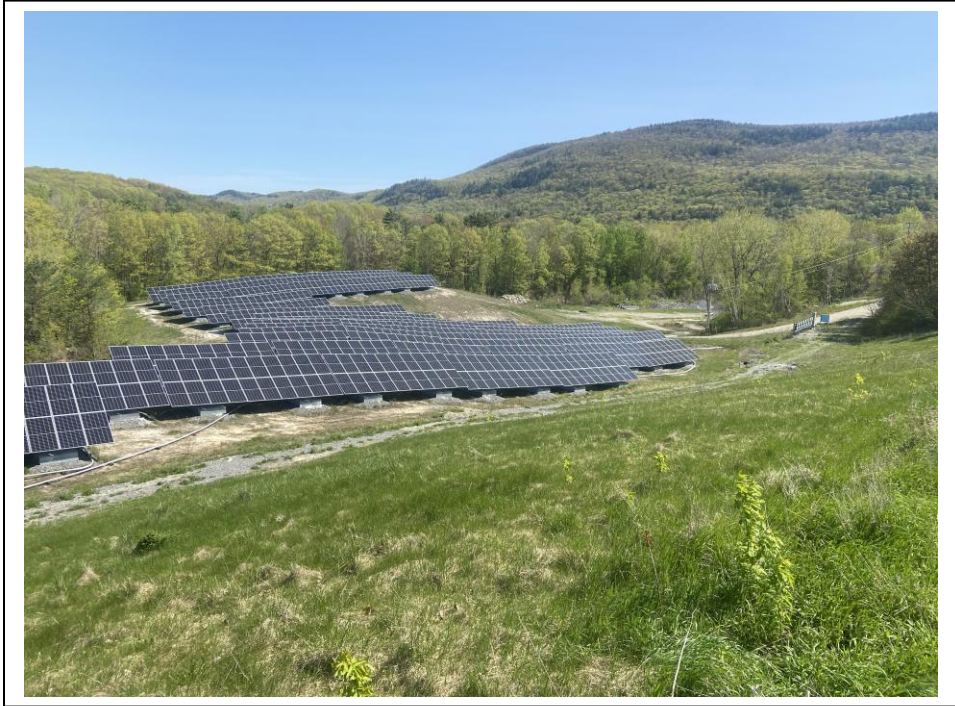
Photo #1 – Landfill Overview

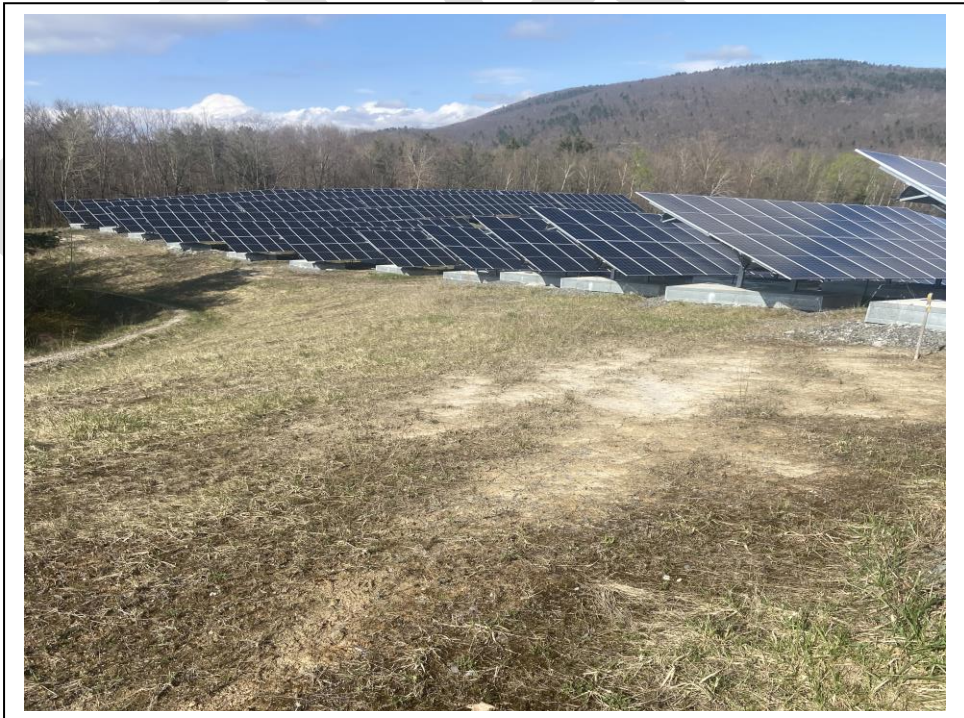
It was noted that there were still areas lacking vegetive cover in and around the new solar arrays. (see attached photo's).

Photo #2 – Area in Need of Vegetative Cover

- B. Several areas were noted where vegetive cover is sparse. Re-seeding and re-establishment of vegetive cover should be conducted where necessary. If any areas of erosion are noted during re-seeding activities, areas should be filled and smoothed prior to re-seeding. Mulch and watering of newly seeded areas is recommended. Monitoring and additional maintenance of all newly seeded areas should be performed as needed. In and around the solar arrays, grass seed that is designed for shady areas should be utilized.

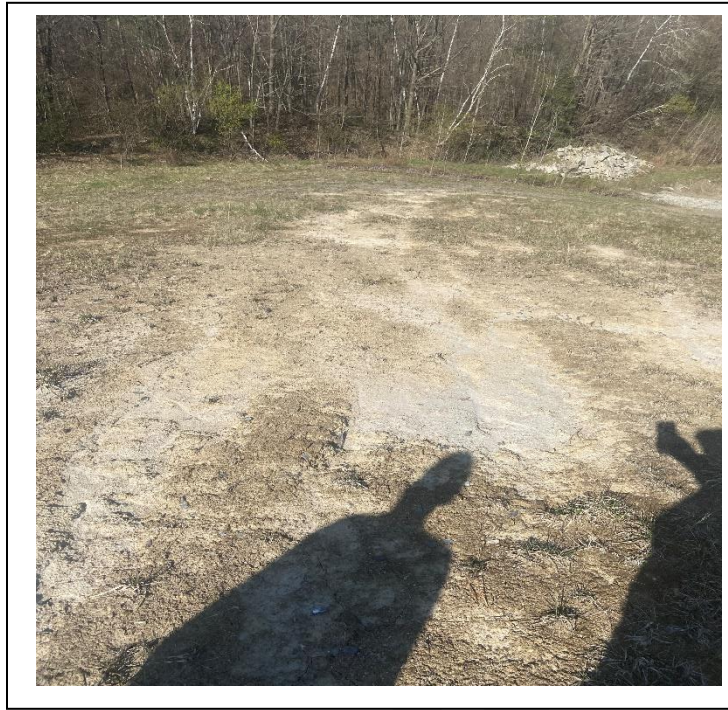
Photo #3 – Area in Need of Vegetative Cover

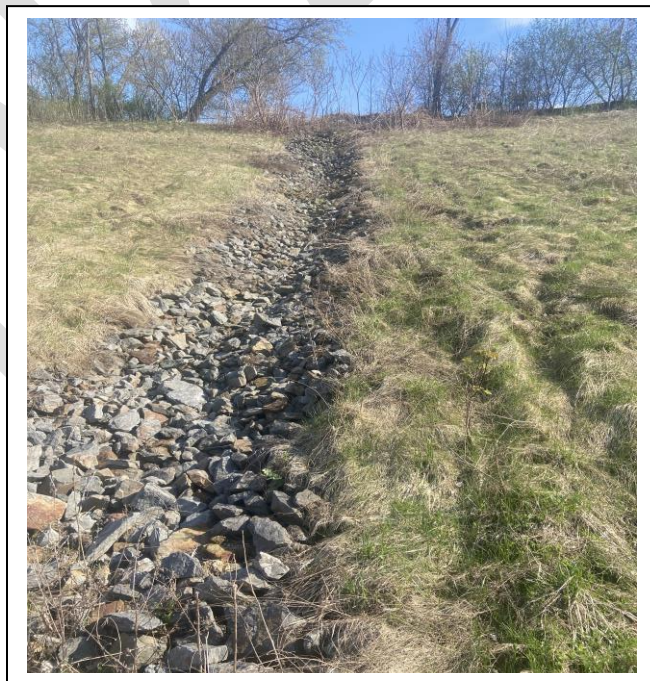
In general, the stone drainage ditches surrounding the site appear to be in good condition. No settlement or other similar damage was noted which would impede their operation. One section of the stone lined ditch on the southeast side of the former landfill appears to have been filled with stone to make an access road rendering the ditch essentially inoperable (see attached photo's).

Photo #4 – Typical Drainage Swale

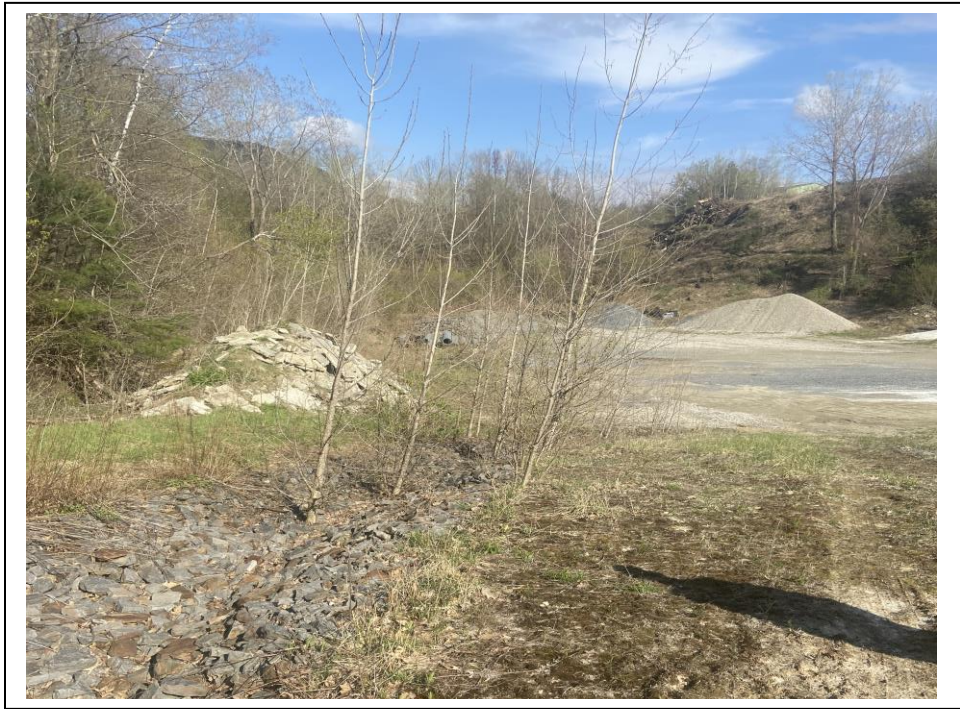
During the inspection, small trees were noted to be growing in one of the stone lined ditches along the north side of the former landfill (see attached photo's). The ditch still appears to be fully functional, however (see attached photo's). The trees and brush should be removed before the root systems have an opportunity to impact the underlying clay cover.

Photo #5 – Drainage Swale In Need of Tree Removal

- D. All brush and small tree growth within the existing stone perimeter drainage ditch on the northeast side of the site should be removed.
- E. The portion of the stone lined ditch that was filled to provide access around the southeast end of the site should be addressed. A culvert should be installed across the access road to facilitate drainage across the roadway and limit the potential for future erosion. Care

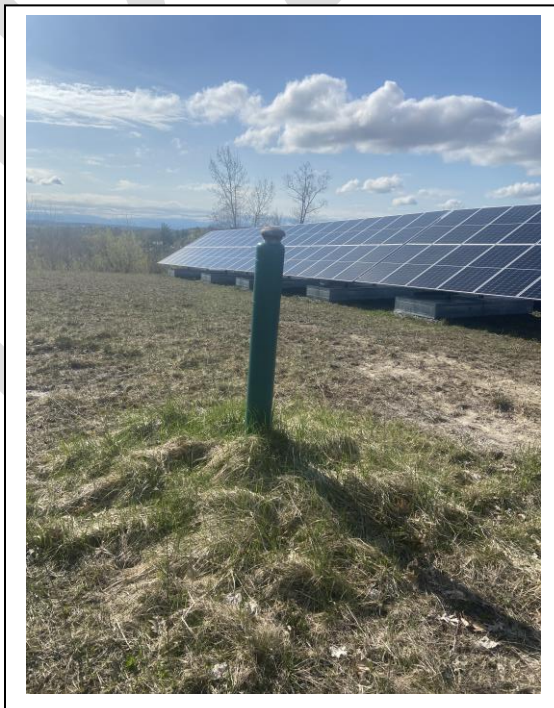
Each of the four (4) existing passive gas vents were observed during the inspection. No settlement or other visible issues were noted, and the gas vents visually appear to be functional (see attached photo's).

Photo #6 – Typical Gas Well

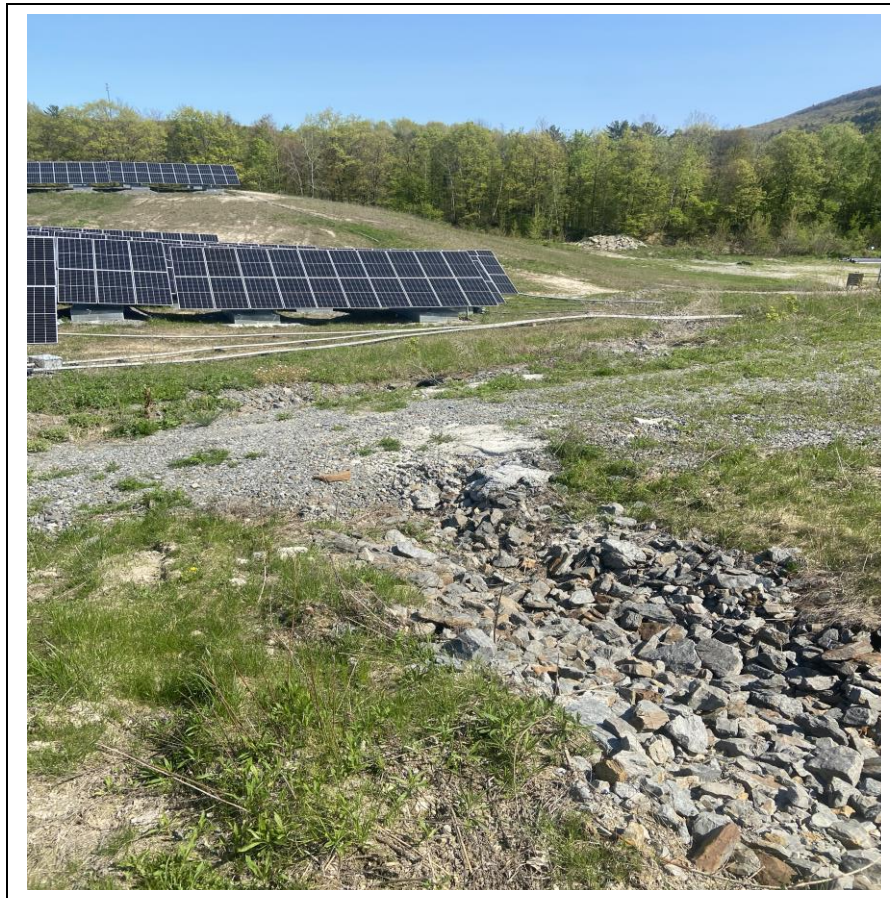
Photo #8 – Filled Stone Drainage Ditch In Need of Culvert

should be taken to ensure that there are no adverse impacts to the existing final cover system during the work.
