RE: Town of Bristol Fire Station  
Authorization to Discharge Permit No. 7468-9015.T

This letter and supporting documentation represent the 2024 Bristol Fire Station Annual Stormwater Inspection Report as required by the above referenced Permit.

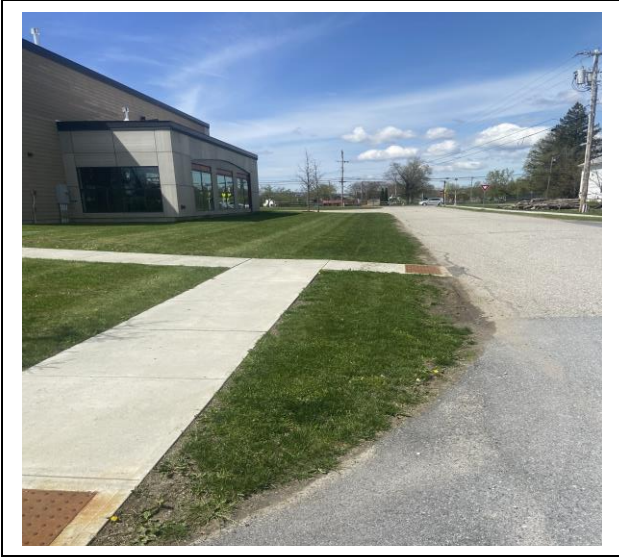
Grass lined swale along driveway

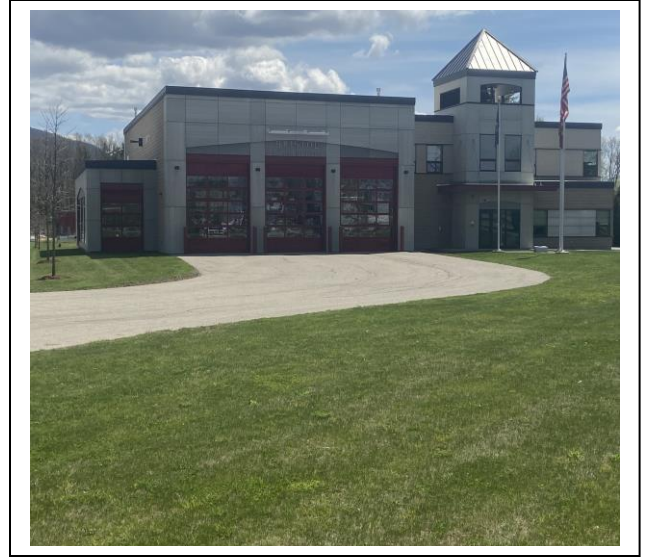
Front drive and lawn area

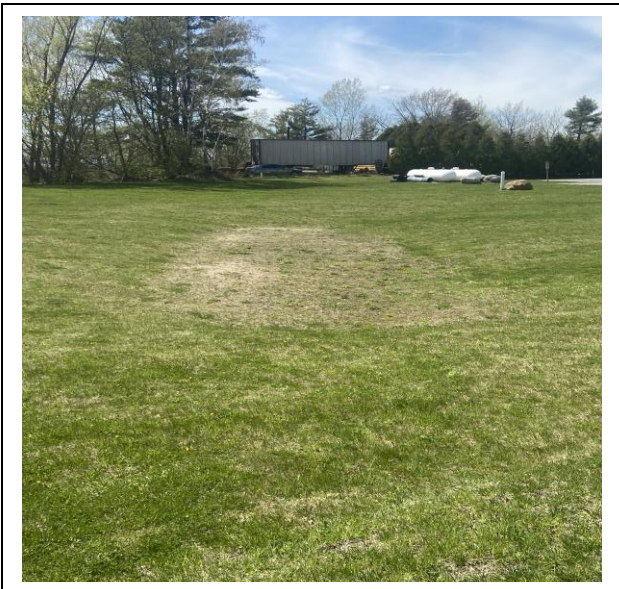
Forebay

During the field inspection, no areas of erosion or significant sediment buildup were noted in or around the forebay or infiltration basin. Minor damage to grass areas of the lawn from snow plowing had already been
