UFP Damages 2019 Oct 17 – Eagle Park, Bristol

Clean-up Day #1 – 19 Oct 2019

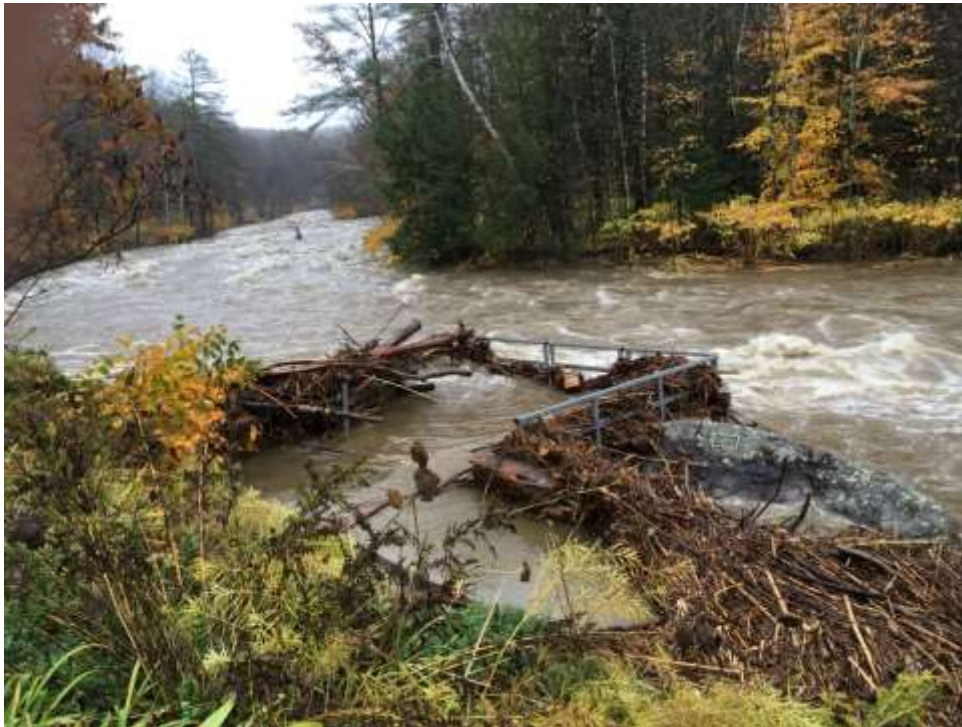
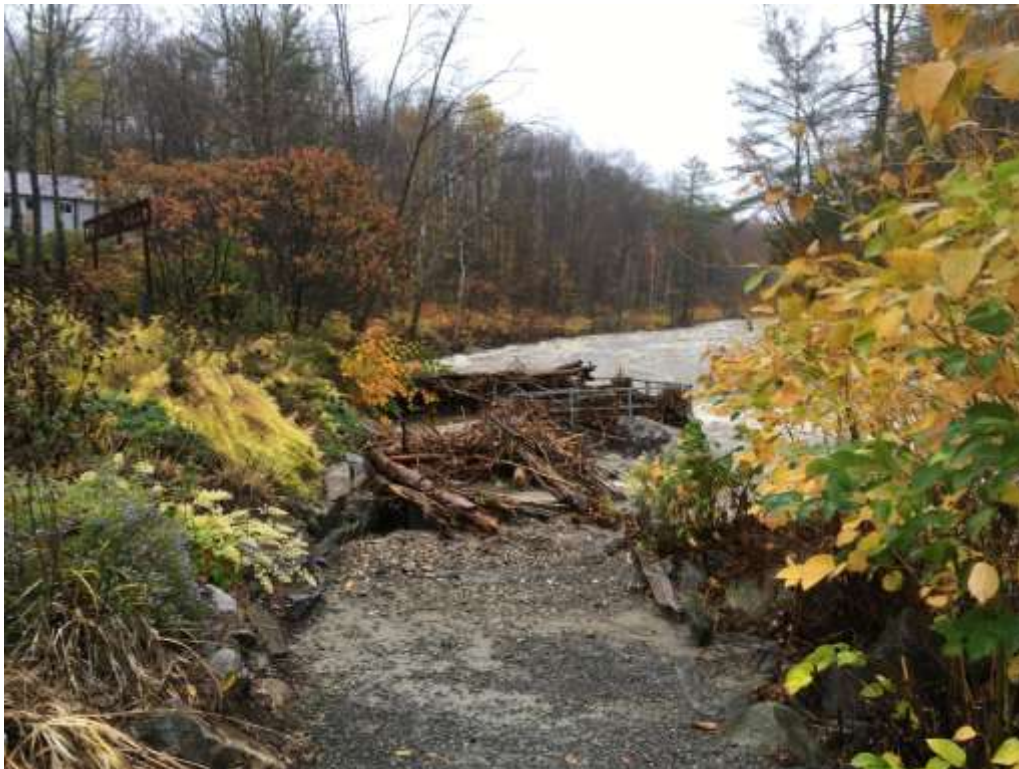
Just past peak flow conditions at the park – 13:35

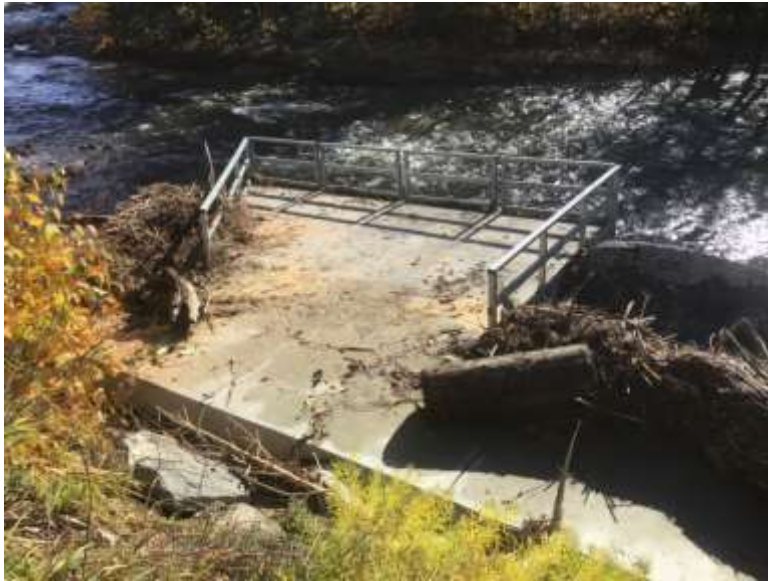
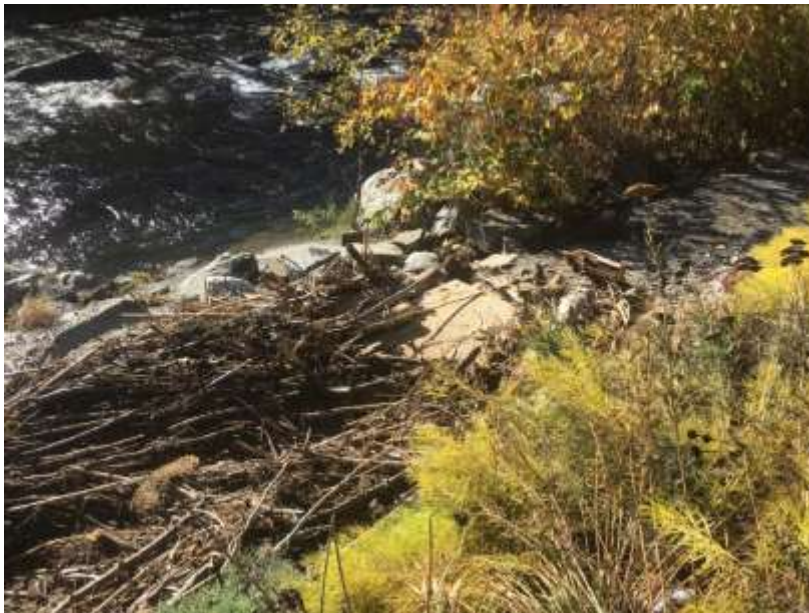
After Clean Up Day #1 - (2 person crew, 2 hours, including chain saw) (Durand and Underwood)

Still more work to clear debris from ADA ramp and fill scour holes in ramp with Sure Pak. Second work day being planned for 10/26 or 10/27 by Bristol CC with posting to Front Porch Forum.

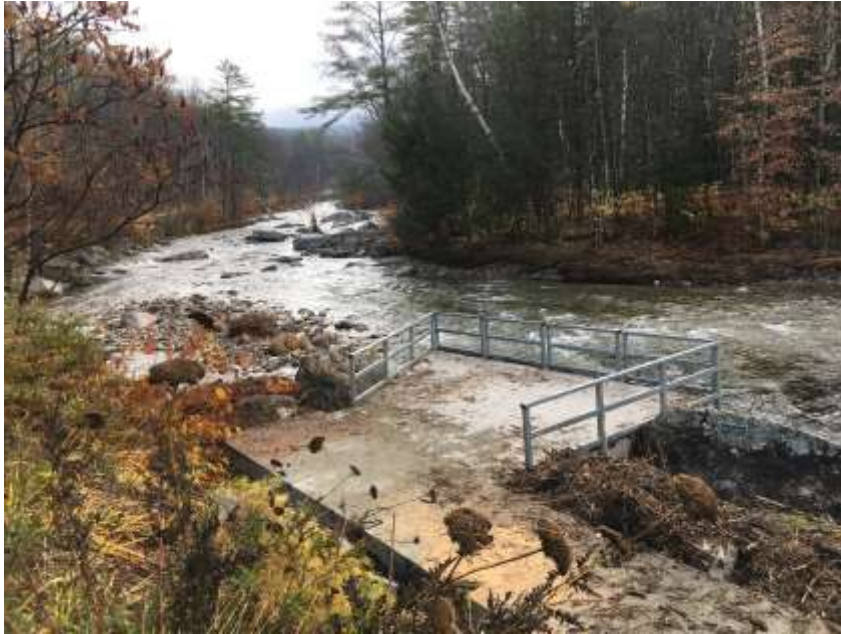
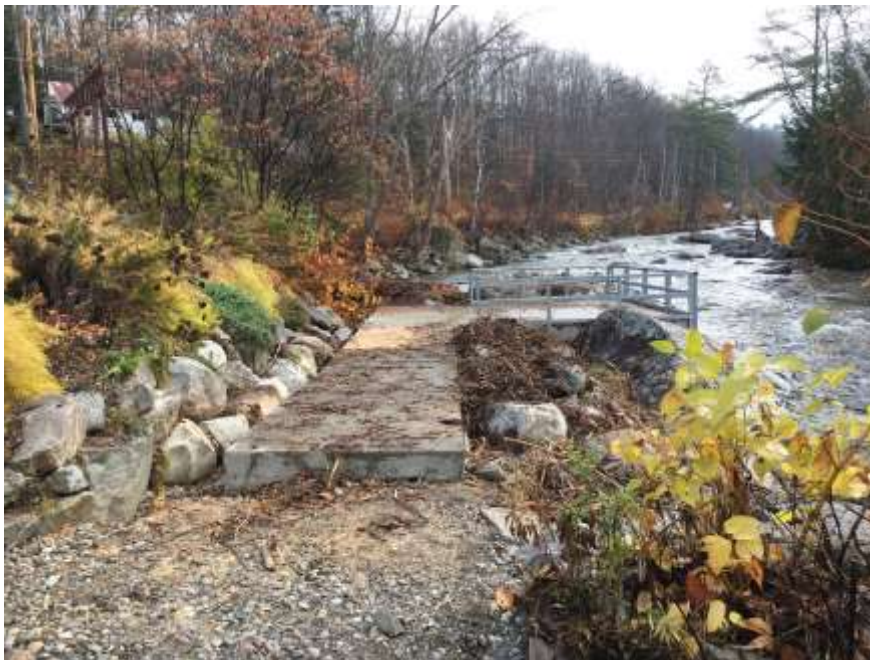
After Clean Up Day #2 - (5 person crew, 1.5 hours, including chain saw)
(Durand, Underwood, Henderson, Diminico, volunteer from New Haven)

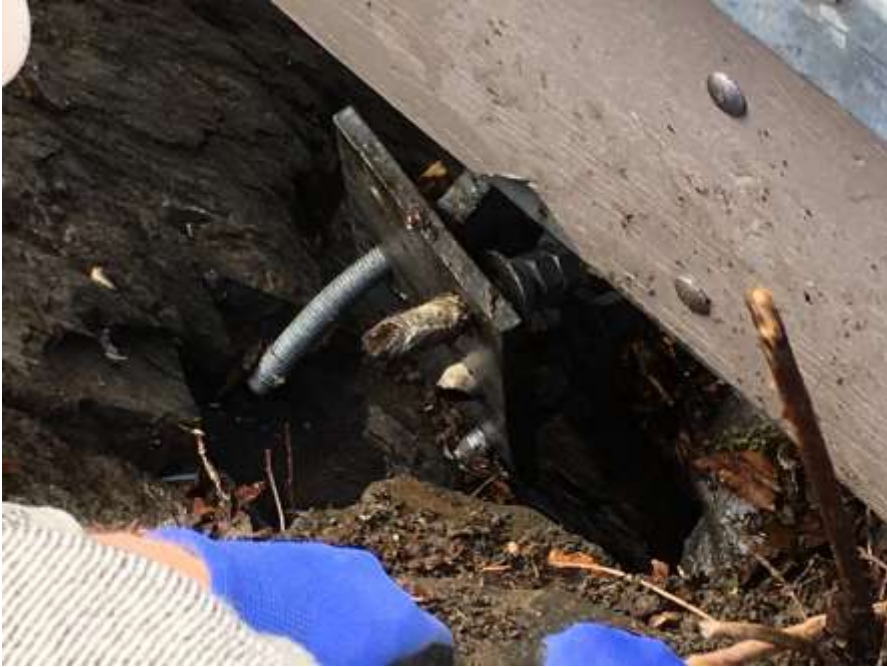
Bank-side bracket

Platform is now cantered slightly toward the upstream corner (i.e., is no longer level, but slopes to the northeast). A kayaker (Will Perini from Starksboro) helped Randy and Kristen inspect the platform foundation by paddling underneath to inspect where the platform is bolted to the big boulders. He reported that one of the fastening brackets was severely bent and a second appeared to be pulled away from the mounting plate.

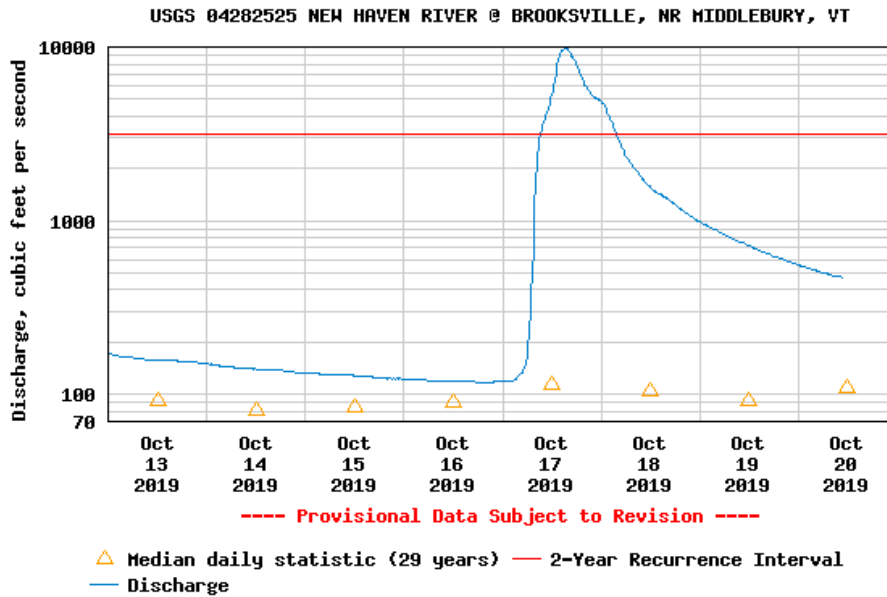
Peak flow (provisional) recorded at USGS gage at Brooksville: **9,900 cfs** at 15:30, 10/17/19

Approximate: **Q10 storm**

Discharge, cubic feet per second

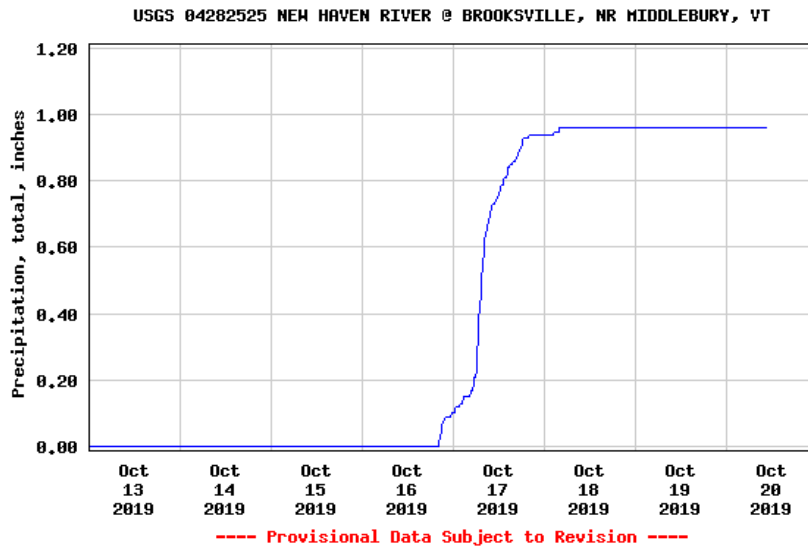
Precipitation, total, inches

Expect there was more rain in Lincoln (anecdotally)
