BRISTOL, VERMONT ANNUAL WASTEWATER SYSTEM EVALUATION 2022-2023

INDIRECT DISCHARGE PERMIT ID 9-0208-1

Prepared By: VTM Engineering, PLC

Date: May 31, 2023

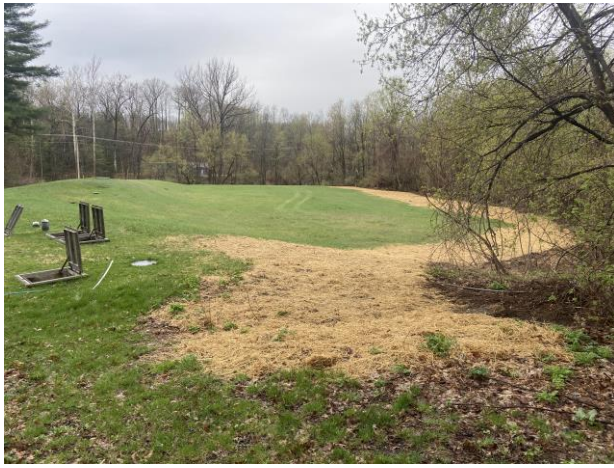
VTM and VTUMS personnel walked each of the eight disposal fields. The disposal field area is neat and clean and appears to be mowed on a regular basis. During last season's inspection, VTM noted that sumac was encroaching on the disposal fields which brings with it the potential for root damage to the disposal fields. In the spring of 2023, VTUMS removed the sumac and graded and re-seeded the impacted areas. The disposal field and surrounding area are now in much better condition and removal of the sumac allows for easier access to the deep monitoring wells. Several box alder trees were noted to be still encroaching on the disposal fields. These trees should be removed as time allows. Regular mowing of the disposal fields and surrounding areas should be continued.

Overview of the wastewater
distribution field

- l. Replace the existing dosing siphon counters with mechanical counters when practical.
- m. Verify proper operation of the dosing syphons.
- n. Continue regular mowing and trimming of the disposal field area.

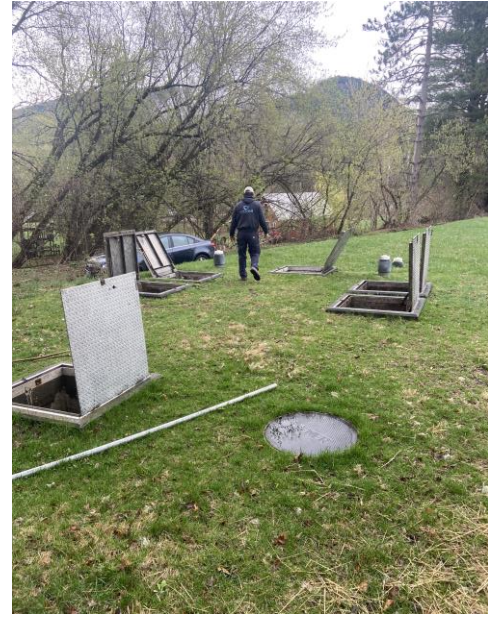
Based on VTM's observations, the septic tank slide gates, safety locks and hasps on hatches appear to be in working condition. The hatches are functional but are seeing some wear and may need to be evaluated for replacement in the future. The septic tank outlet trough was noted to be in poor condition and needs re-bricking. Pumping of both compartments in Cell #1 is recommended based on sludge and grease buildup.

Septic tank access hatches

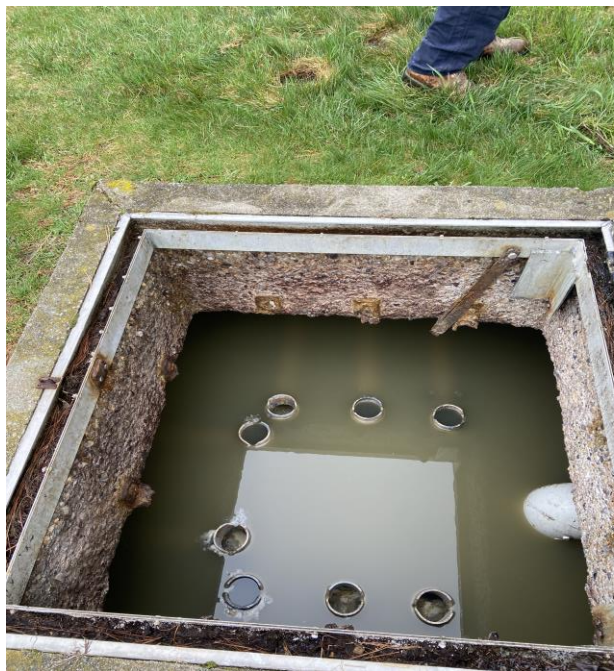
1. Fields #3, #5, #7 and #8 were observed to be in operation
2. Fields #1, #2, #4 and #6 were observed to be off
3. Appeared to be good even flow between the fields, very little grease observed in splitter box
4. The splitter box and associated piping inside the box appeared to be in good condition.

VTUMS indicated that they conduct regular verification of even flow to the four fields and conduct skimming of grease in the splitter box if needed. VTM observed VTUMS rotating the disposal fields by opening the valves to dormant disposal fields #1, #2, #4 and #6 and closing the valves to operating fields #3, #5, #7 and #8. Fields #1, #2, #4, #6 will be the operating fields for the next 12 months. Once the valves were opened and the previously dormant fields were brought on-line, even flow was observed to each of the four operating fields. No issues of concern were noted within the splitter box.

Splitter Box

- k. Continue to monitor the splitter box flows regularly. Clean the v-notches with a brush regularly to ensure equal flow to each of the disposal fields.

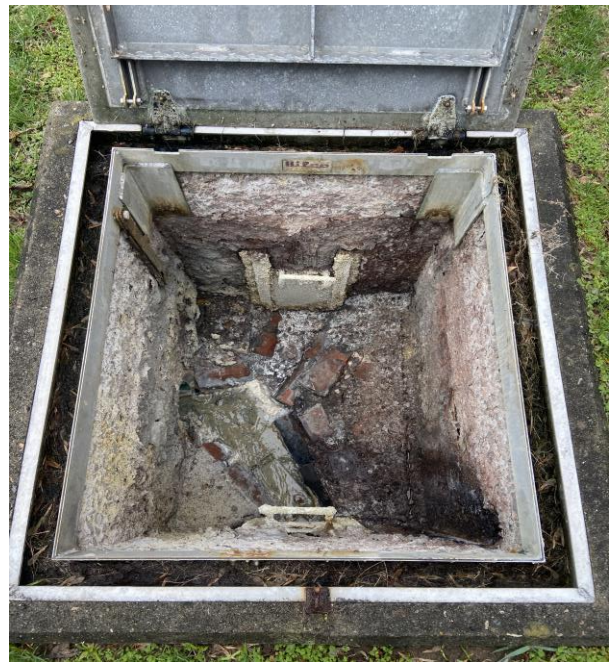
Description	Comments
Septic Tank Inlet	Cell 1 Needs Pumping
Septic Tank Outlet	Eff. Trough Needs Rebuilding
Splitter Box	Good condition
Dosing Siphon #1	VTUMS to Check Operation
Dosing Siphon #2	VTUMS to Check Operation
Dosing Siphon #3	VTUMS to Check Operation
Dosing Siphon #4	VTUMS to Check Operation
Dosing Siphon #5	VTUMS to Check Operation
Dosing Siphon #6	VTUMS to Check Operation
Dosing Siphon #7	VTUMS to Check Operation
Dosing Siphon #8	VTUMS to Check Operation
Disposal Fields #1-8	No issues noted

Septic tank outlet trough

- g. Re-build the septic tank outlet trough.
- h. Remove the remaining box alder trees that continue to encroach on the disposal fields.
- i. USGS elevations should be determined for the top of Wells #2, #3 and #4 as well as the shallow monitoring wells within the disposal field. Subsequent water depth data should include USGS elevations.
