**SYCAMORE PARK  
MANAGEMENT PLAN**

**BRISTOL, VERMONT**

**DRAFT FOR REVIEW**

Prepared by:  
Bristol Conservation Commission

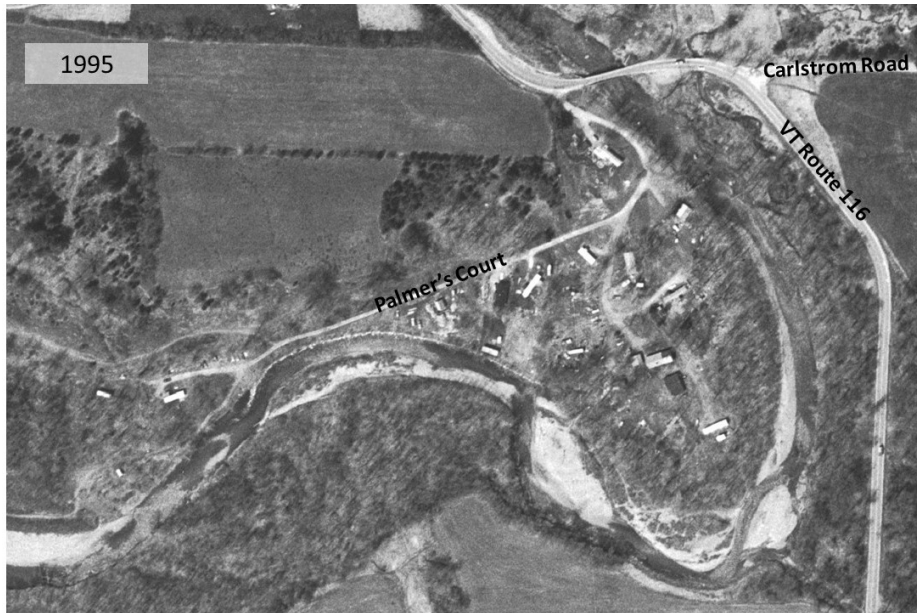
Figure 2. Residential homes and driveways (Palmer's Court) occupied Sycamore Park prior to the flood of 1998; houses were removed during a FEMA buyout following the flood.

Prior to the 1998 flood, these lands were the site of Palmer's Court mobile home park. These homes were developed on this point of land between 1963 and 1974 (Attachment B). By the mid-1990s, ten homes were located here (Figure 2). These structures were damaged in the June 1998 flood, and subsequently removed from the property as part of a FEMA buyout.

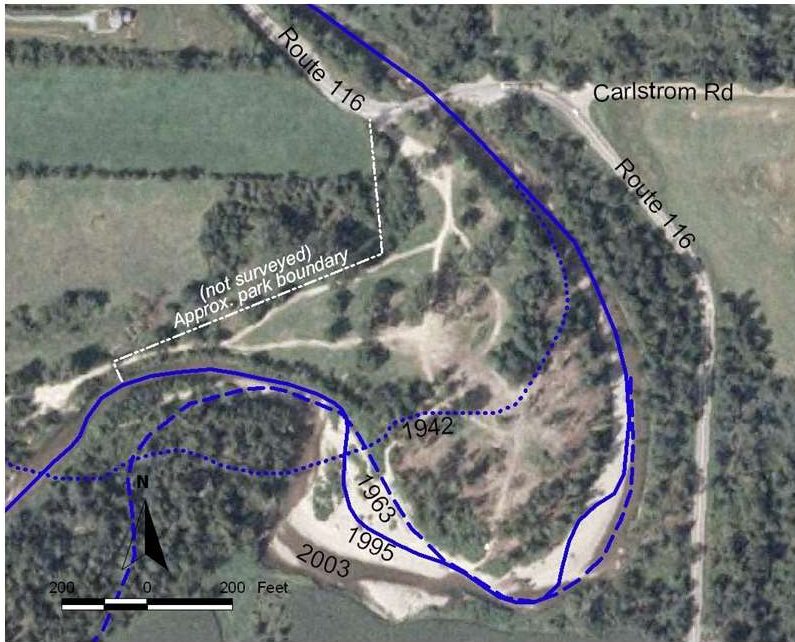
Figure 3. Historic positions of the New Haven River in vicinity of Sycamore Park, based on review of aerial photographs on file at the NRCs offices, Middlebury, VT. Base image is from 2003, taken just after structures had been removed from the park during the FEMA buyout.

The park is located within a corridor of active channel migration at risk of sudden erosion hazards during flood events. Figure 3 shows the historical channel positions of New Haven River. The river has cut into the cornfield to the south and west, eroding more than 2 acres of cropland between 1998 and 2003. Even prior to the flood, this was a very actively-adjusting section of channel, based on historic positions of the channel in 1942 and 1963.

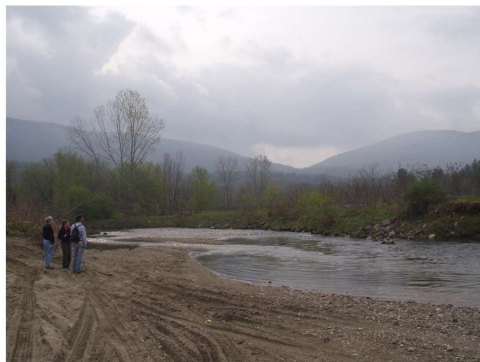
*Figure 4. Vehicle tracks along the channel margins at the south end of Sycamore Park, May 2004.*

Vehicular access to the park is restricted for several reasons. Historically, ATVs and vehicles were directly accessing the river channel and beach areas (Figure 4), and this activity has the potential to impact surface and groundwater quality (from oils, greases, and other automotive fluid leaks). Vehicles in the park would be at risk along this river that is prone to flash flooding. And finally, passage of the vehicles over beach areas contributes to overall instability of the channel and increases streambed and bank erosion. Compaction of beach sediments under the weight of passing vehicles creates preferential pathways for flood waters and can contribute to channel avulsions and enhance rates of lateral channel adjustments.

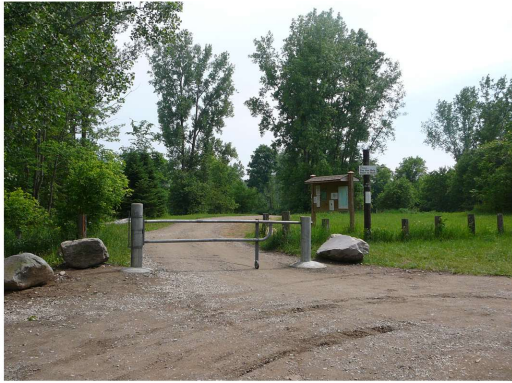
*Figure 5.  
Padlocked gate  
installed by the  
Town of Bristol in  
May/June 2007 at  
the parking area  
near the north end of  
the park.*

In May and June of 2007, several improvements were made in the Park by a collaboration of professionals, town personnel, and the Bristol Recreation Department with funding through the Edith Stock Trust. These improvements were designed to enhance conditions in the park for bird habitats and had the secondary benefit of further protecting the hydrologic and geomorphic functions of the park. A pad-locked gate was installed near the northern end of the park (Figure 5). An existing wooden-pole barrier in the vicinity of the gate was supplemented by a large-rock barrier to restrict motor vehicle access to the parking area near the Park entrance off Route 116. Footpaths previously accessed by motor vehicles to drive onto the sediment bars of the river channel were further blocked by shallow trench excavation and fill (Figure 6). These measures appear to have substantially reduced the occurrence of motor vehicles in the park interior; however, limited motorcycle use is occasionally evident, and ATVs can cross into the park from adjacent lands.

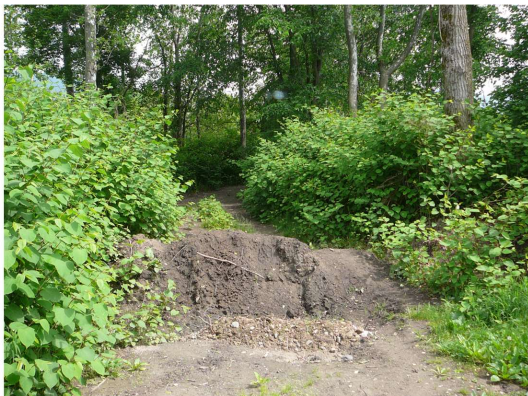
*Figure 6.  
Fill material blocking  
motor vehicle access to  
footpath extending to the  
river channel at the  
southern end of the Park,  
June 2007. Evidence of  
motorcycle (dirt bike)  
use over the berm.*

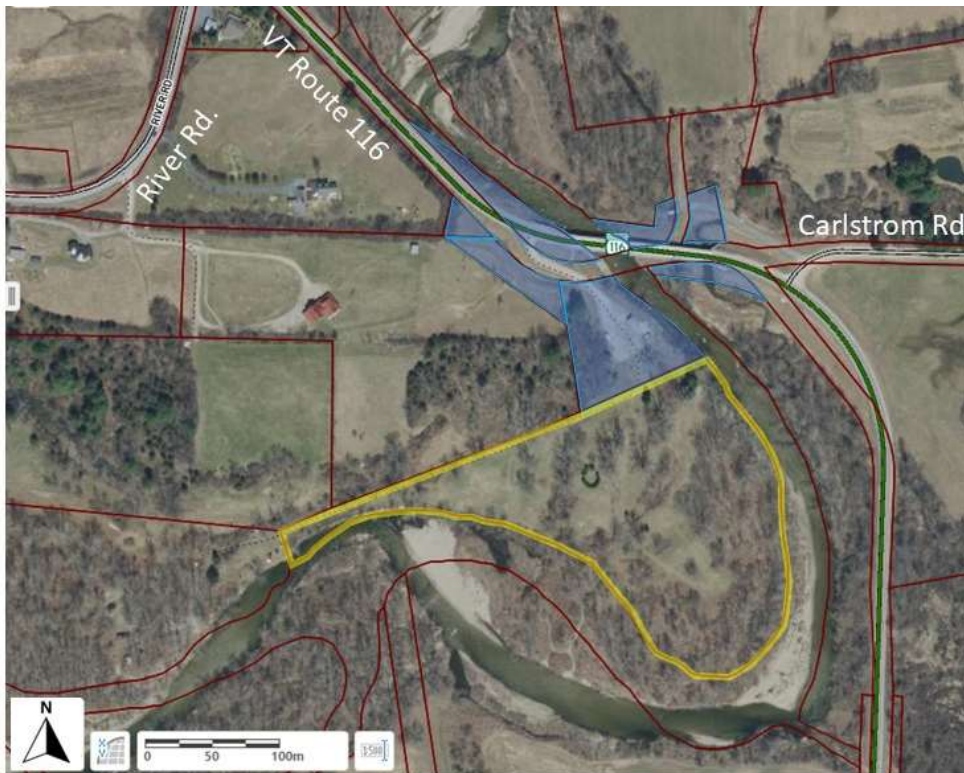
## Appendix A. Tax Parcel Map

-   Parcel Boundaries
-   Sycamore Park, owned by Town of Bristol
-   Parcels owned by VT Agency of Transportation

The park is an 8.4-acre parcel and does not extend east to the other side of the river, according to town tax maps (see Appendix A). A private parcel that abuts the park to the west is accessed through the park. This landowner holds a key to the park's entrance gate and is permitted to drive through the park.
