EAGLE PARK MANAGEMENT PLAN

BRISTOL, VERMONT

DRAFT FOR SELECTBOARD REVIEW

Bristol Conservation Commission

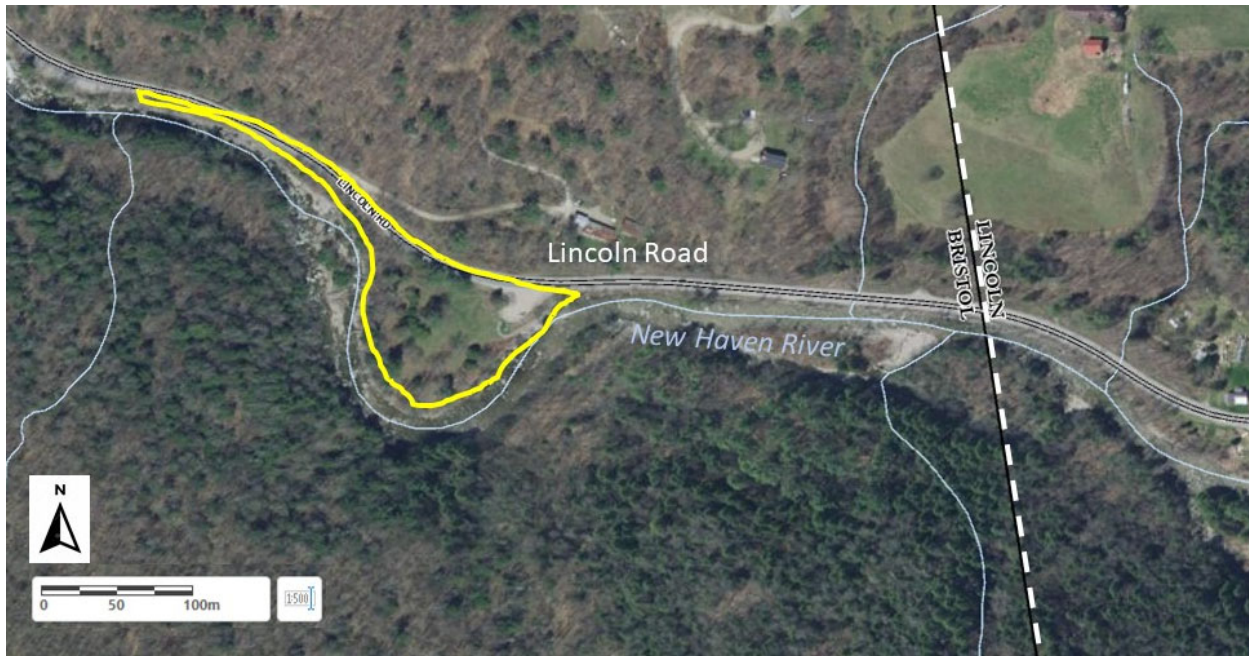
Figure 1. Approximate boundaries of Eagle Park, accessed from a parking area on the south side of Lincoln Road (Property boundaries, approximated from Bristol Tax Parcel Maps, are for planning purposes only and do not represent actual surveyed boundaries).

Eagle Park is a 5.5-acre parcel located at 908 Lincoln Road approximately 0.7 mile east of Bartlett’s Falls near the Bristol-Lincoln town line (Figure 1). The park offers a sparsely-forested meadow along the New Haven River for bird-watching, picnicking, and recreating, and features the Chuck Baser Memorial Universal Fishing Platform that provides Americans with Disabilities Act (ADA) compliant access to the river for fishing. The property is owned by the Town of Bristol, and is jointly managed by the Bristol Selectboard, the Recreation Department and the Conservation Commission.

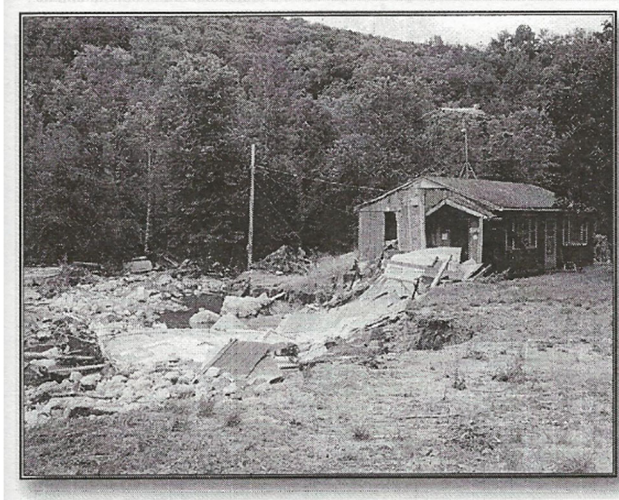
Figure 2. Buildings previously on site were damaged during the 1998 flood. Source: History of Bristol, Vermont: 1762 – 2012, 4th Ed., Bristol Historical Society, 2012

The town of Bristol acquired the lands of Eagle Park in 2000 during recovery efforts following the flood of July 1998 (Figure 2). Grant funding from the VT Agency of Commerce & Community Development supported site cleanup and buyout of these lands which were subsequently conveyed to the town. A condition of the buyout was that the site remain undeveloped and be incorporated into the Town's park system (Bristol Land Records).

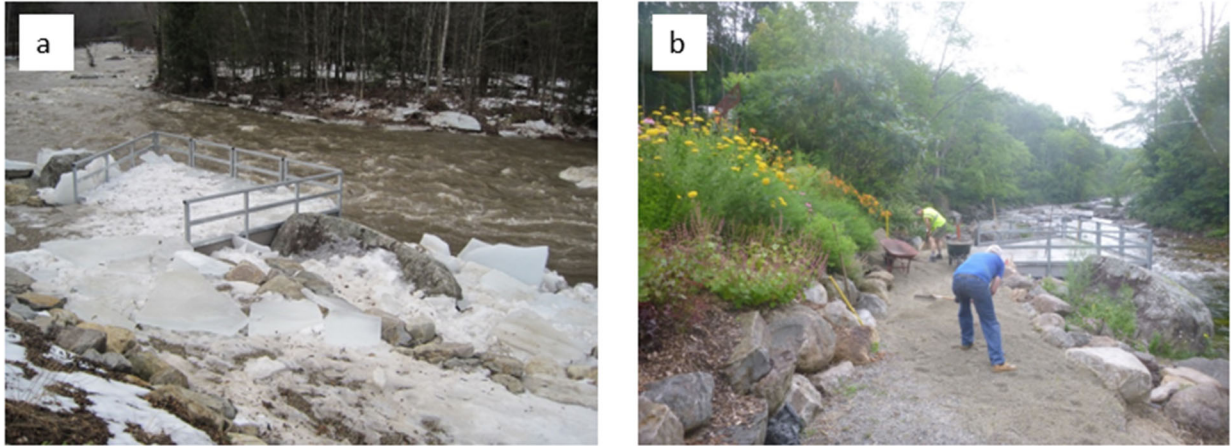
Figure 6. Universal Fishing Platform (a) receives ice during thaw event on January 30, 2013. (b) Bristol CC members replace gravel on access ramp to the platform during an August repair activity following flooding on July 1, 2017 that eroded a segment of the walkway.

Because of its function as an ADA-compliant fishing access, this platform and ramp is purposely located along the river side and is periodically overtopped by floodwaters and receives large woody debris and ice. The platform is anchored between two large glacial boulders to mitigate for impacts from ice, debris and strong currents. Effects of past flood and ice-out events have been usually mild and addressed during annual cleanup activities of the Bristol Conservation Commission and other citizen volunteers (Figure 6). The Conservation Commission directed installation of a concrete ramp on the lower half of the access path in 2018 in an effort to reduce the need for repeated gravel replacement.

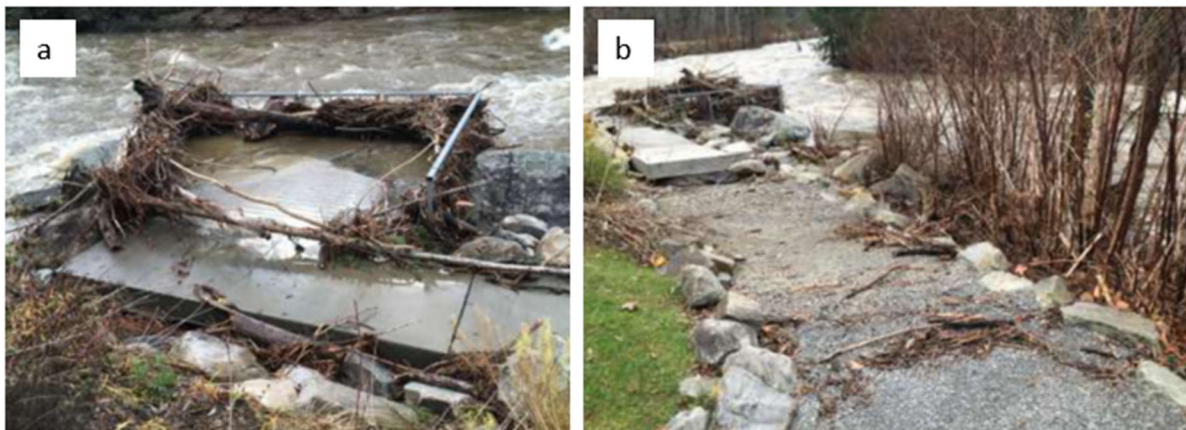
Figure 7. (a) Large woody debris was caught by the UFP railings during flooding on Oct 31 – Nov 1, 2019. (b) Floodwaters eroded gravel from the access path and the concrete slab cracked when undermined during this same event.

Two past flood events were sufficiently impactful to result in more substantial damages. Both floods were federally-declared disaster events. The first occurred in 2011 on August 28 during Tropical Storm Irene – a flood with an annual exceedance probability of approximately 3% in the New Haven River watershed (Olson, 2014). The gravel-packed access ramp was washed out, and expenses to restore the ramp were reimbursed, in part, through federal and state grants. The second substantial flood event occurred on November 1, 2019. Heavy rains following a wet October, generated peak flows on the New Haven River with an annual exceedance probability of 1 to 2% (Olson, 2014). Post-event site inspections and survey indicated that floodwaters rose to approximately 1 foot over the top surface of the platform, and the upstream anchoring boulder moved (SLR Corp presentation to Selectboard, 9/27/21). Brackets attaching the platform were separated from the boulder, and the platform is now off-level. The concrete ramp was undermined and cracked.

To ensure maximum reimbursement of proposed repairs to the platform and ramp from federal and state agencies under this federally-declared disaster, design plans for repair must be reviewed and approved by the appropriate agencies. The COVID-19 pandemic emerged in the months immediately following the 2019 flood, and led to delays and disruptions to the normal process of FEMA site inspections and design review. In 2021, the Bristol Selectboard engaged the engineering firm that worked on the original construction to conduct an inspection of the site, and develop design plans for repair of the platform and ramp, as well as mitigation designs for FEMA review and approval. ~~Mitigation alternatives include removable railings on the platform, and an access ramp of composite decking founded on helical piles to replace the gravel and concrete access ramp.~~ At the time of this Management Plan update, ~~a determination from FEMA on has approved both~~ the repair and mitigation designs ~~was pending for repair of the access ramp and platform.~~ Construction has gone out for bid and is scheduled to occur within a permitted window between August 1 and October 1 of 2023.

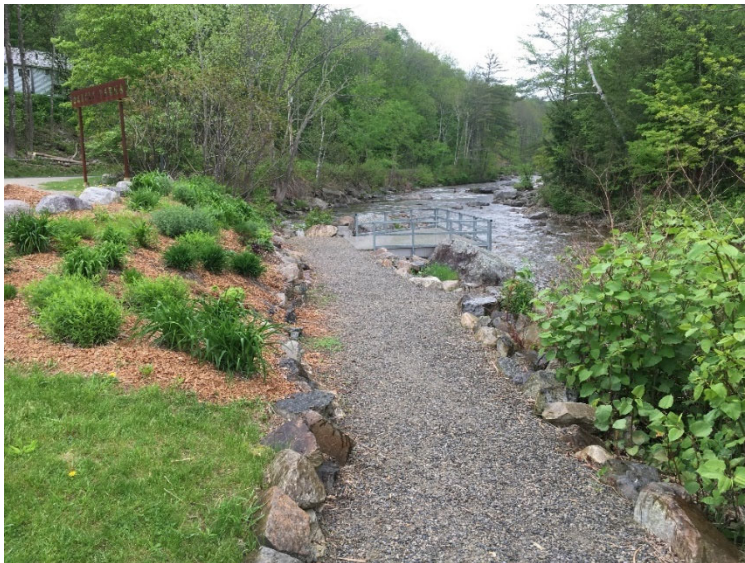
Figure 9. Access ramp leading to the UFP is flanked by a perennial garden on the north and invasive Japanese Knotweed to the south. (Photo dated prior to 2018).
