# Construction Observation Report

**Date:** March 6, 2024

**Project:** Repair of the New Haven River Universal Fishing Platform (SLR #14680.00002)

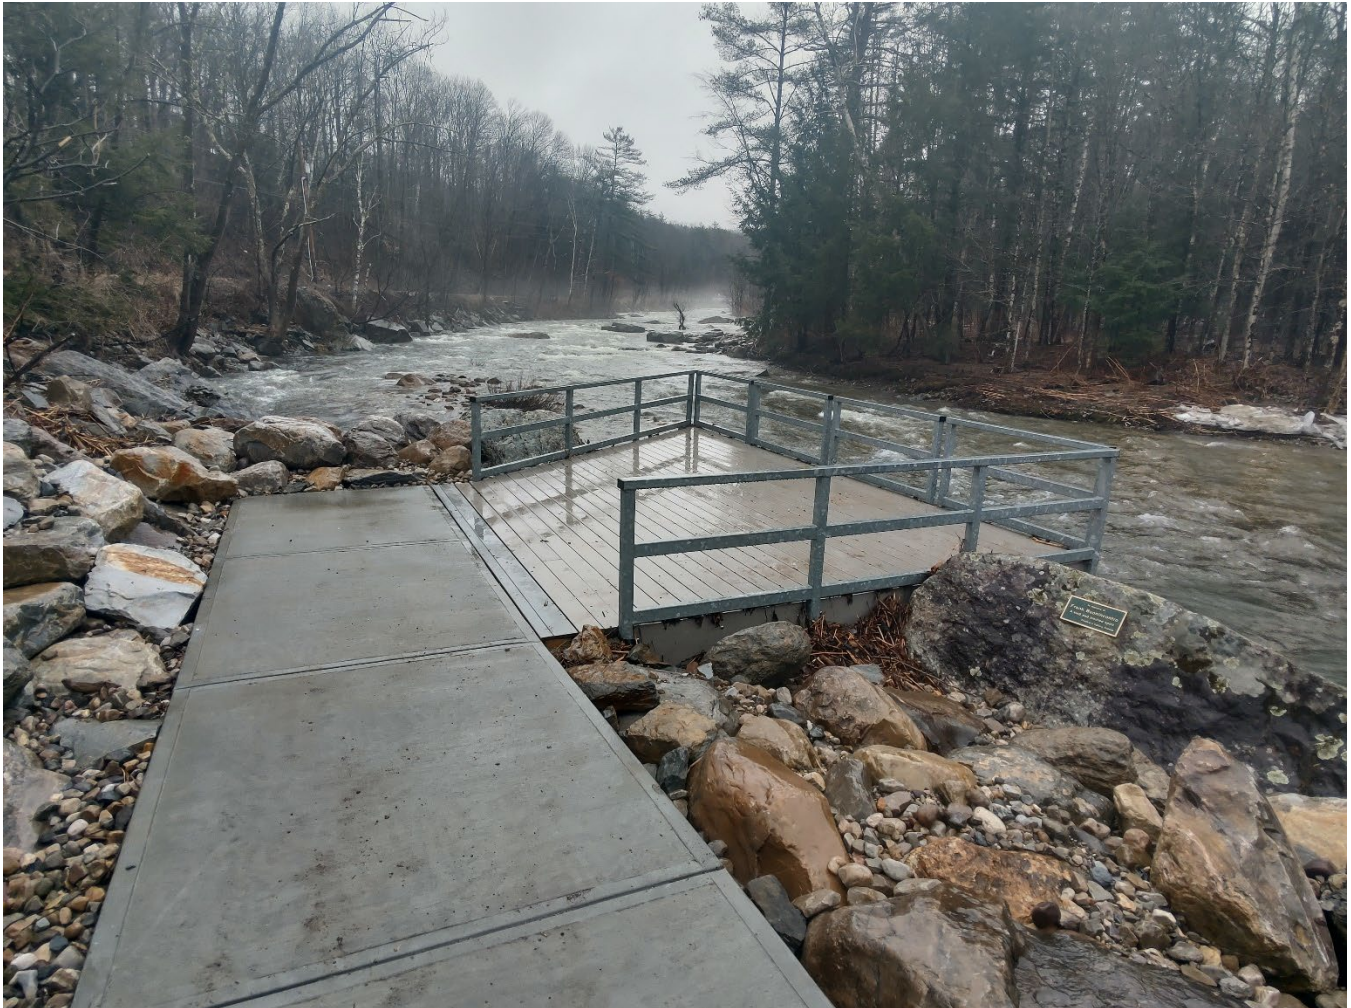
- Placement of stone boulders on both sides of the concrete walkway complete upon arrival. Bank run gravel washed into voids to fill and to help lock stone together.

**Figure 1: View of newly placed boulders with voids filled with bank run gravel. Note deck boards added to fill gap between platform and concrete walkway.**

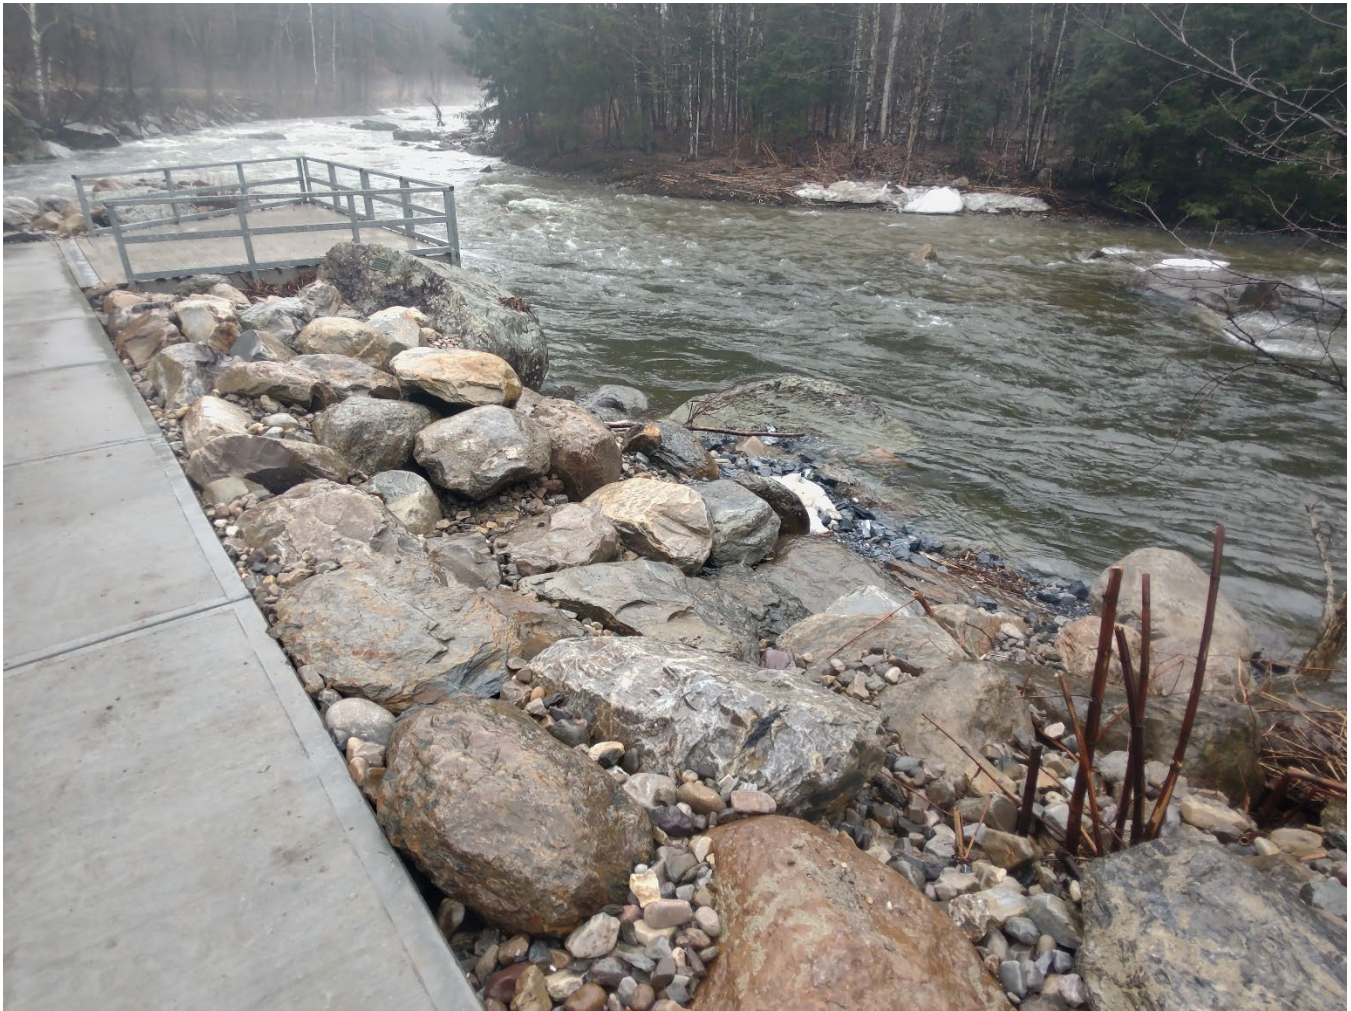
- More boulders added on the river side of the walkway to fill void and pack newly placed boulders in with existing large boulders as best as possible.

**Figure 2: View of completed boulder placement on river side of the walkway with stepping stones placed for access to edge of river.**

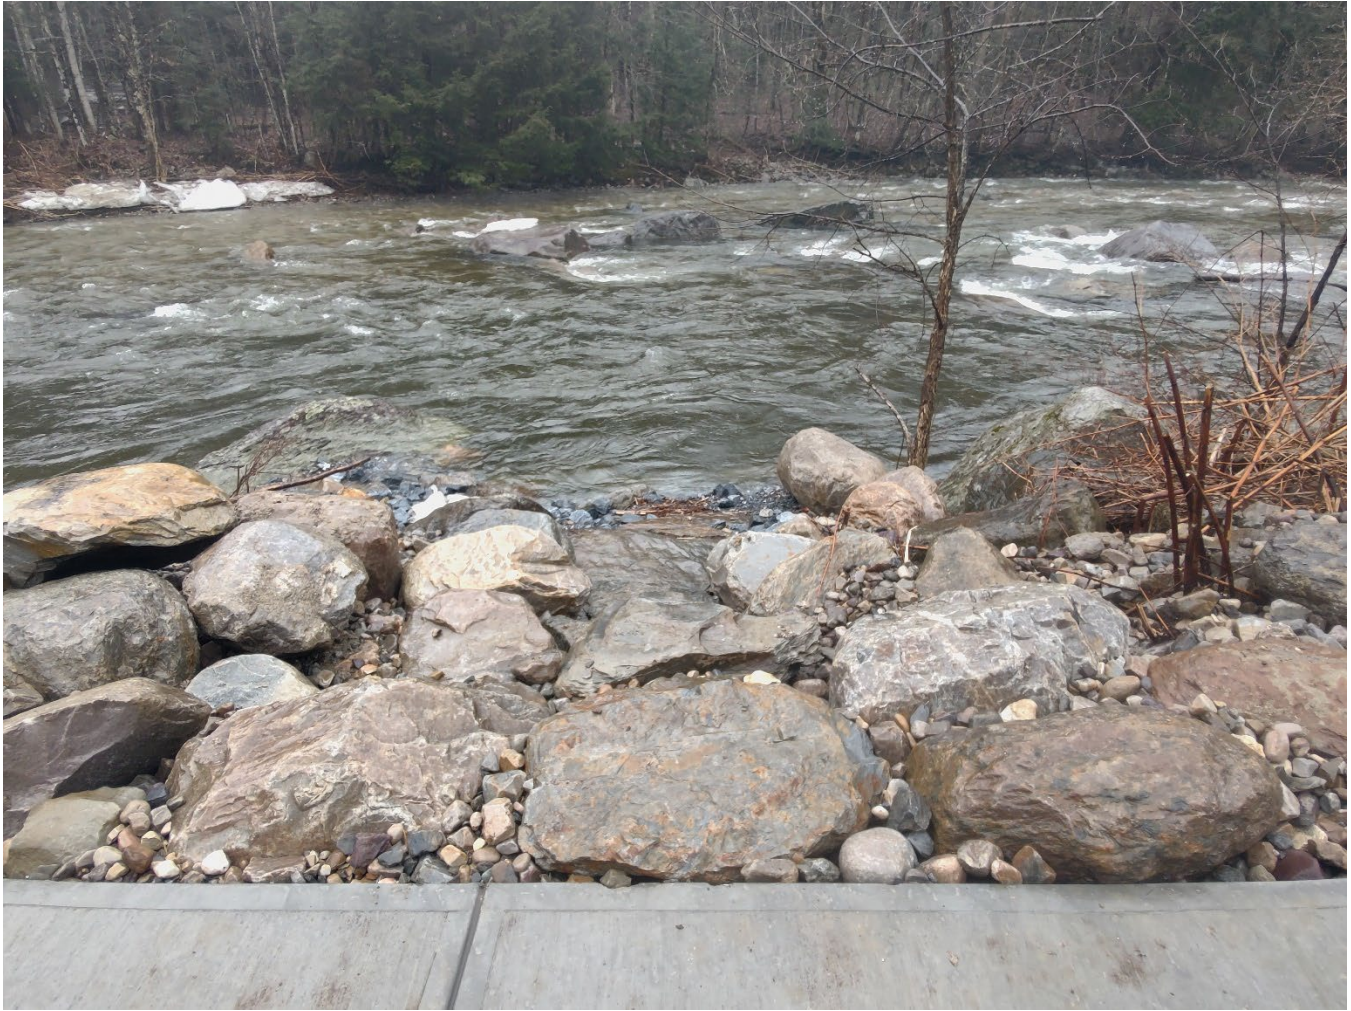
**Figure 3: Stepping stones placed for access to the river visible at the center of the photo.**

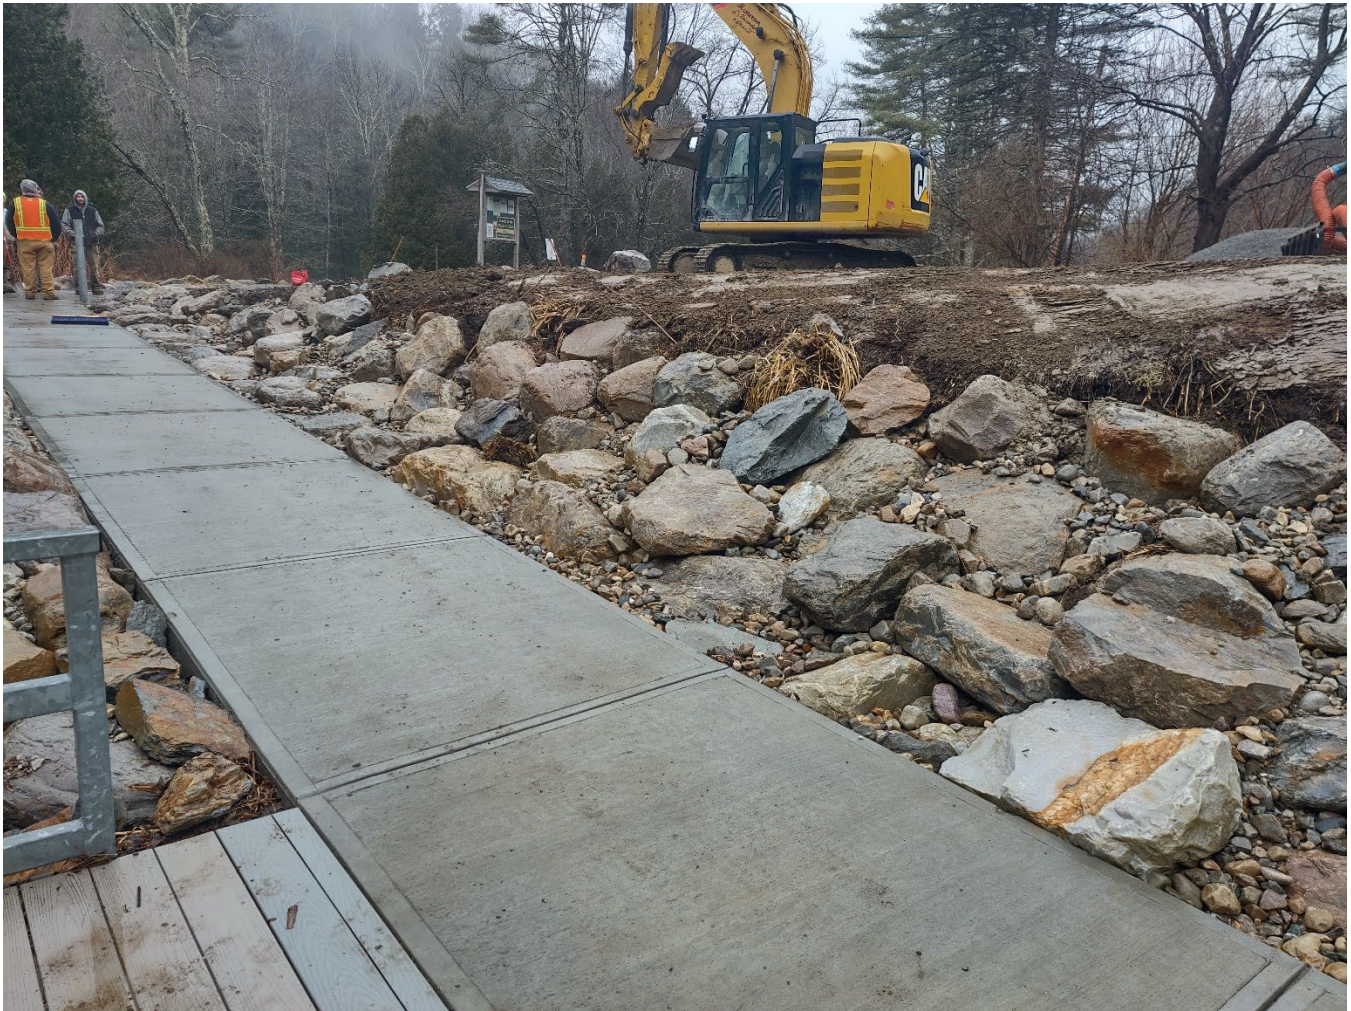
- Top of slope has been reshaped and topsoil placed to restore the area that was previously planted.
- Composite deck boards were placed to fill gap between the platform and concrete walkway.

**Figure 4: View of completed boulder placement on the parking lot side of the walkway. Work underway to shape top of slope and spread topsoil to restore lawn / planting area.**

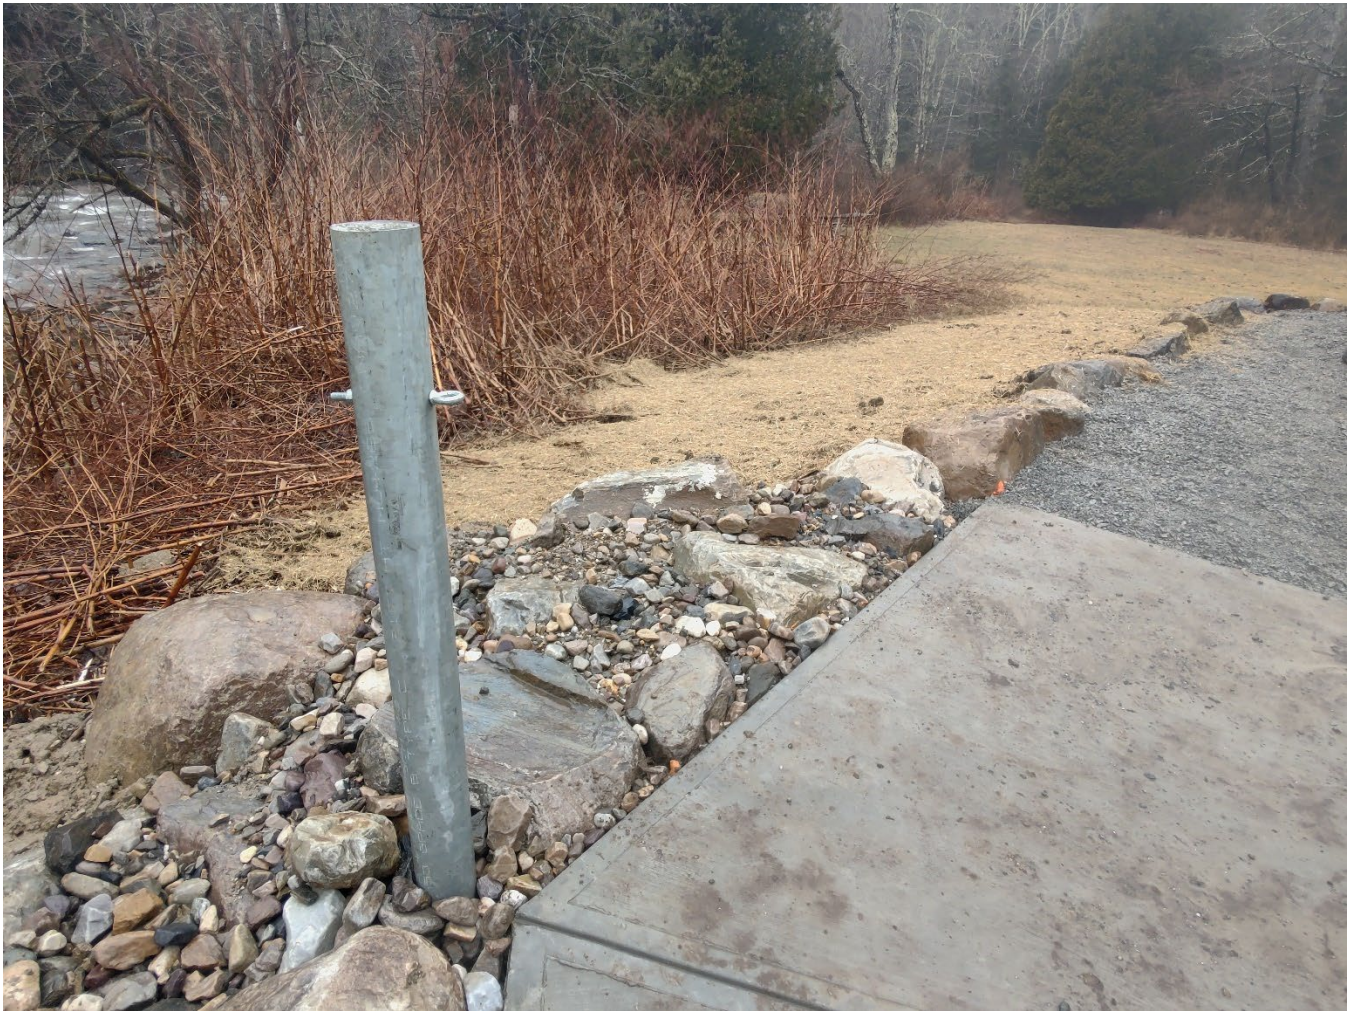
- Galvanized posts were cut to length and filled with concrete. Cap will be placed on top of the posts. Threaded eye-bolts were placed through both posts.

**Figure 5: Galvanized post cut to length and filled with concrete. Threaded eye bolt attached to the post. Restored lawn area with seed and mulch visible in background.**

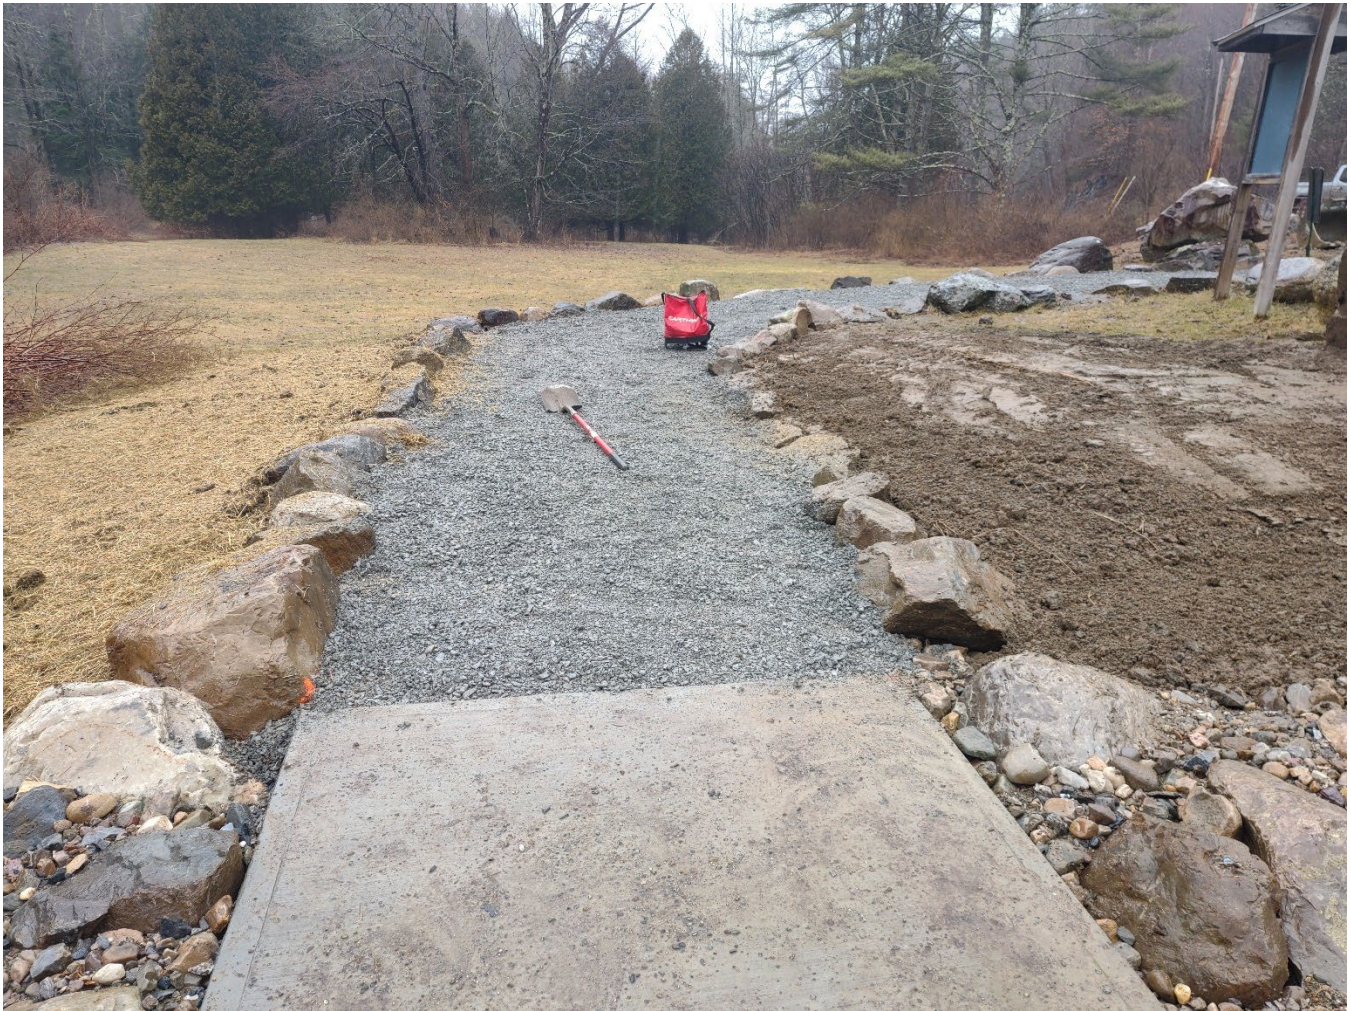
**Figure 6: Restored gravel path lined with small boulders, restoration of lawn area underway to the right of the path in photo.**

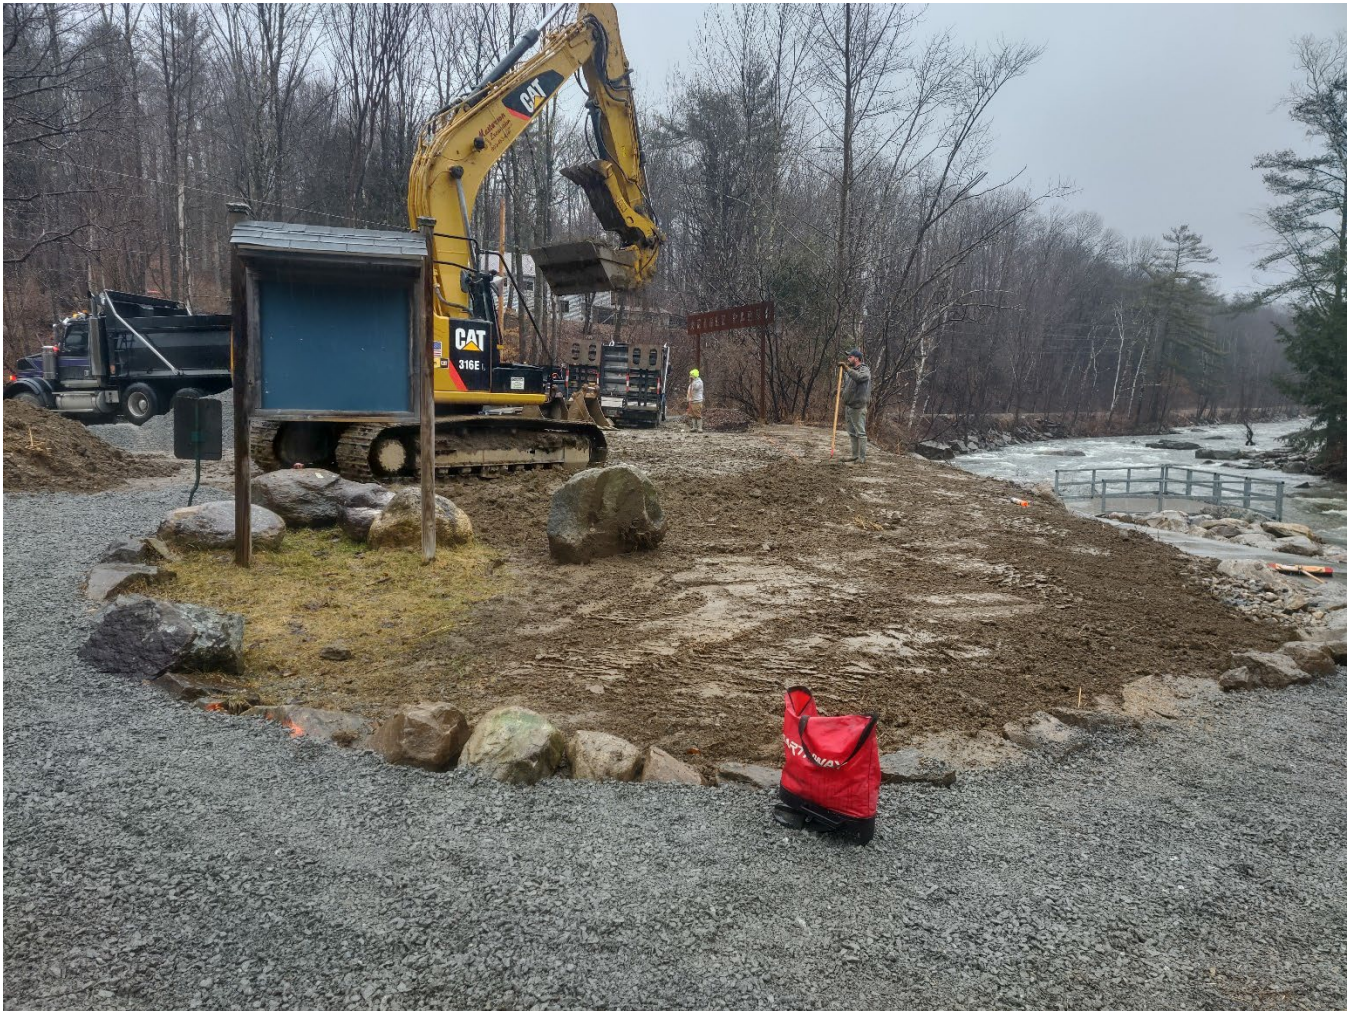
- Memorial stone was reset and placed near the entrance of the gravel walkway and informational sign.

**Figure 7: Reshaping of the upper slope and restoration of the lawn area underway. Memorial stone reset to the right of the informational sign in photo. Restored gravel walkway visible in foreground. Split rail fence to be installed in the restored lawn area at edge of parking. Barrier stones to be set as needed once split rail fence has been installed.**

- Installation of the split rail fence to be TBD, currently scheduled for April 1<sup>st</sup> or sooner, depending on weather conditions.
- Boulders that previously lined the edge of the parking lot will be repositioned based on the final location of the split rail fence.
