BRISTOL, VERMONT ANNUAL WASTEWATER SYSTEM EVALUATION 2023-2024

INDIRECT DISCHARGE PERMIT ID 9-0208-1

VTM Engineering, PLC

Revised May 28, 2024

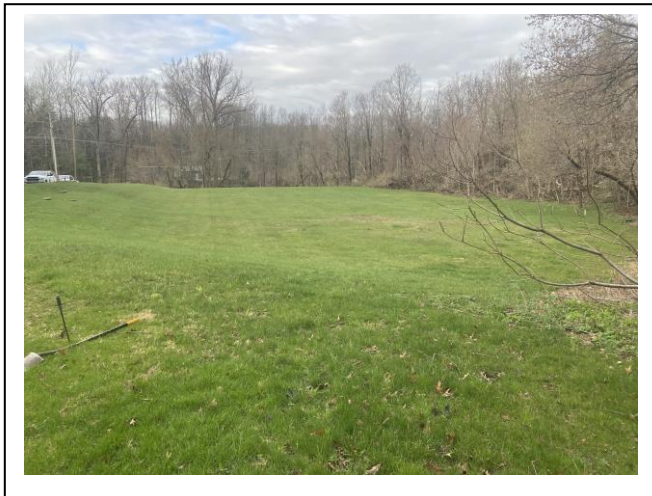
VTM and VTUMS personnel walked each of the eight disposal fields. The disposal field area is neat and clean and appears to be mowed on a regular basis. During last previous inspections, VTM noted that sumac and box alder trees were encroaching on the disposal fields. Trees bring the potential for root damage to the disposal fields. In the spring of 2023, VTUMS removed much the sumac and graded and re-seeded the impacted areas. A box alder tree has fallen on the east side of the disposal area. Annual maintenance should continue to be conducted each year around the perimeter of the disposal area to ensure that tree encroachment into the disposal area is kept in check. During the inspection several box alder trees were noted to be still encroaching on the disposal fields. These trees should be removed as time allows. Regular mowing of the disposal fields and surrounding areas should be continued.

Overview of the wastewater distribution field

9. Re-build the septic tank outlet structure trough to the splitter box.
10. Replacement of splitter box valve #?
11. Remove the remaining box alder and sumac trees that continue to encroach on the disposal fields.

13. Replace the existing dosing siphon counters with mechanical counters when practical.
14. Verify proper operation of the dosing syphons.
15. Continue regular mowing and trimming of the disposal field area.

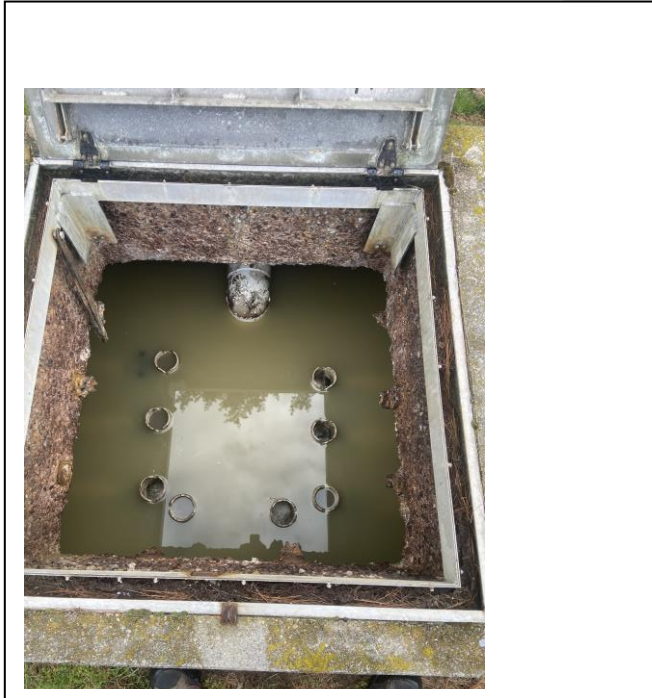
1. Fields #3, #5, #7 and #8 were observed to be off
2. Fields #1, #2, #4 and #6 were observed to be in operation
3. Appeared to be even flow between the fields, very little grease observed in splitter box
4. The splitter box and associated piping inside the box appeared to be in good condition.

VTUMS indicated that they conduct regular verification of even flow to the four fields and conduct skimming of grease in the splitter box if needed. During the inspection of the splitter box, VTUMS conducted the annual rotation of the disposal fields. Valves to operating fields #1, #2, #4, and #6 were closed. Valves to previously dormant fields #3, #5, #7 and #8 were opened and will now be in operation for the next 12 months. Even flow was observed to each of the four new operating fields. No issues of concern were noted within the splitter box.

Splitter Box
