Lawrence Memorial Library – Bristol, Vermont

Historic Architectural Assessment

Site Visit: October 24th, 2022 11am
60 Deg. Calm to light wind, overcast.
Report Date: November 11th, 2022

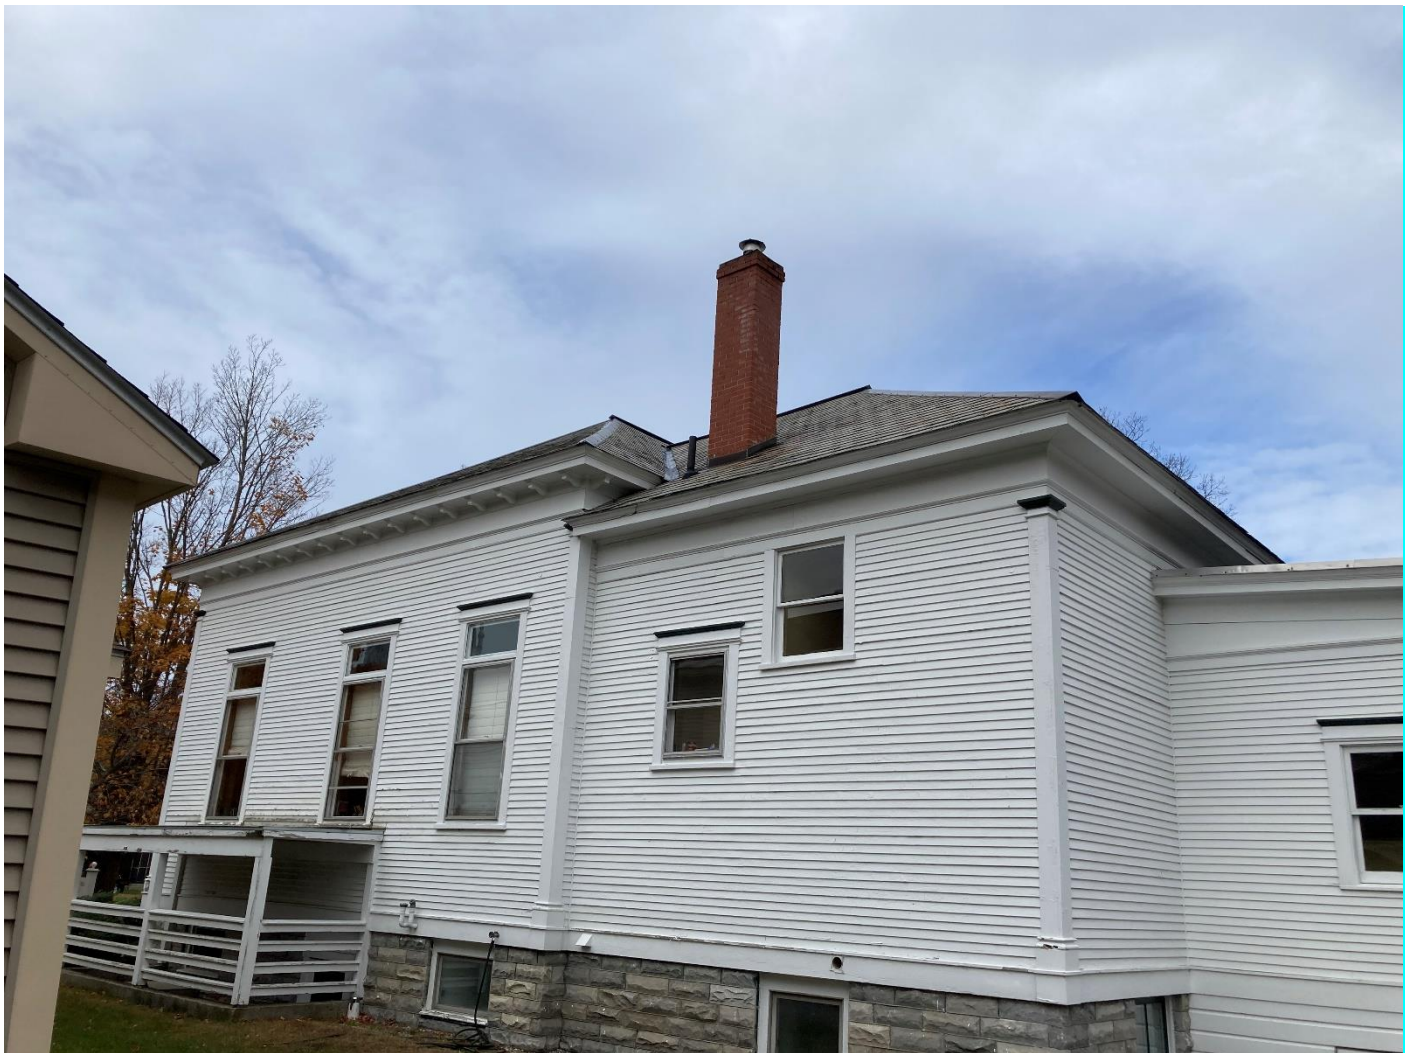
There are at least two complicating conditions for re-painting of the building’s exterior and minor siding repair: First the historic nature of the building requires that the work be undertaken by a craftsman aware of the historic implications of the work. Second the presence of lead paint is likely and the contractor will need to be aware of the implications. Any disturbance of painted surfaces likely to contain lead-based paint, should be done in accordance with all local, state and federal laws. I did observe some wood rot (wood ‘punkyness’) on the surface, particularly around the windows where rot is typically evident.

Refer to [Preservation Brief #10: Exterior Paint Problems on Historic Woodwork](#), which should be used as a guideline in addressing further paint repairs. Recommendation for frequency of repainting old wood structures typically range from three to seven years, to keep them looking their best. I recommend putting in place an exterior painting maintenance schedule that included a ‘minor / touch up’ painting every three years, alternating with a full repaint about every six to seven years. This could be adjusted as the need is observed over time.

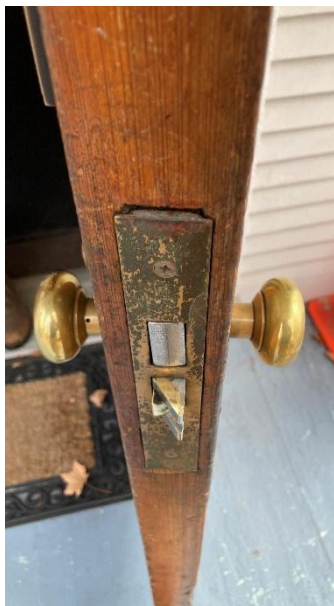
The Main entry doors are out-swinging original glass and wood doors, with brass mortise hardware. This hardware is not ADA compliant. Also, the doors are only accessed via steps. Signage should be added that indicates the location of the ADA accessible entrance. The glass is code compliant tempered safety glass.

Refurbish Front door and door hardware to bring back to like new condition.

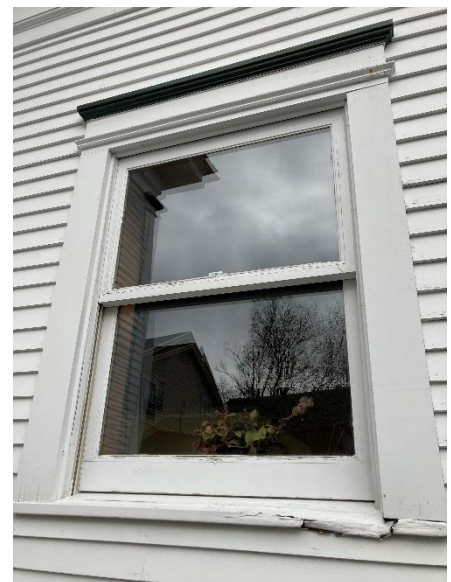
2). Smaller double hung wood windows most with aluminum storms (noted at least two smaller windows on the South side that do not have storm windows, as shown here).

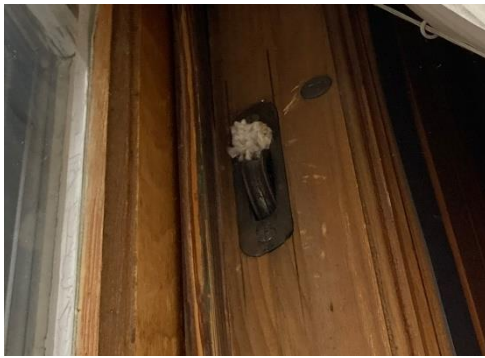
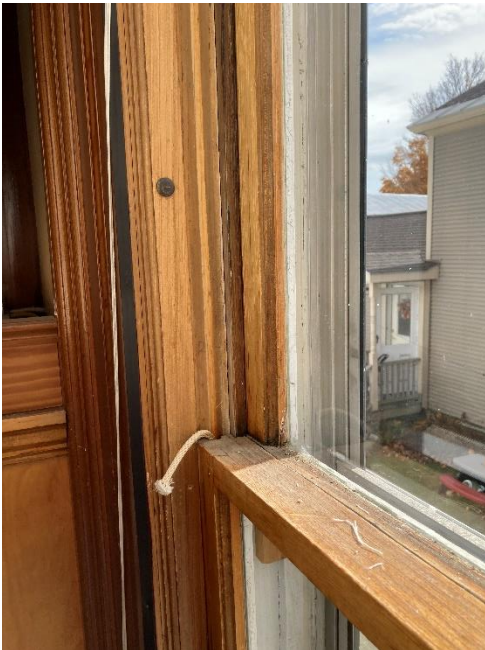
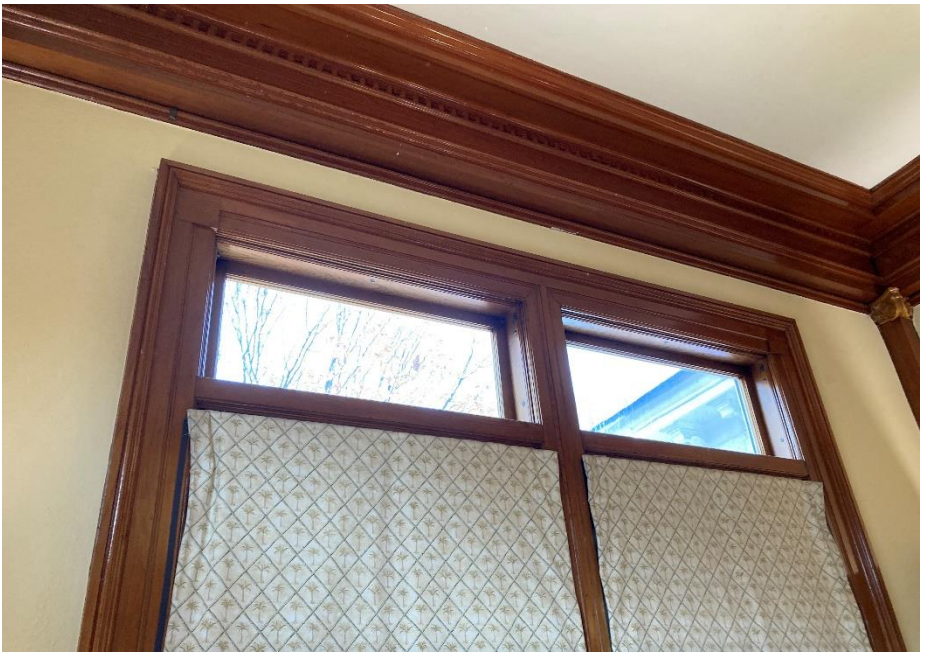
It was noted that the counterweight cords have been cut from all observed windows. Also discussed there is moisture build-up trapped between the panes of the glass in several of the upper lites.

The interior finish of these windows is suffering from drying and aging due to exposure to the elements (sun and condensation moisture), particularly on the South side. To promote the longevity of these windows they should receive a refinish every several years (in line with exterior painting). Also of note, the newer East addition seemed to have reused / relocated existing windows, and

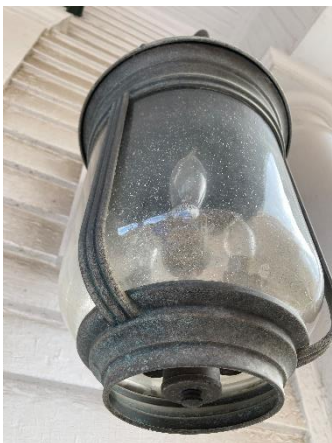
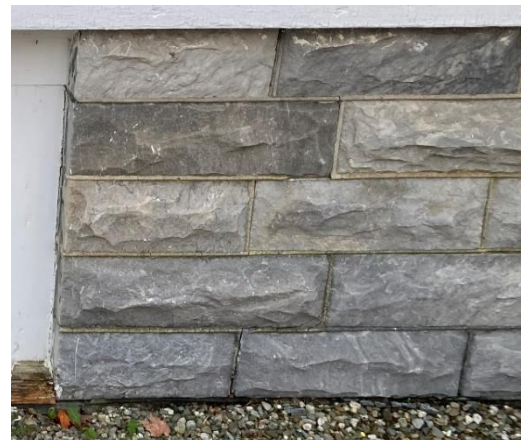
Exterior Lighting:

The exterior historic lighting at the main entrance was discussed as desiring to be restored.

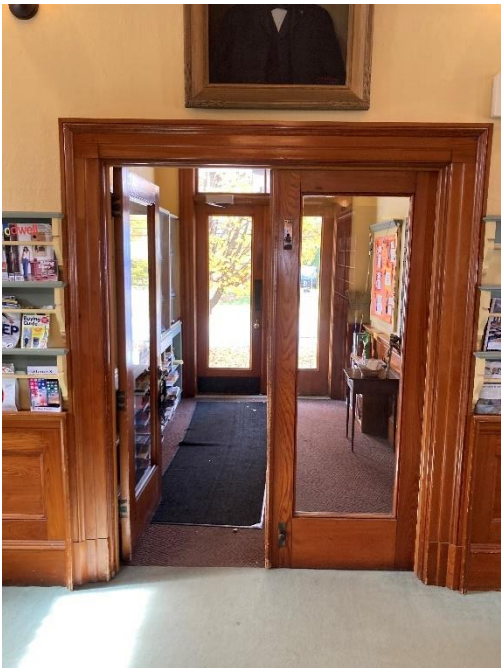
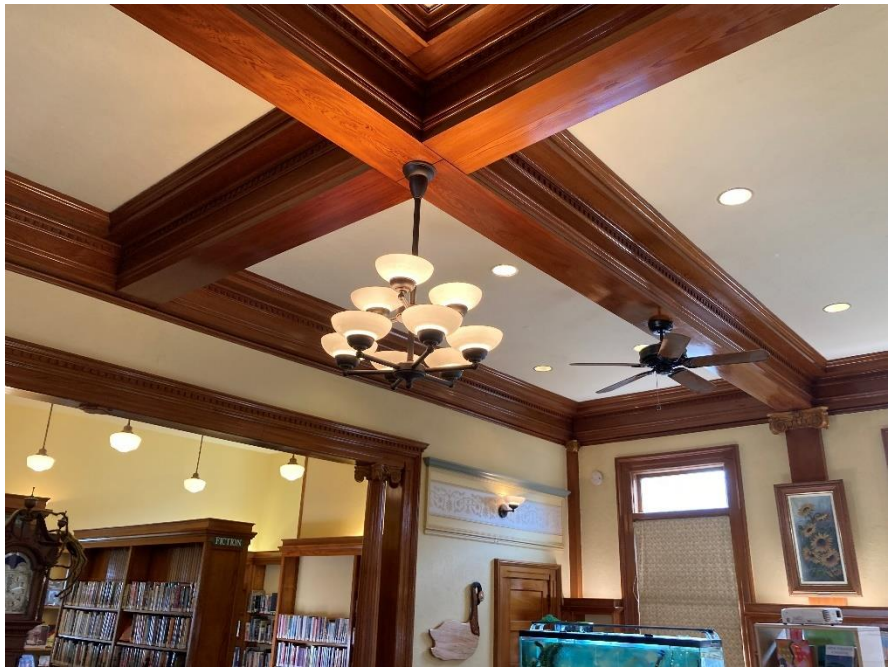
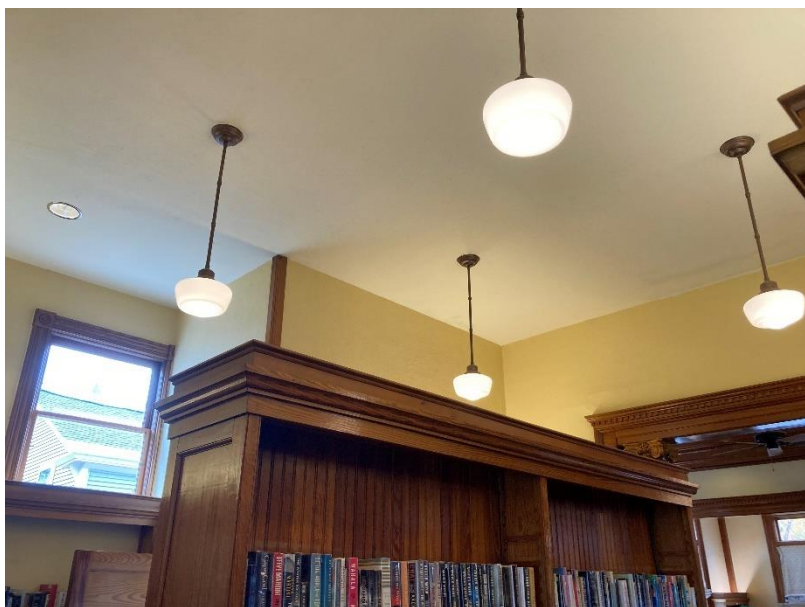
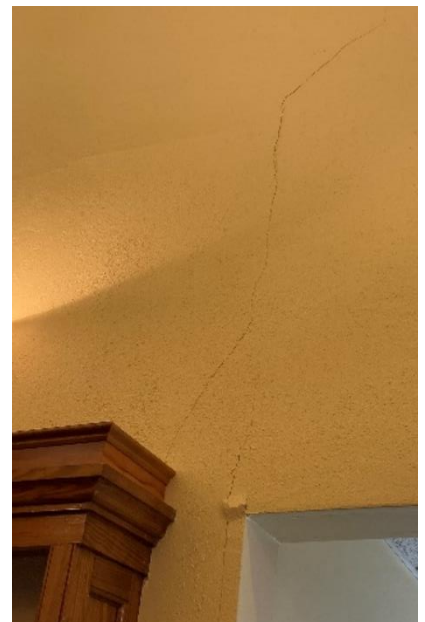
A beautiful space with ornamental woodwork representational of the local craftsmanship available at the turn of the last century in this rural community. While obviously well used, this space is lovingly maintained. There is some superficial cracking showing up on the plaster walls, that in my opinion are cosmetic and do not represent structural movement, more likely caused by thermal and humidity changes within the space.
